## **Structural Evaluation**

**Westmoreland County Community College PSTC Class A Live Fire  
Training Structure ("Burn Building")**

**EL&M No.: 23012**

**July 18, 2023**

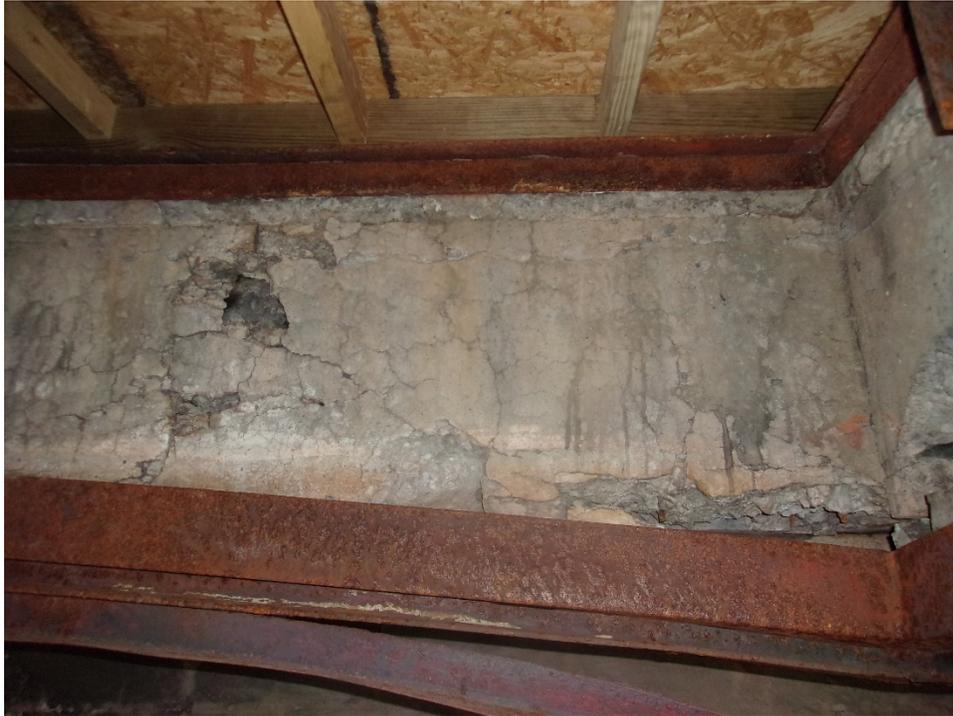
**Severely spalled concrete with exposed reinforcing within chopout opening at ceiling in Room 201 (above and below)**

Item	Observations and Recommended Actions
Elevated Floor and Roof Slabs (cont.)	<p><u>Recommended Actions:</u> After <u>immediately</u> removing the steel frame at the chopout opening at the ceiling of Room 201, saw cut around the perimeter of the damaged concrete and remove all delaminated (loose) concrete, including around exposed reinforcing bars. Remove corrosion from exposed reinforcing and apply an anti-corrosion bonding agent to the exposed reinforcing and the existing concrete surfaces. Patch the concrete with a high strength (bond and compressive strengths), non-shrink, cementitious repair material, such as SikaTop 123 Plus or SikaTop 111 Plus, or other equivalent repair materials from other manufacturers that is suitable for exterior vertical / overhead applications, to restore the slab to its original conditions. Provide proper cover over slab reinforcing. Follow the manufacturer's instructions for preparing slab surfaces and mixing/ placing/curing the patch material. After patching and curing the concrete, provide thermal linings within the opening to protect the concrete in the future.</p> <p>Remove remaining fire brick at the floor in Room 201 to expose the remainder of the top of the slab. Rout and seal all cracks wider than 1/32" in the top surface of the second floor slab in Room 201. Seal cracks with a flexible, exterior-quality sealant such as Sikaflex 1a. Another option is to pressure inject the cracks with an epoxy adhesive such as Sikadur 52. After repairing cracks, apply a coat of MasterProtect H 1000, by BASF, or an equivalent concrete sealer by Euclid Chemical Company or Sika USA, to the entire top surface of the floor slab in Room 201. Prepare the concrete surface and apply the sealer in accordance with the requirements of the manufacturer. Reinstall the fire brick on the floor after applying and properly curing the concrete sealer.</p> <p><u>At the crack in the second floor slab, near the corner of the interior stairwell, more investigation is required.</u></p> <p>Remove the fire brick from the top of the second floor slab in the Closet adjacent to Room 203 for a distance of at least 3'-0" from Column C3 in both directions, or farther if required to reveal the full length of the slab crack that is visible at the slab edge in the stairwell. Remove the 4" CMU wrap around all four sides of Column C3 below the second floor slab and look for</p>

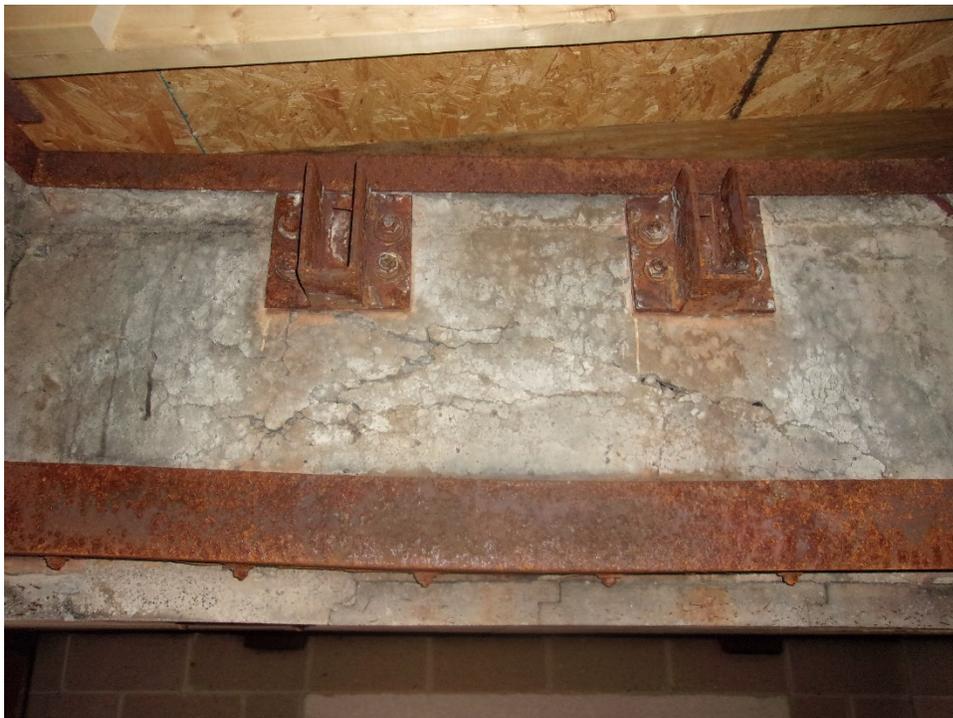
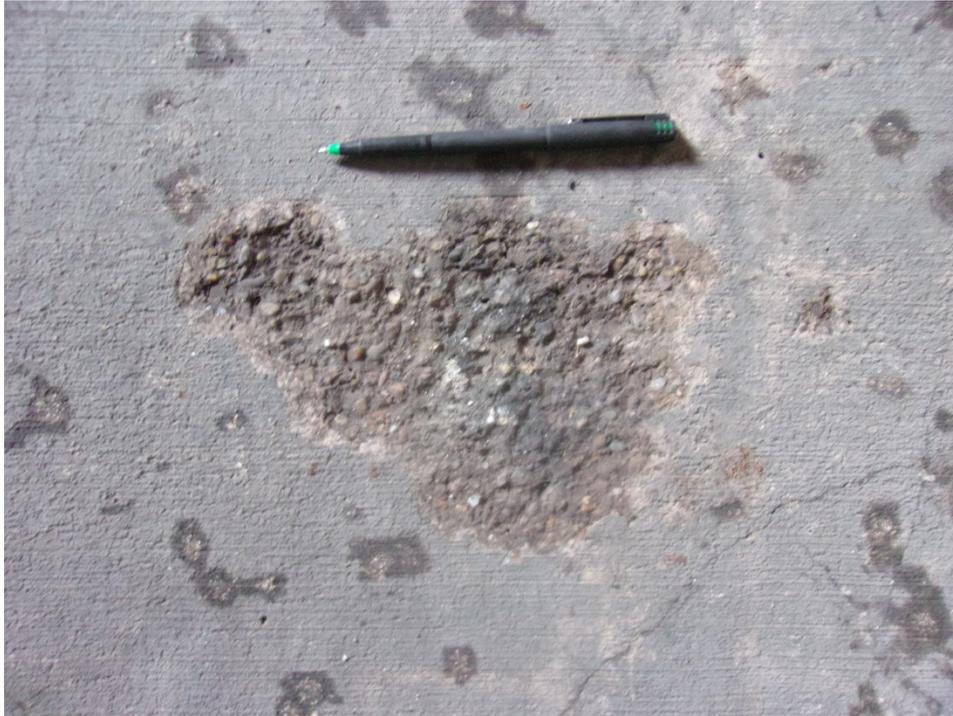
**Cracked, delaminated and spalled concrete within chopout opening at ceiling in Room 201 (above and below)**

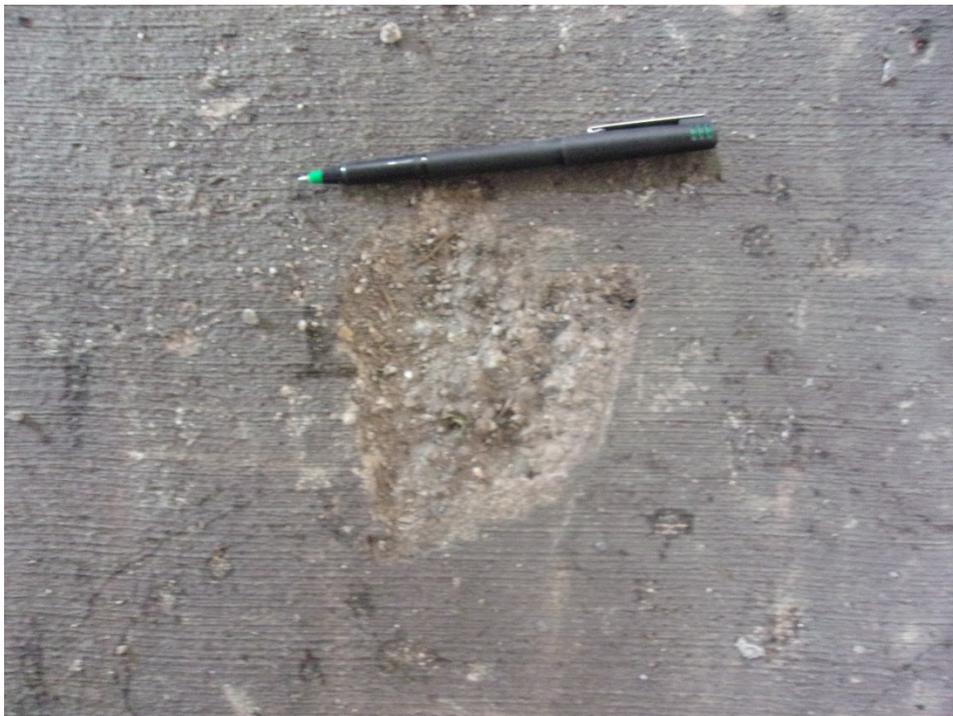
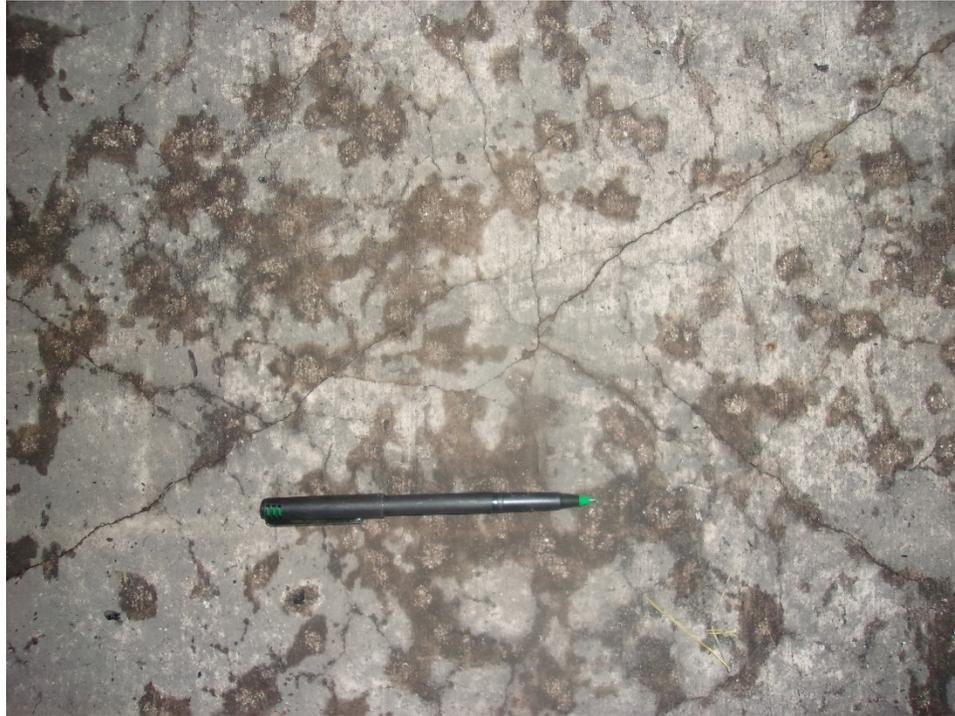
**Minor (shallow) spalls in top of slab where fire brick was removed  
at floor of Room 201 (above and below)**

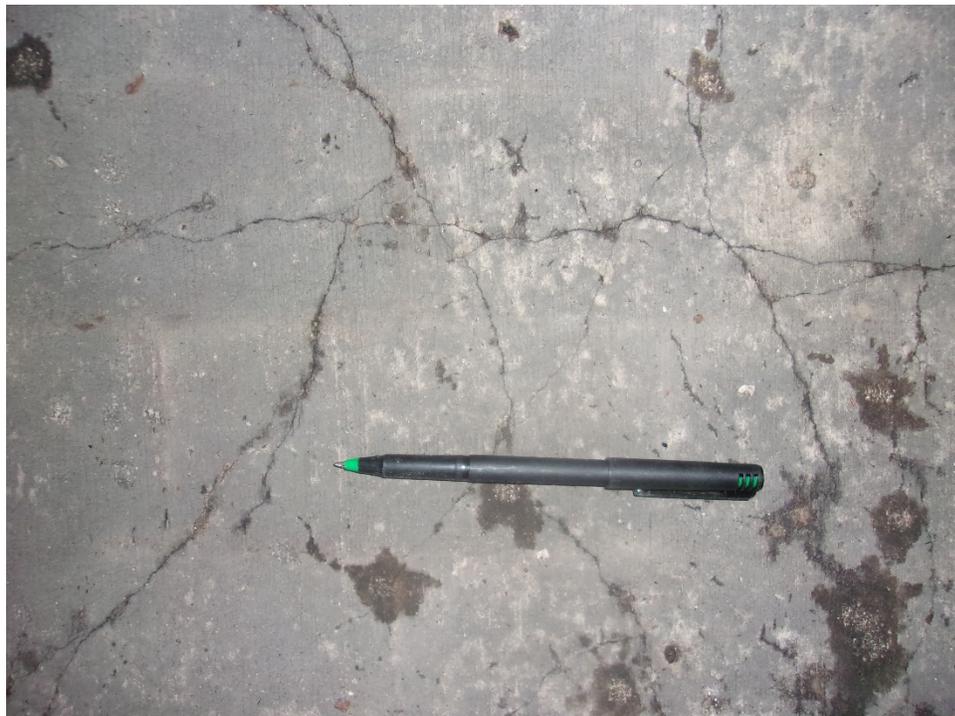
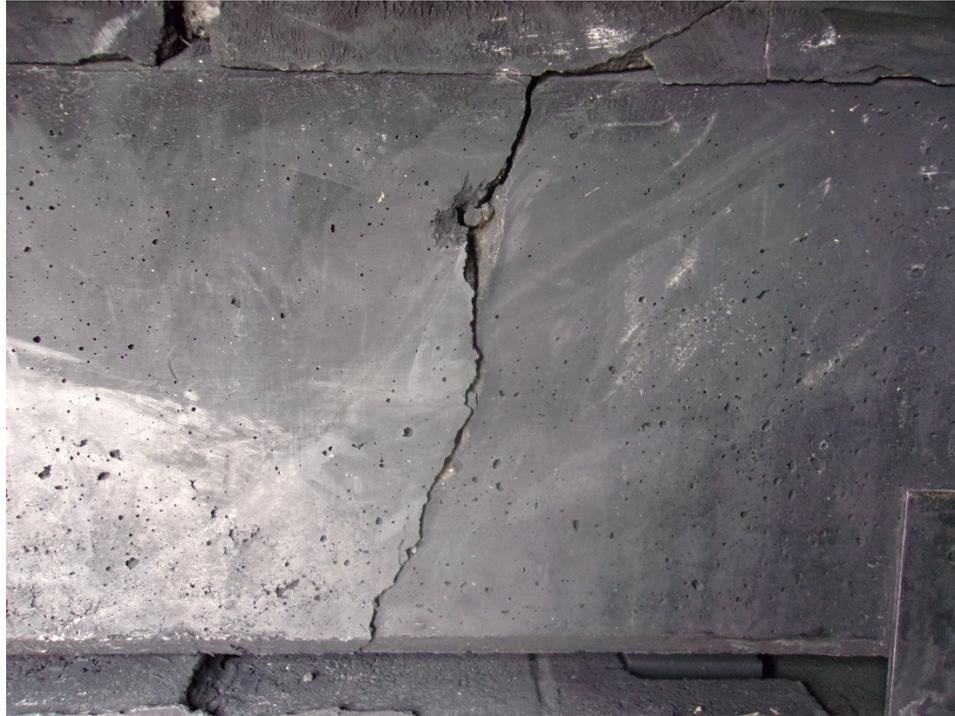
**Typical cracks and chips in top of slab where fire brick was removed at floor of Room 201 (above and below)**

- Remove remaining fire brick at the floor in Room 201 to expose the remainder of the top of the slab. Rout and seal all cracks wider than 1/32" in the top surface of the slab as indicated in the table on Page 8 of this report.

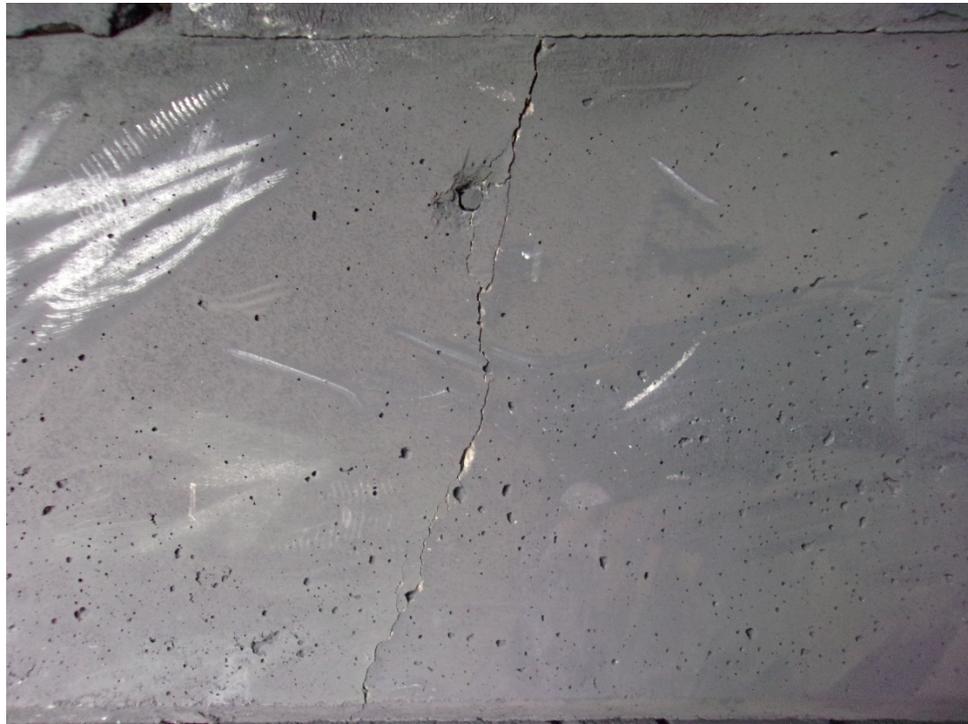
**Moderate crack at vertical edge of second floor slab at interior stairwell**

- At the crack in the second floor slab, near the corner of the interior stairwell, more investigation is required. Remove the fire brick from the top of the second floor slab in the Closet adjacent to Room 203 for a distance of at least 3'-0" from Column C3 in both directions, or farther if required to reveal the full length of the slab crack that is visible at the slab edge in the stairwell. Remove the 4" CMU wrap around all four sides of Column C3 below the second floor slab and look for cracks in the faces of Column C3. Once the fire brick is removed from the second floor slab and masonry wrap removed from Column C3, notify EL&M so that EL&M can send an engineer to evaluate the conditions.

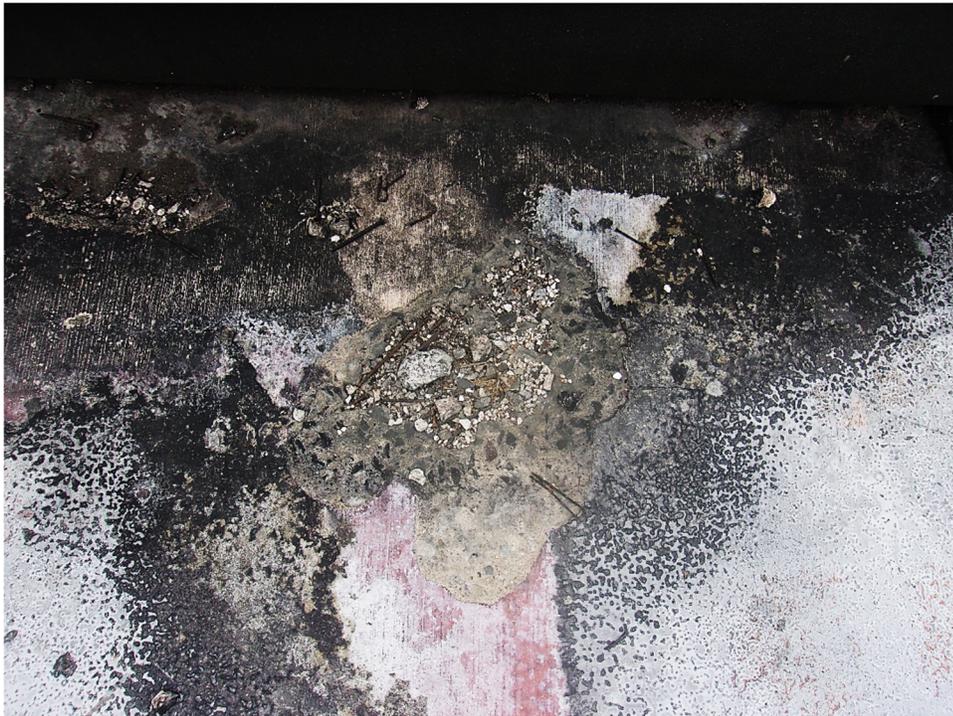
**Typical minor cracks in vertical exterior edges of elevated slabs**

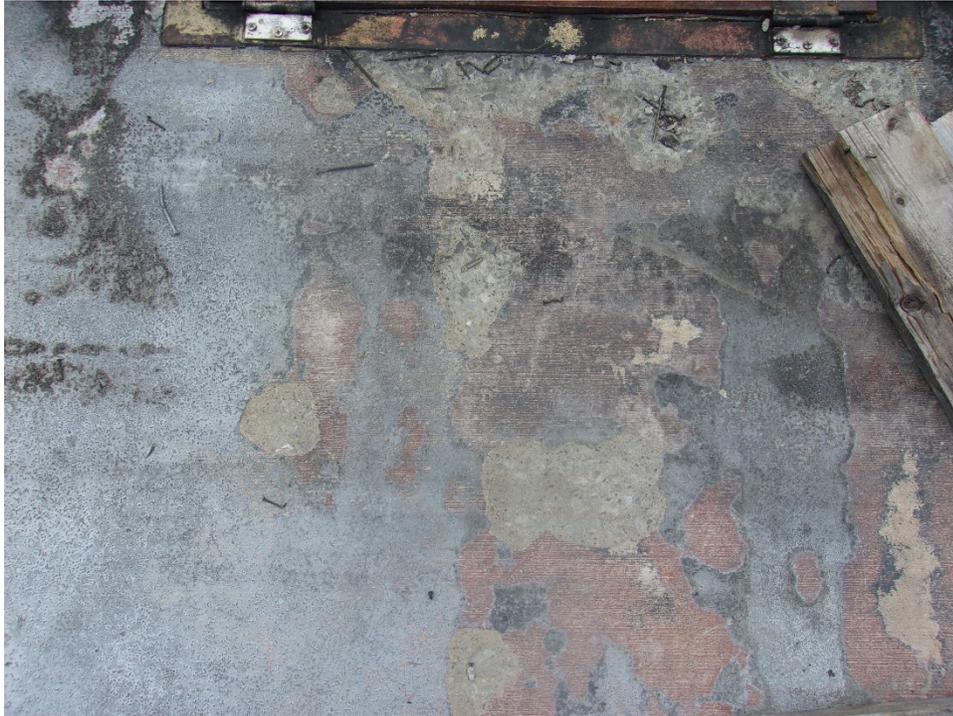
**Minor spalls at top of roof slab adjacent to chopout opening**

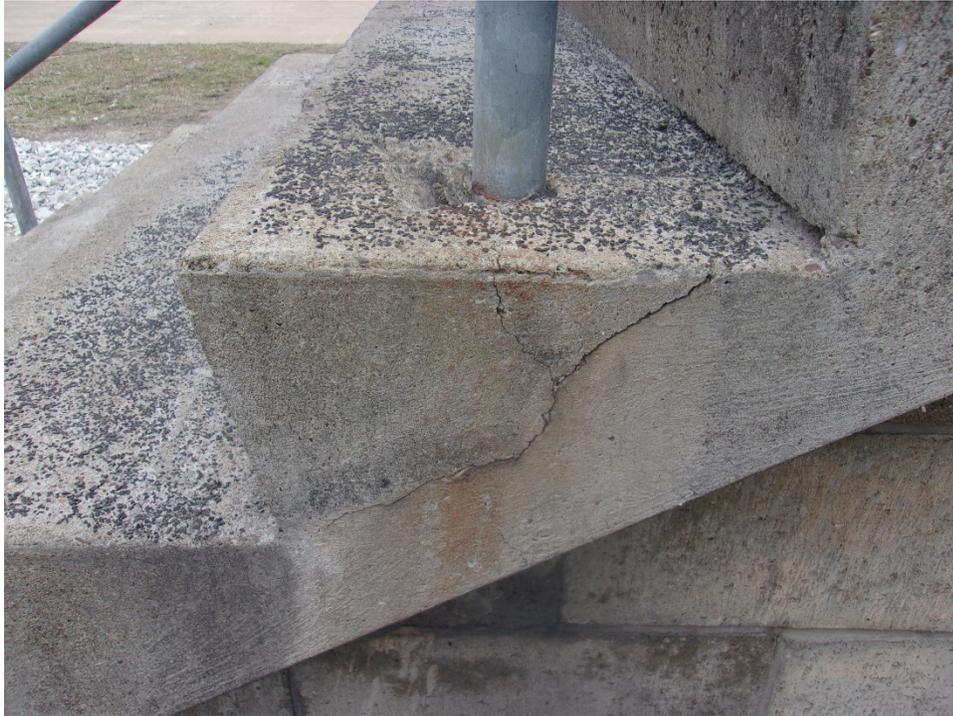
**Typical minor chips in concrete stair nosings at interior and exterior concrete stairs and typical grout missing from core at base of embedded guardrail posts**

- Fill the cores at the base of the embedded guardrail posts at the exterior concrete stairs with a non-shrink grout to prevent standing water in the cores, which could freeze and damage the treads further and possibly cause the guardrails to become loose and unstable. Epoxy inject the cracks in the steps adjacent to the guardrail posts.

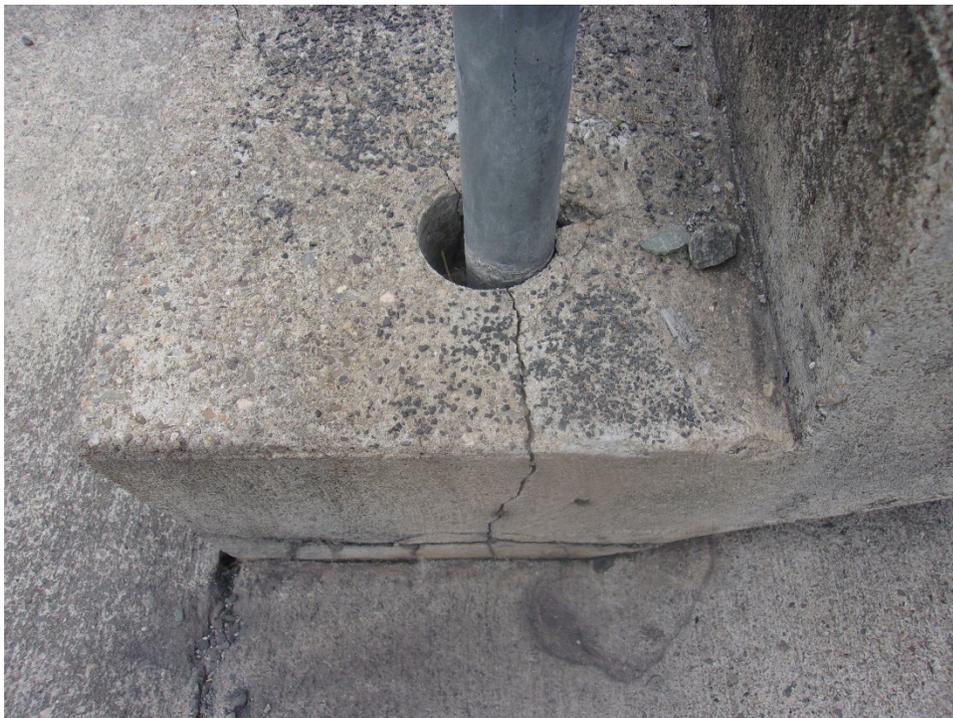
**Typical cracks at embedded guardrail posts at exterior concrete stairs  
(above and below)**

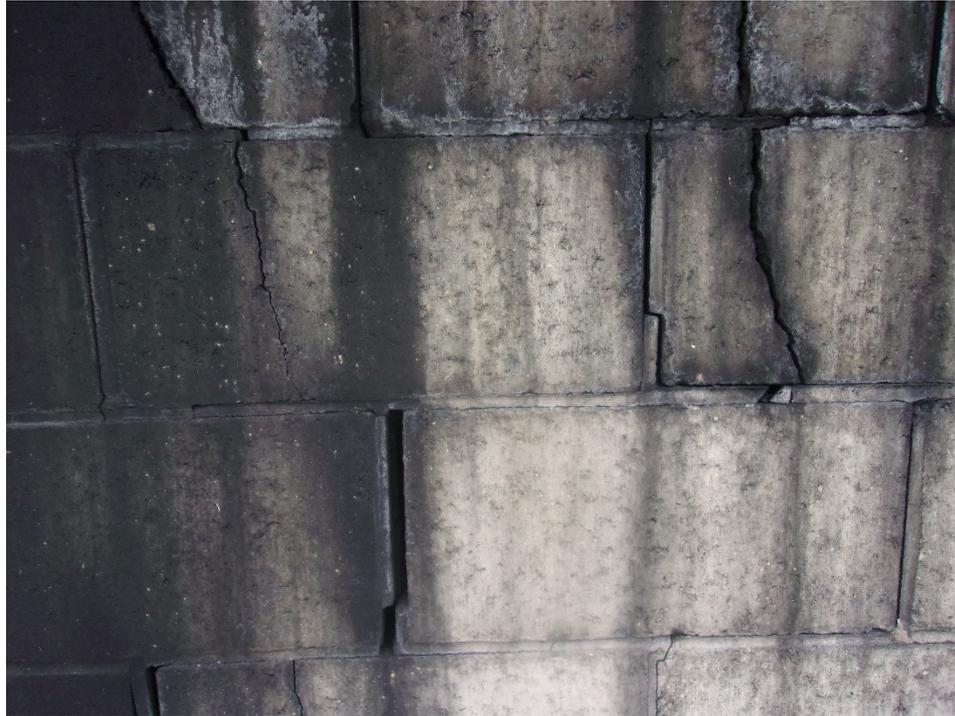
**Moderate to severe cracks at exterior surface of second floor wall at C Elevation**

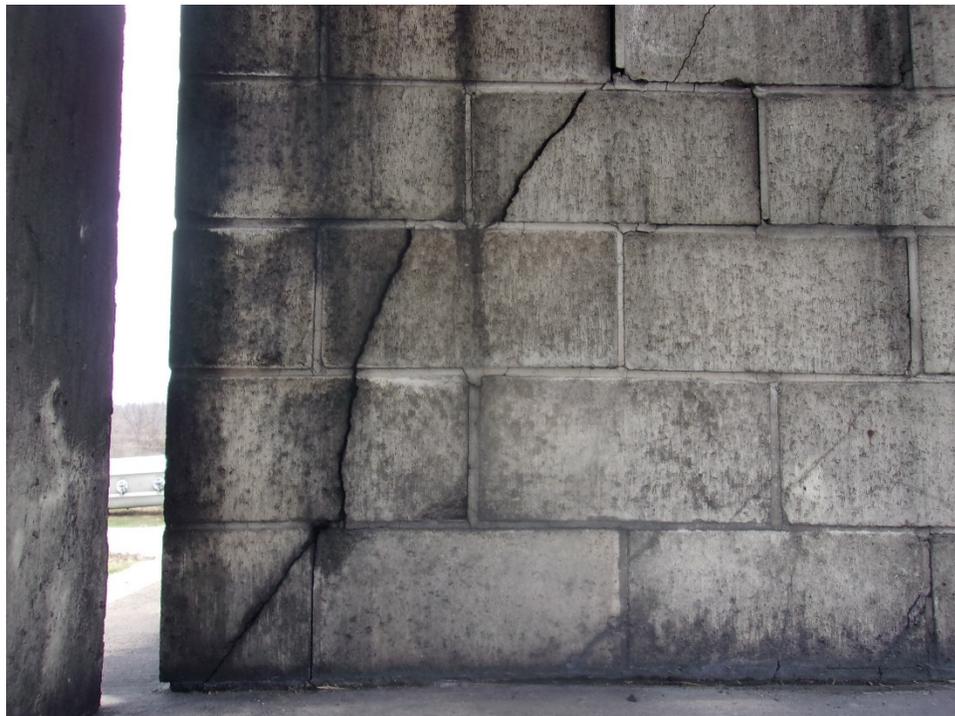
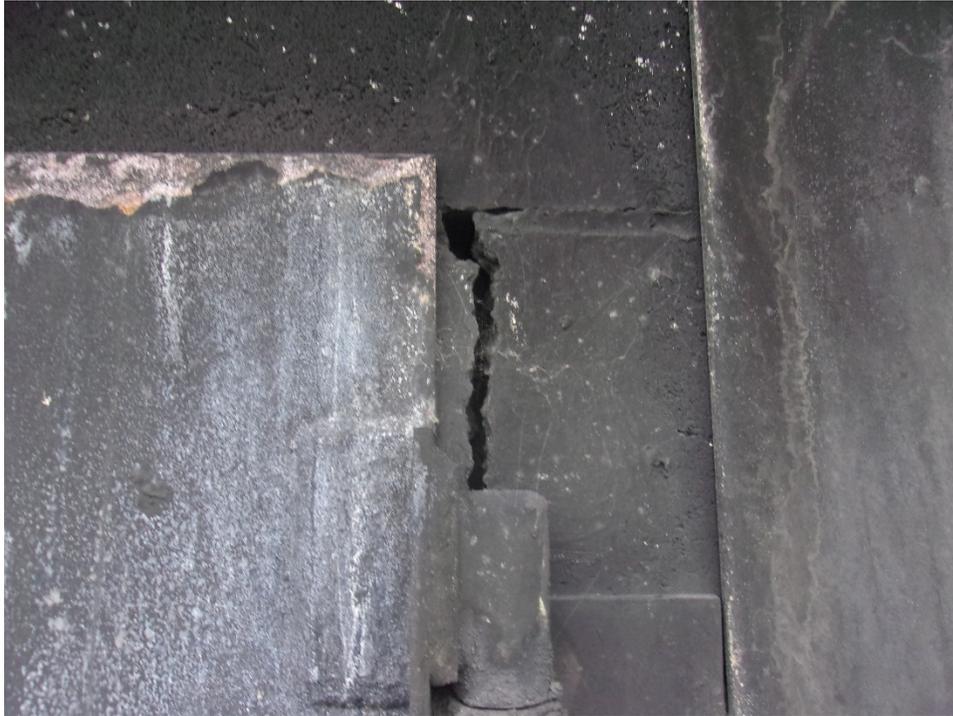
**Moderate to severe cracks at exterior surface of second floor wall  
at C Elevation at CD corner (above and below)**

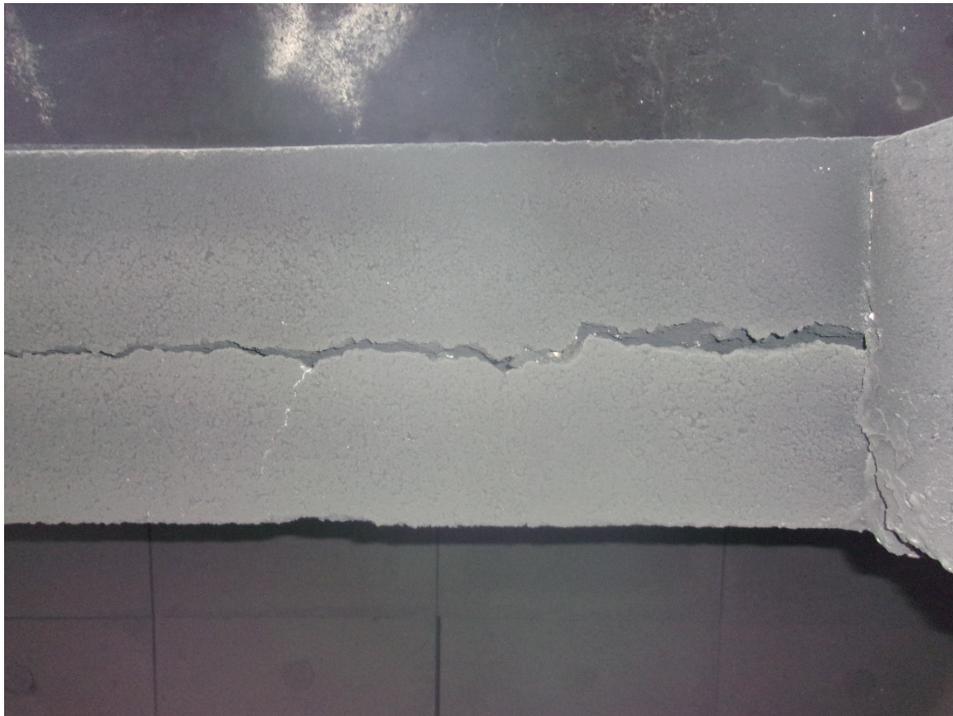
**General deterioration at exterior surface of first floor wall at A Elevation**

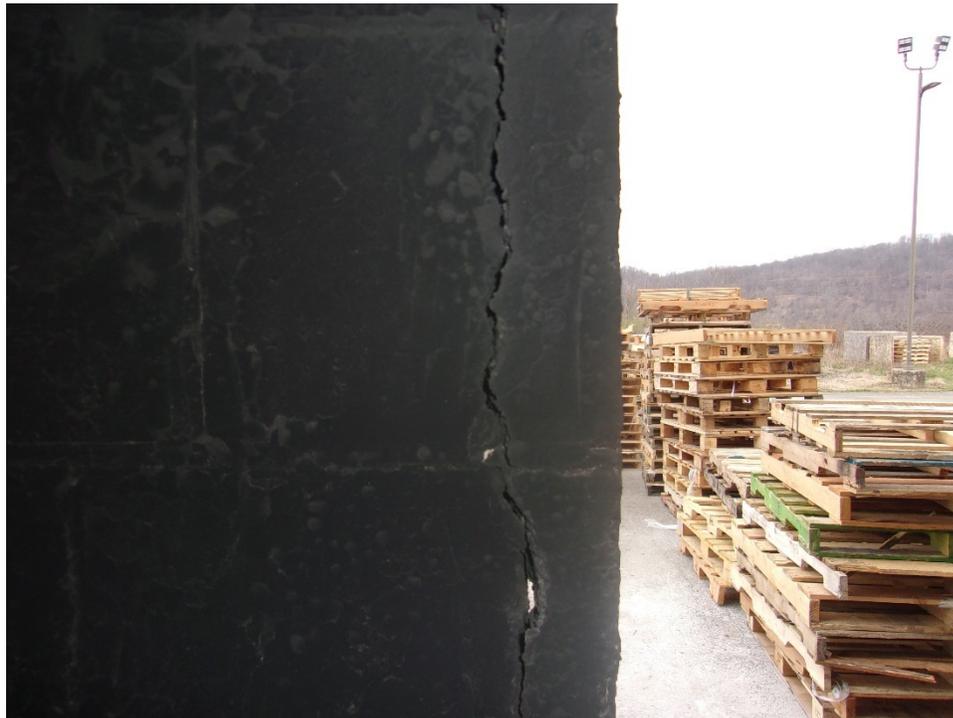
**Severe cracks at south jamb of double door opening in Room 100  
(exterior face above and interior face below)**

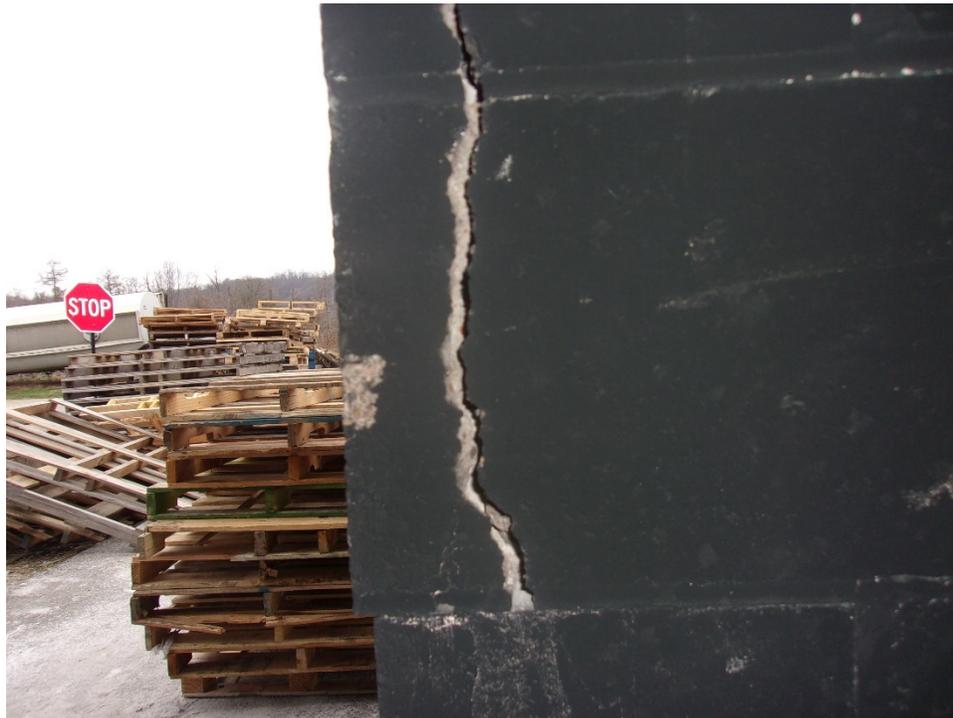
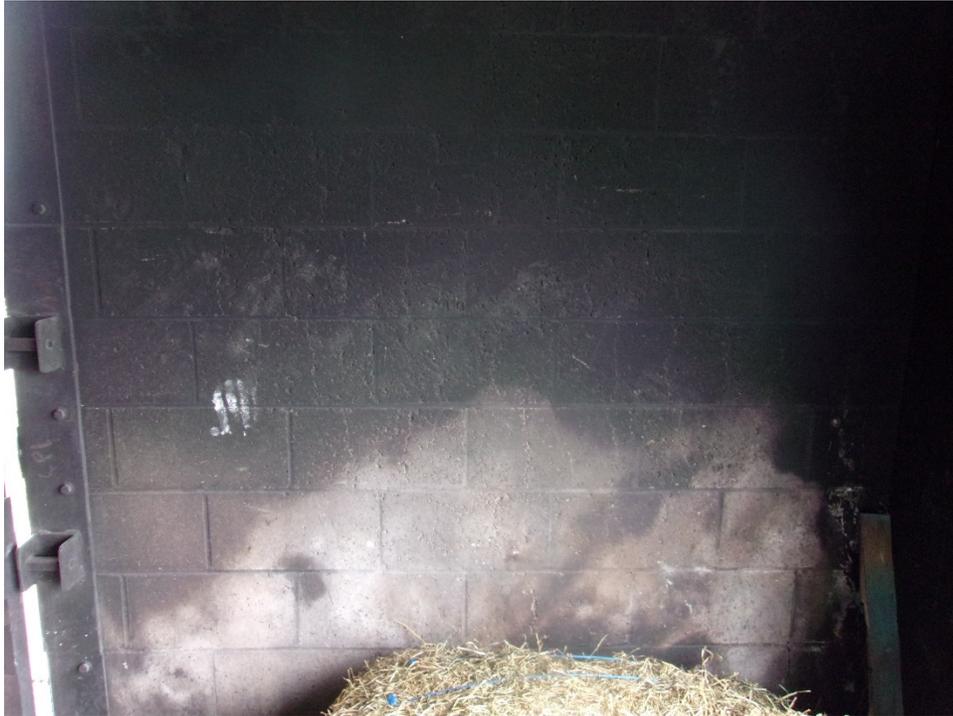
**Severe cracks at north jamb of double door opening in Room 100  
(exterior face above and interior face below)**

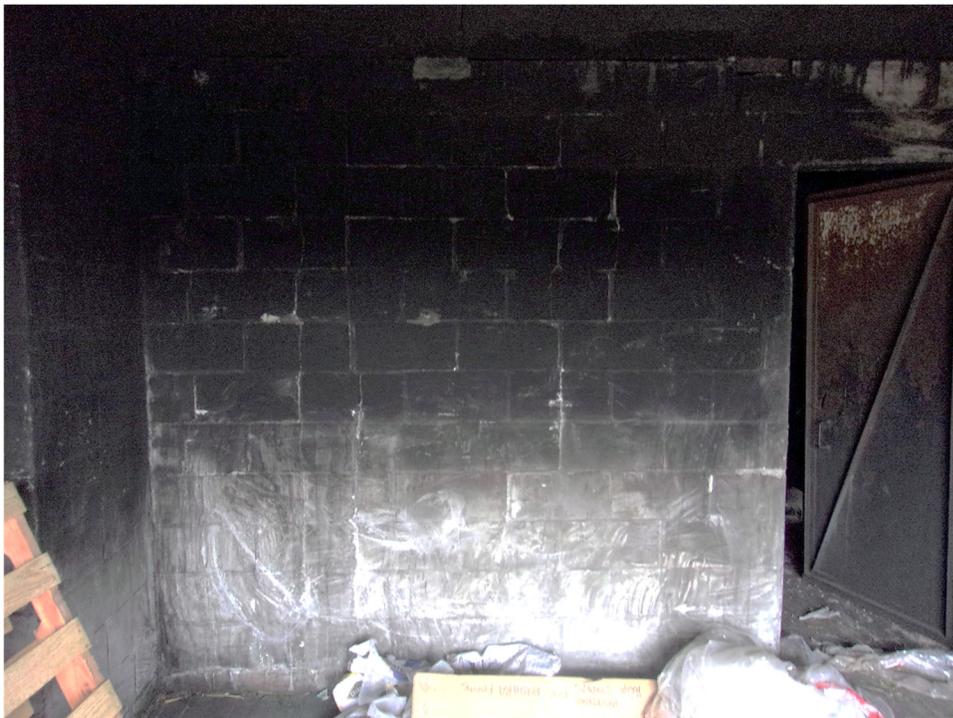
**General deterioration at interior surface of south wall in Room 100**

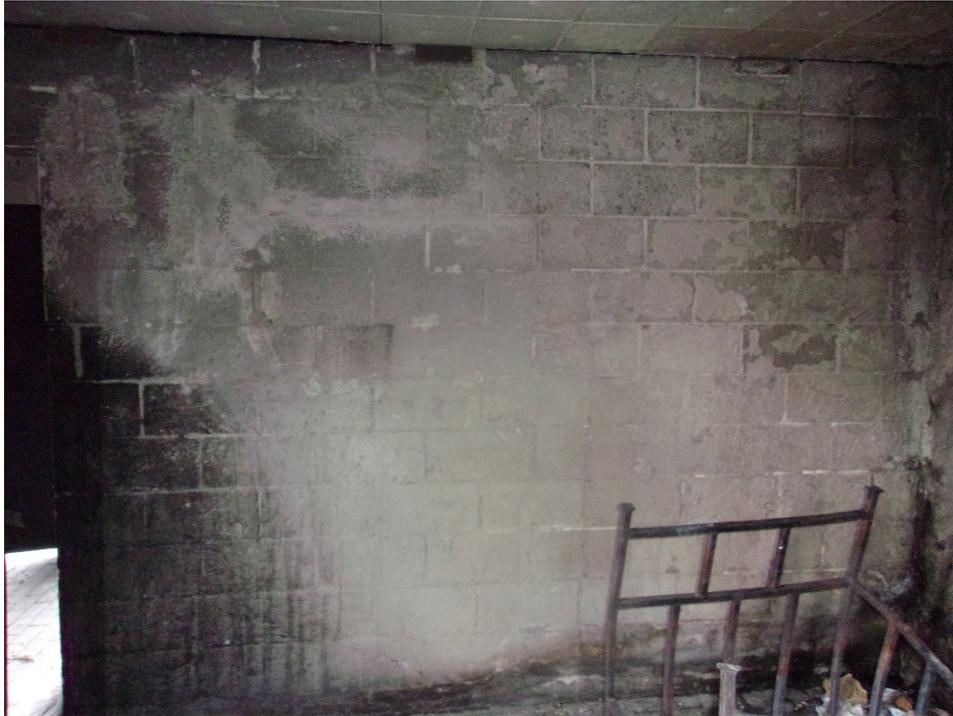
**General deterioration at east wall in Room 100 (backside of Room 101)**

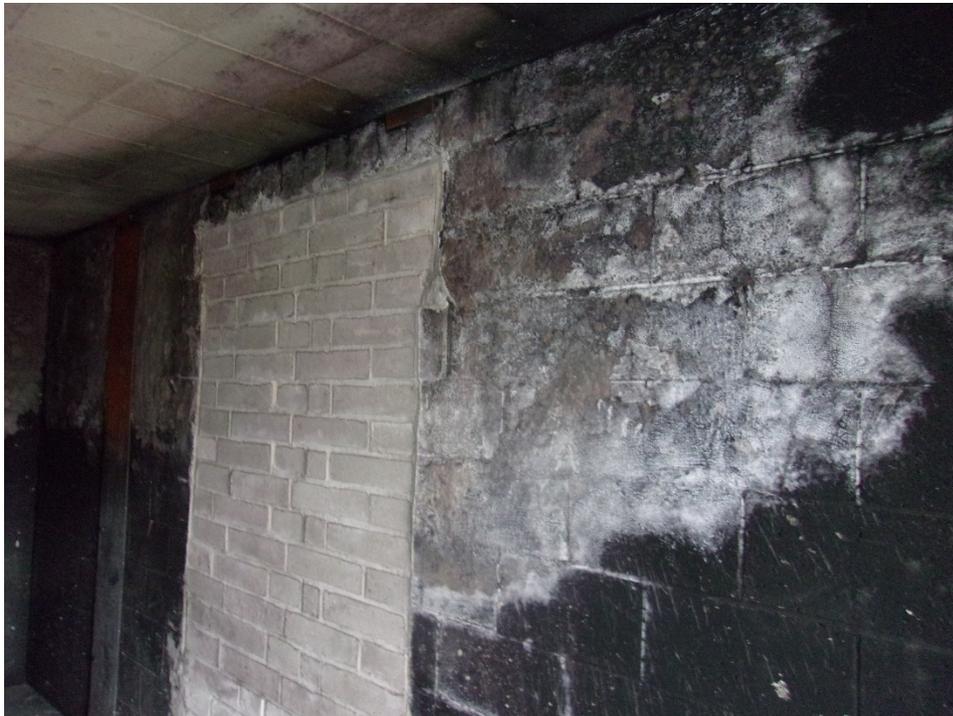
**Severely deteriorated west wall in Room 101**

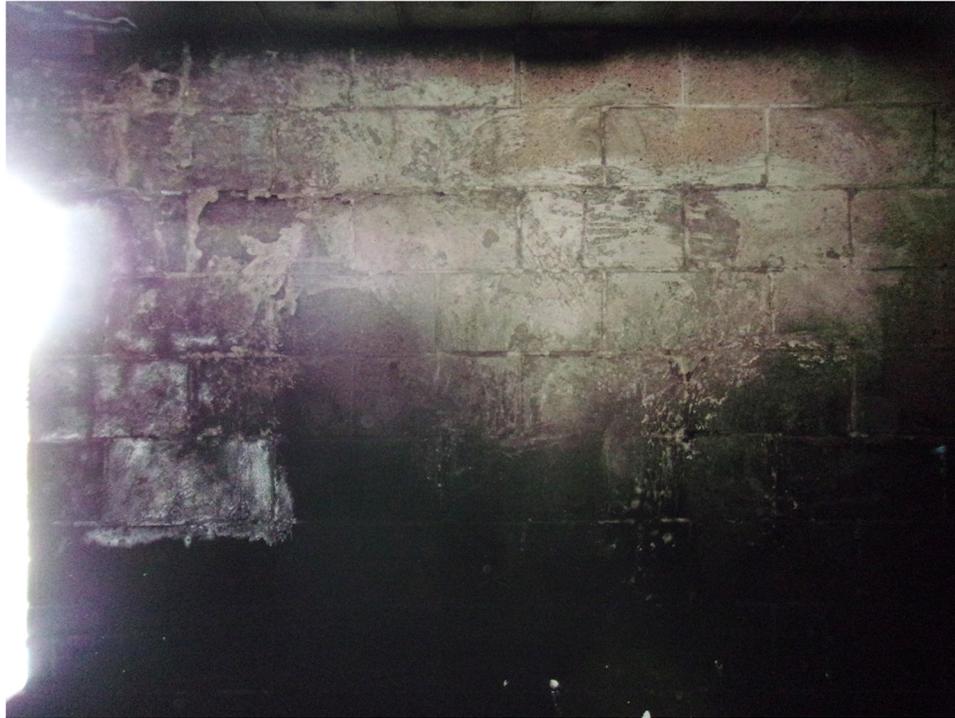
**Deterioration at interior surface of east exterior wall in Room 101**

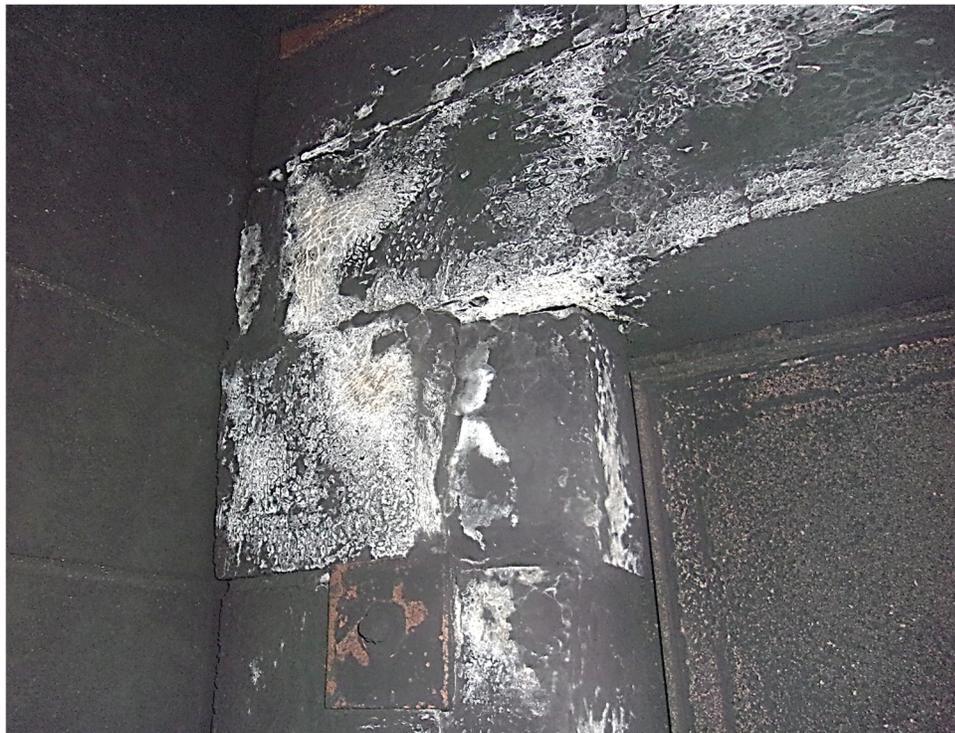
**Deterioration at interior surface of south exterior wall in Room 101**

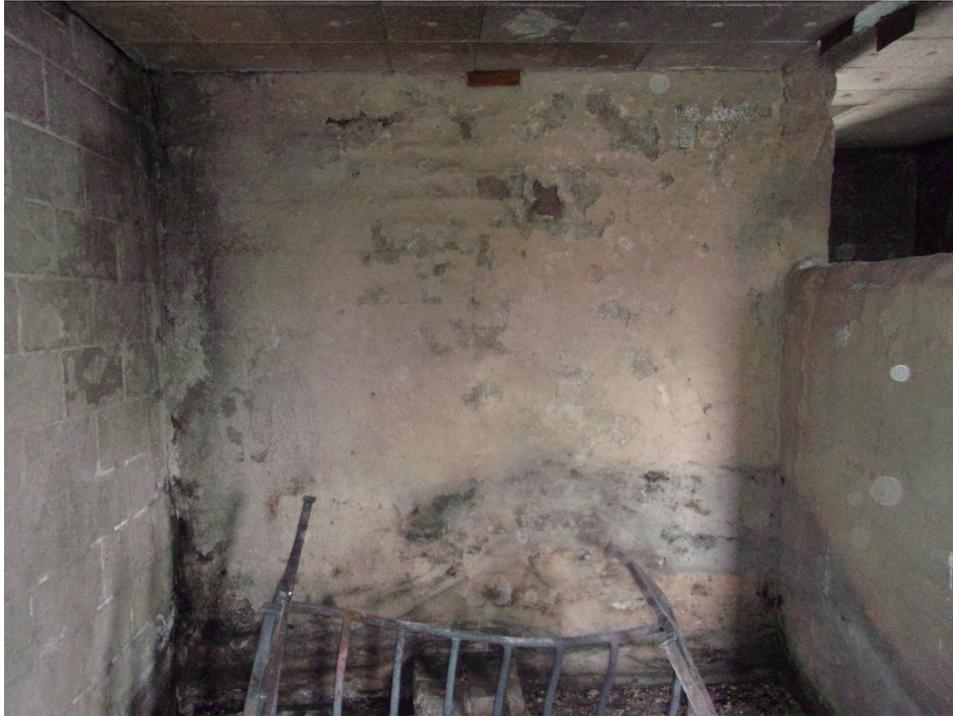
**Severely damaged CMU at jamb of window opening in south wall in Room 101**

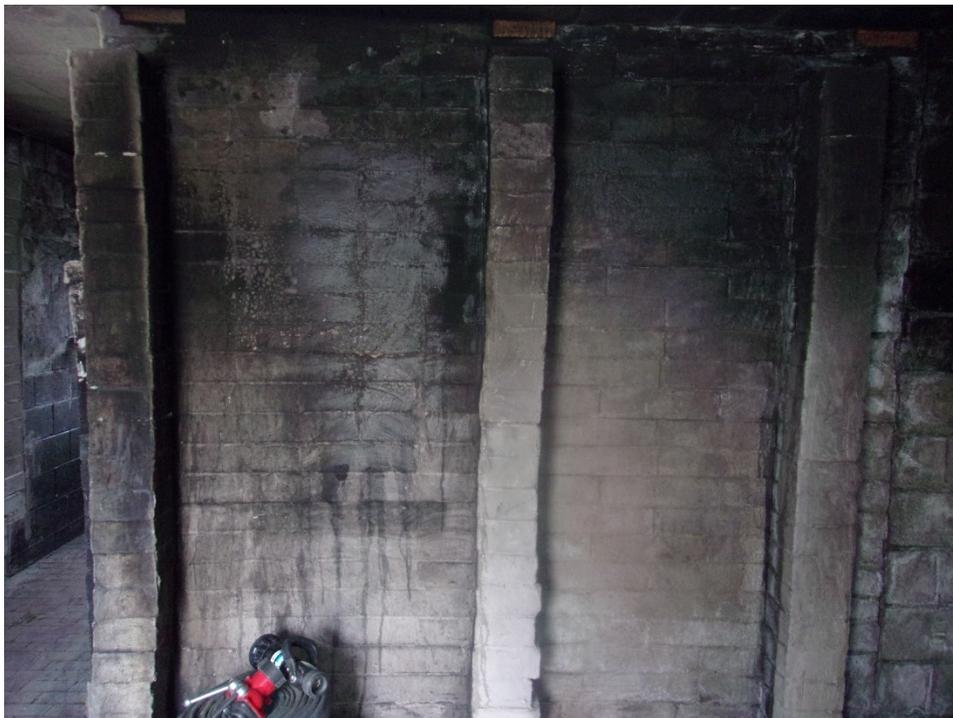
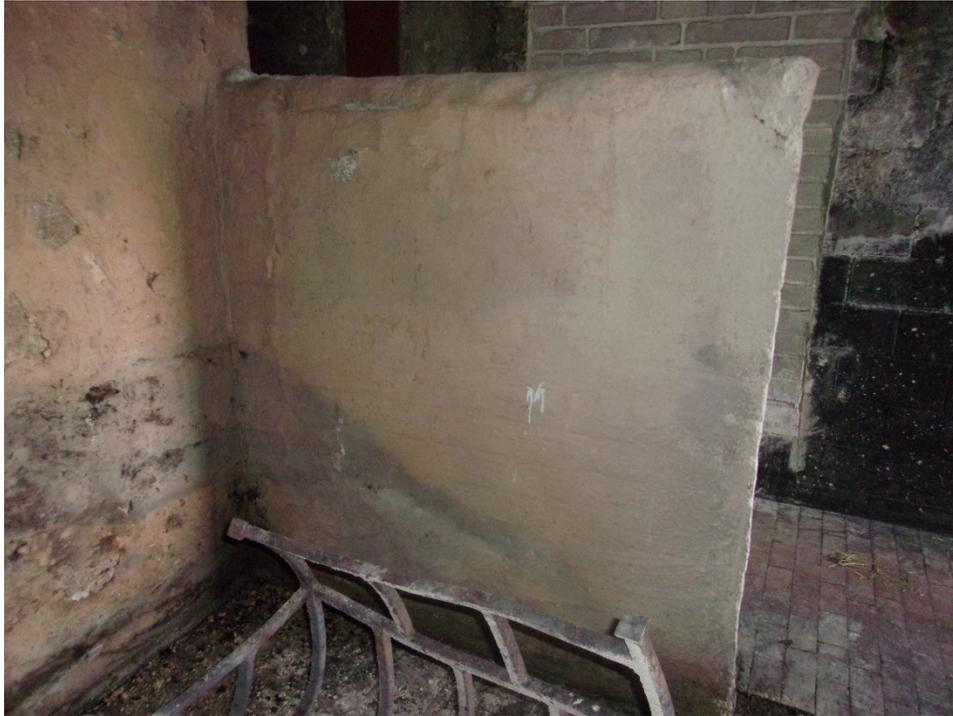
**Severely damaged (unreinforced) north wall in Room 101  
(front side above and back side below)**

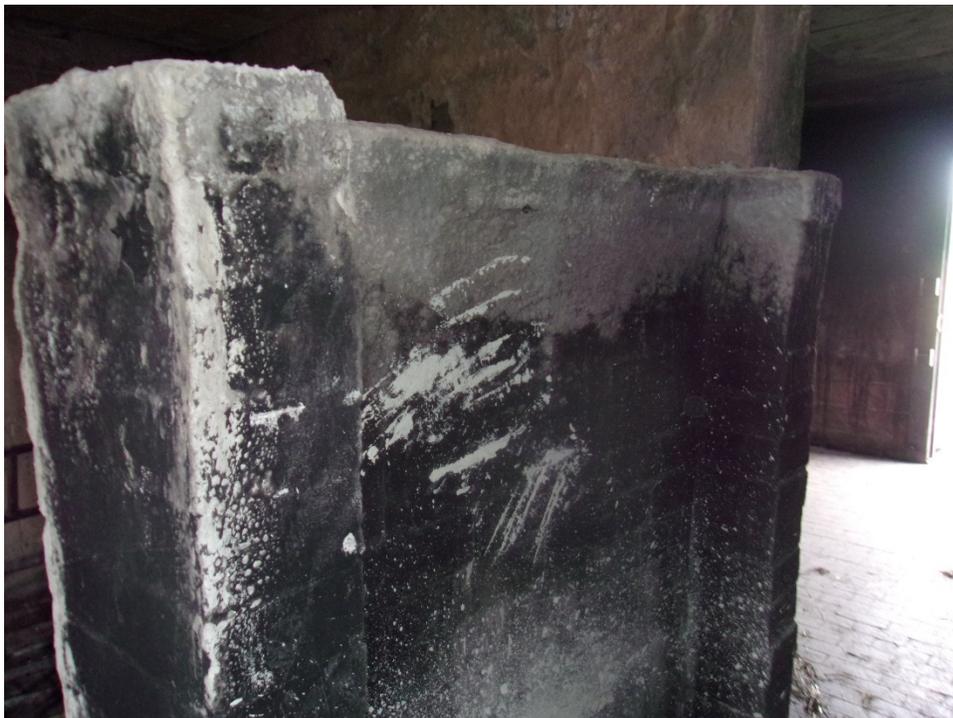
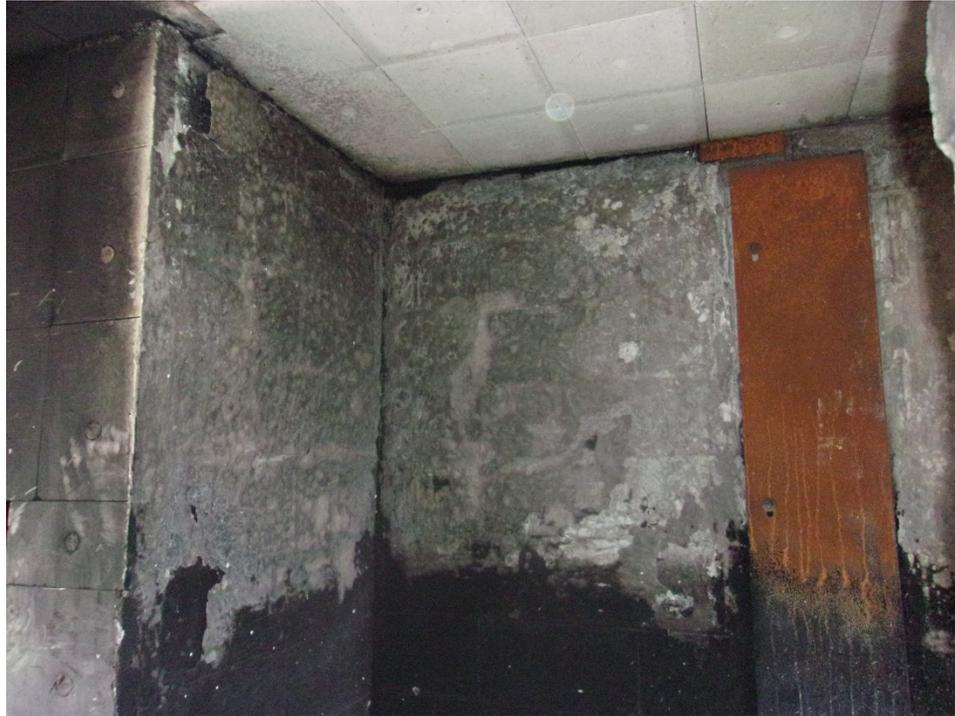
**Severely damaged (unreinforced) partial height east wall in Room 101  
(front side above and back side below)**

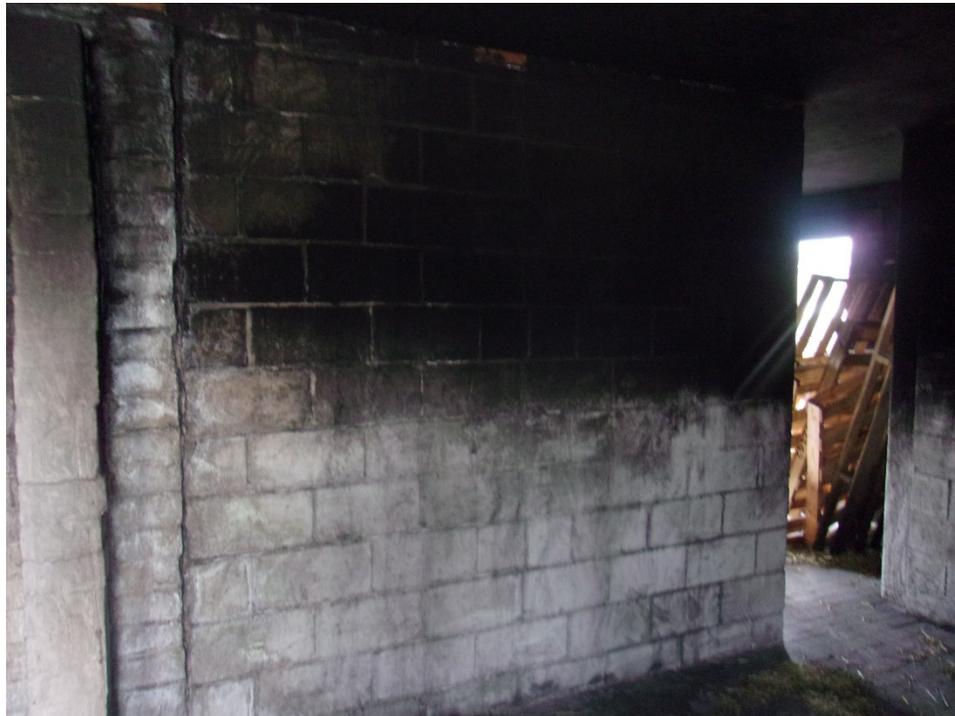
**General deterioration at interior surface of east exterior wall in Room 102**

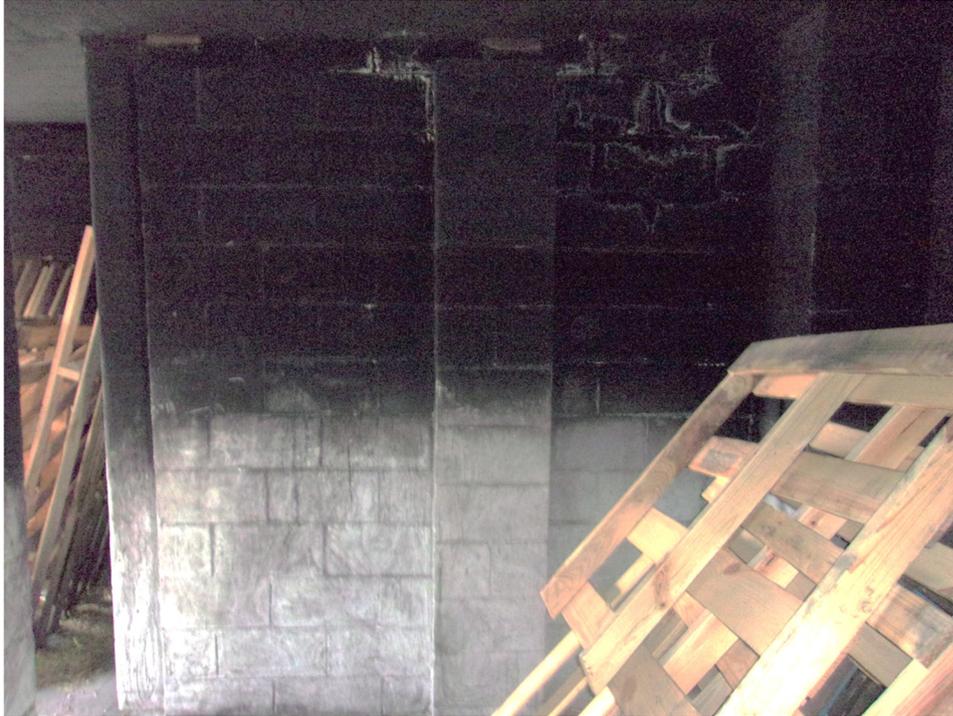
**General deterioration at surface of south wall in Room 102 (backside of Room 100)**
