## **Structural Evaluation**

**Westmoreland County Community College PSTC Class A Live Fire  
Training Structure ("Burn Building")**

**EL&M No.: 23012**

**July 18, 2023**

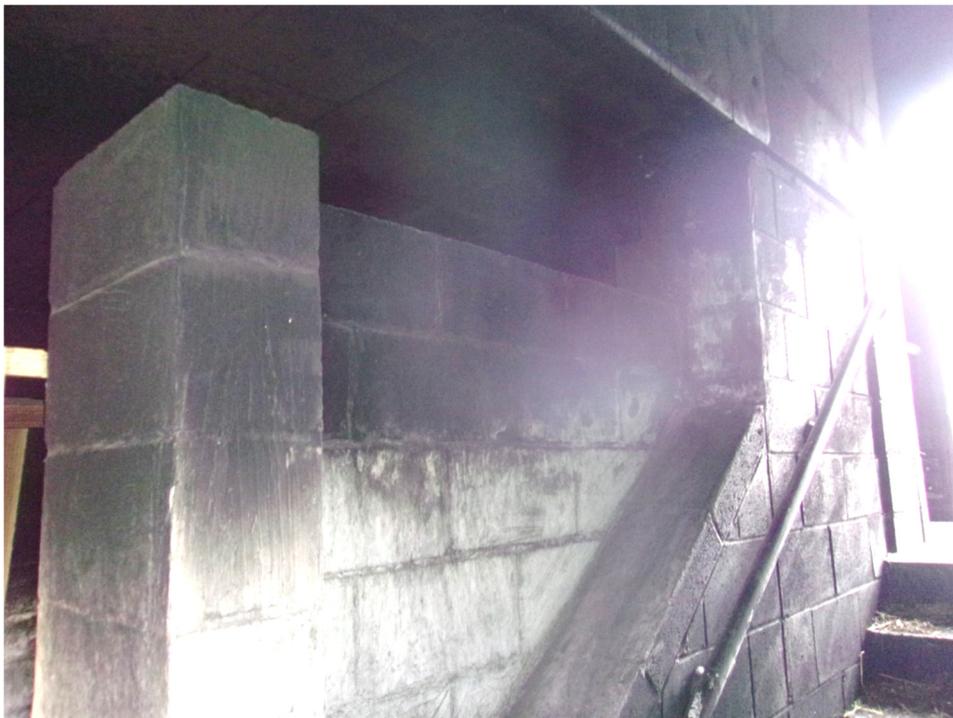
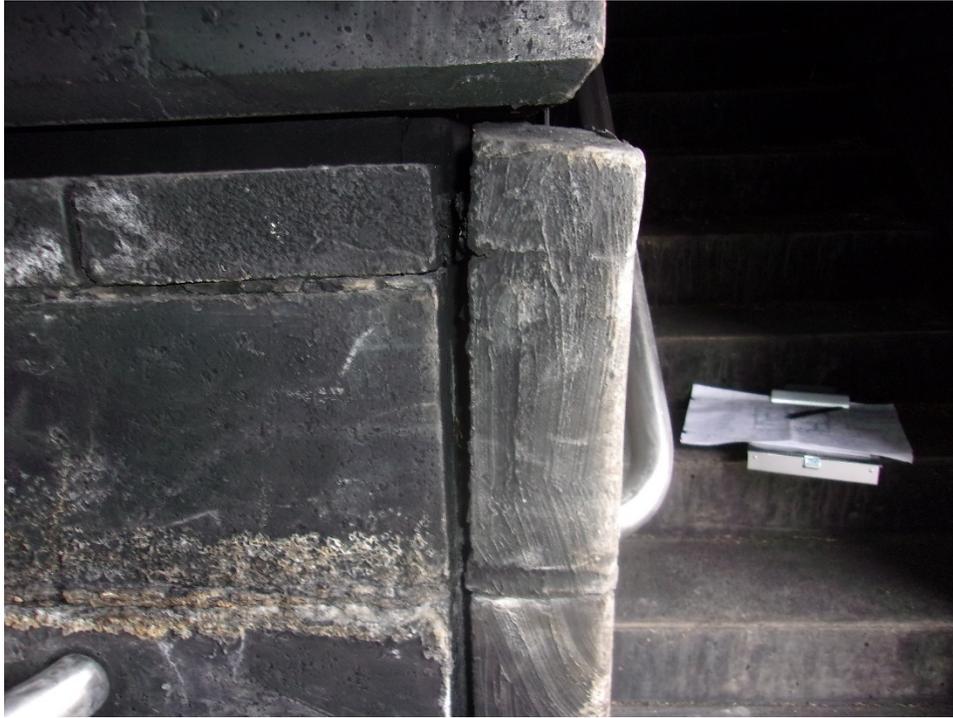
**Unreinforced CMU walls constructed in front of damaged west wall (above) and unstable north wall at stairwell (below) in Room 102**

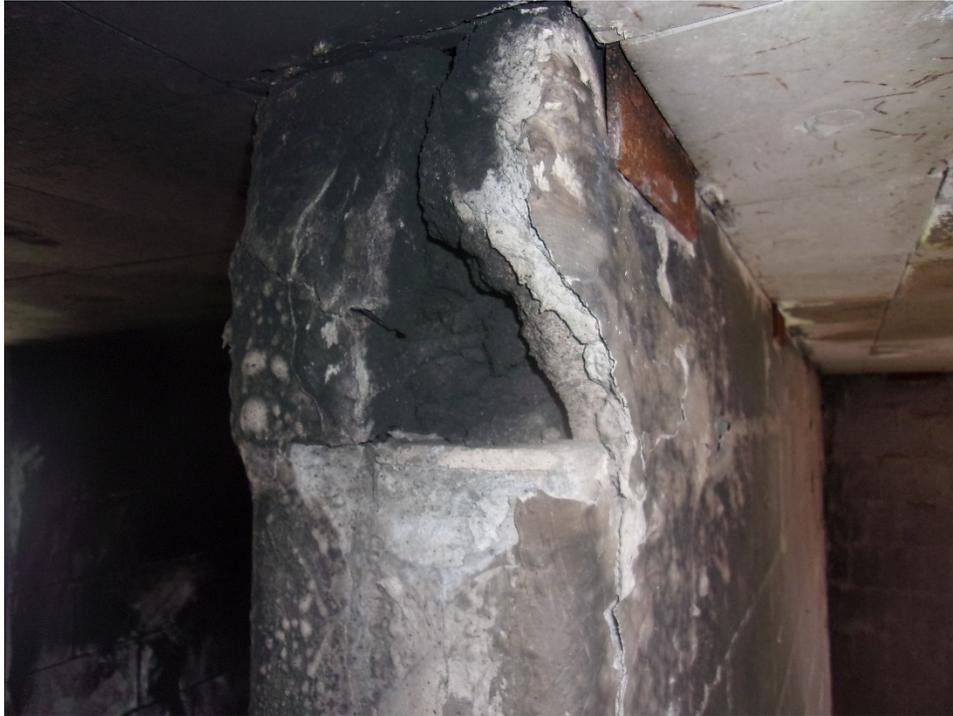
**Severely damaged north wall in Room 201**

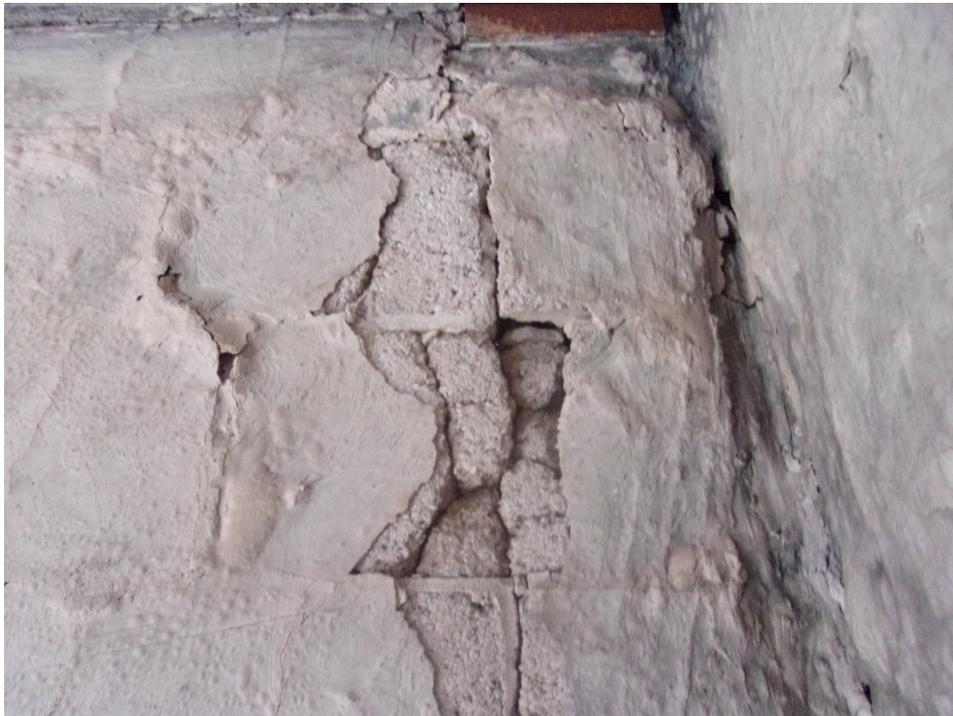
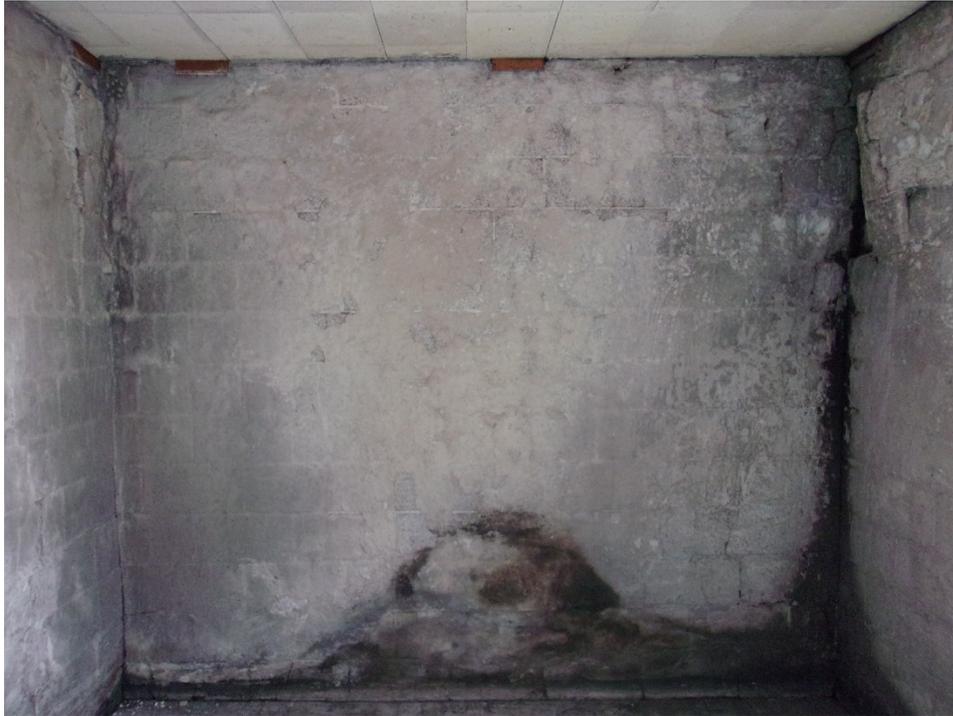
**Severe damage at west (above) and east (below) ends of north wall in Room 201**

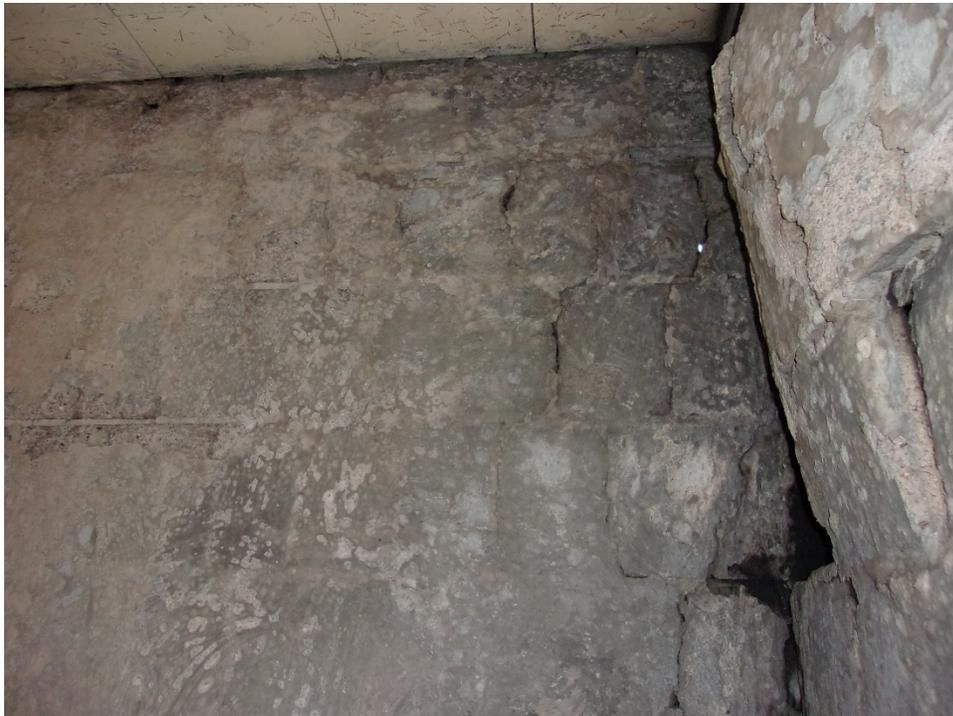
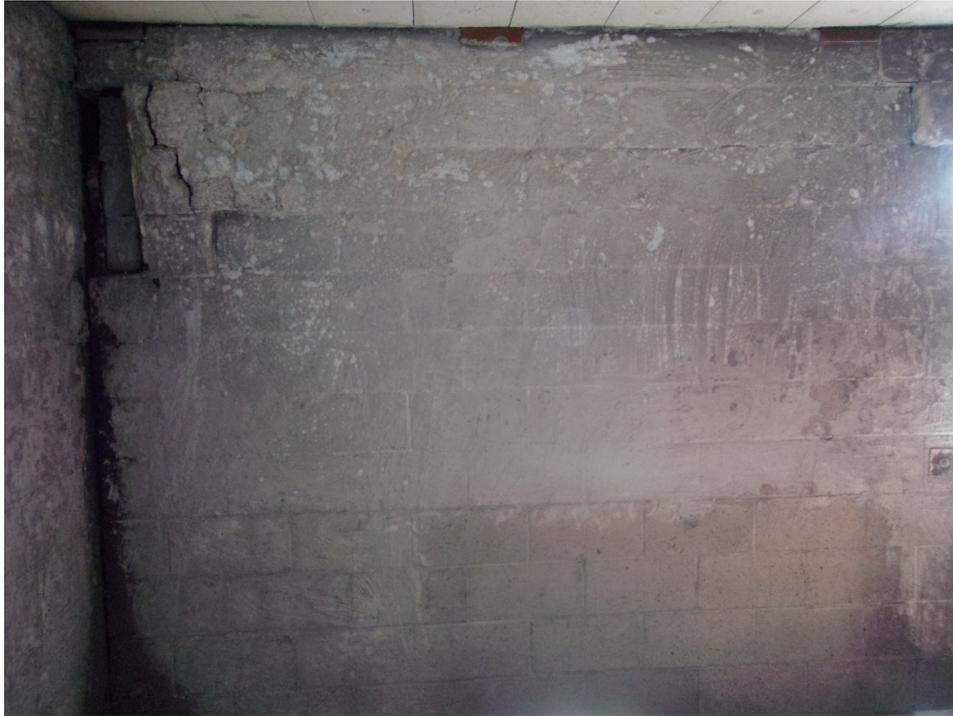
**Severely damaged east wall in Room 201 (above and below)**

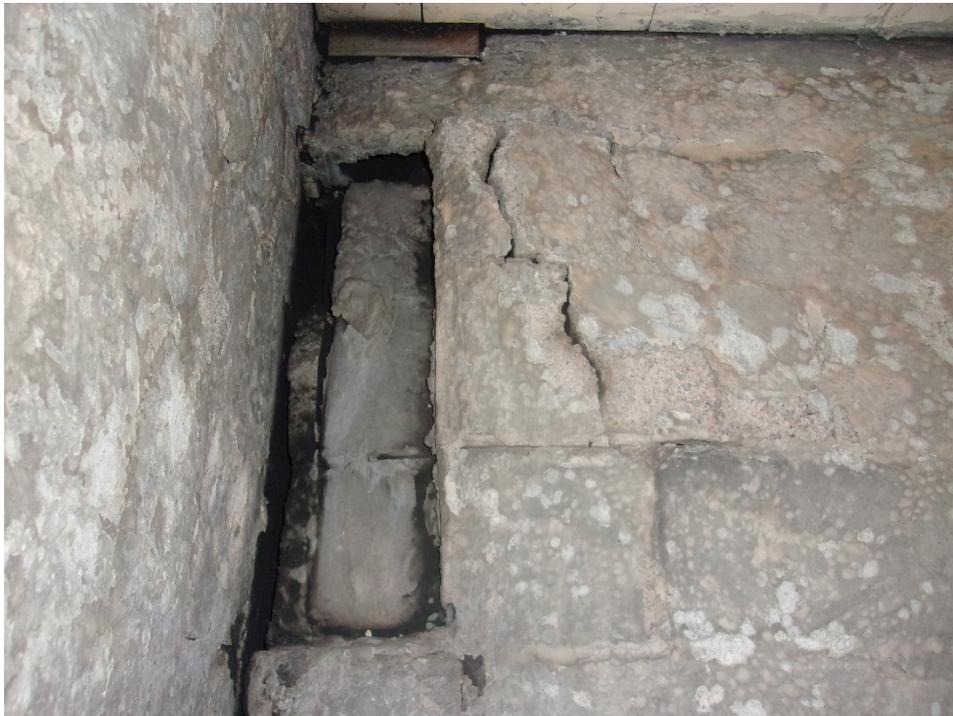
**Severely damaged south wall in Room 201**

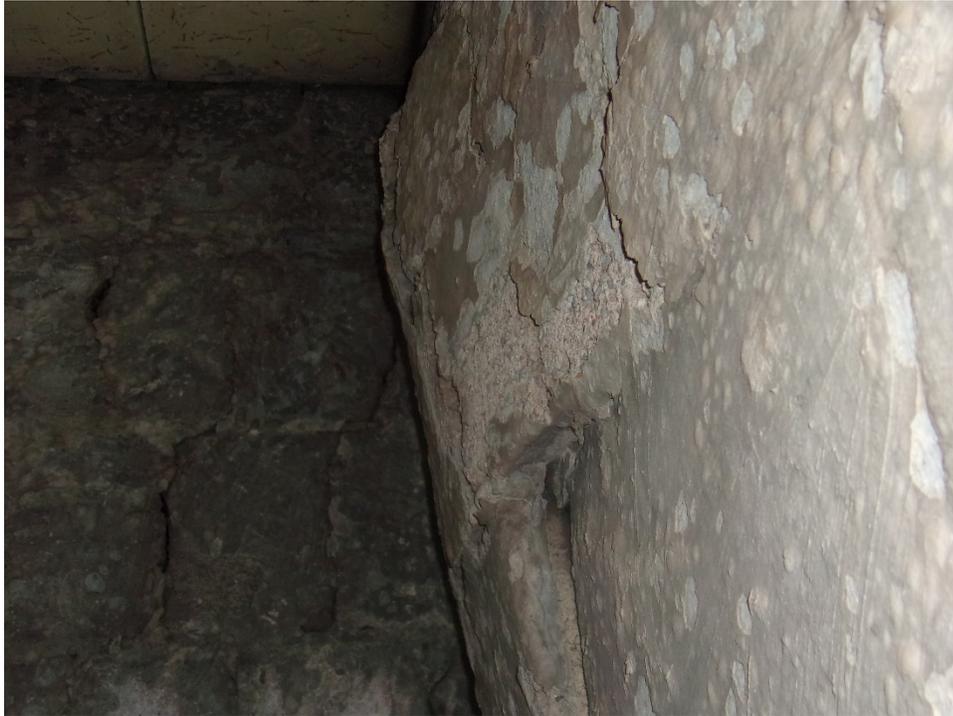
**Spalled CMU at east end of south wall in Room 201**

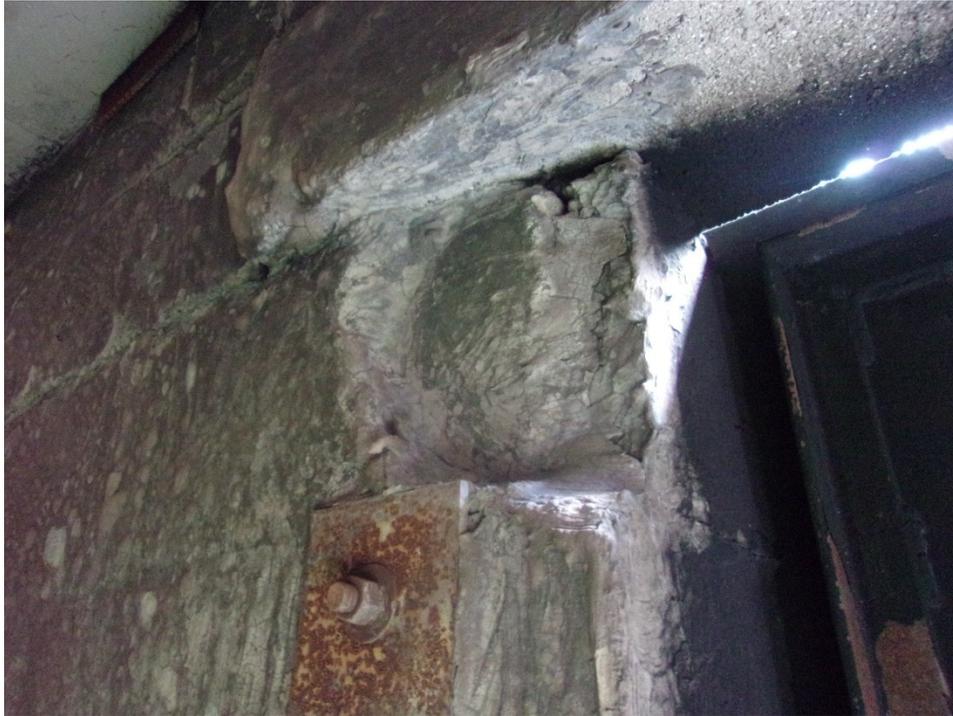
**Displacement at east end of lintel at window opening in south wall in Room 201**

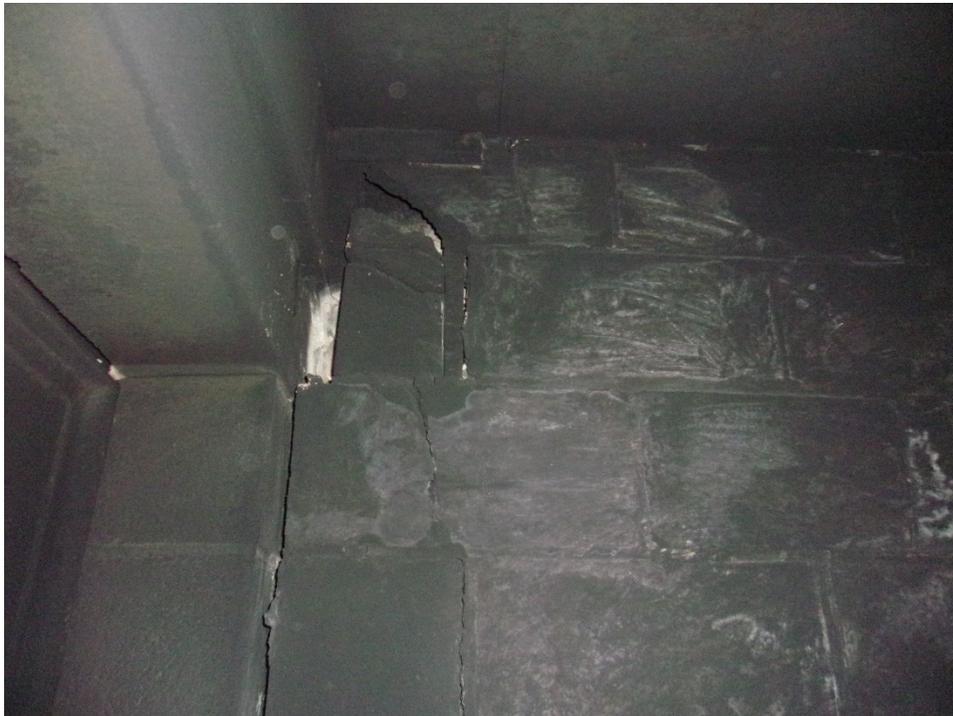
**Spalled CMU at east jamb of window opening in south wall in Room 201**

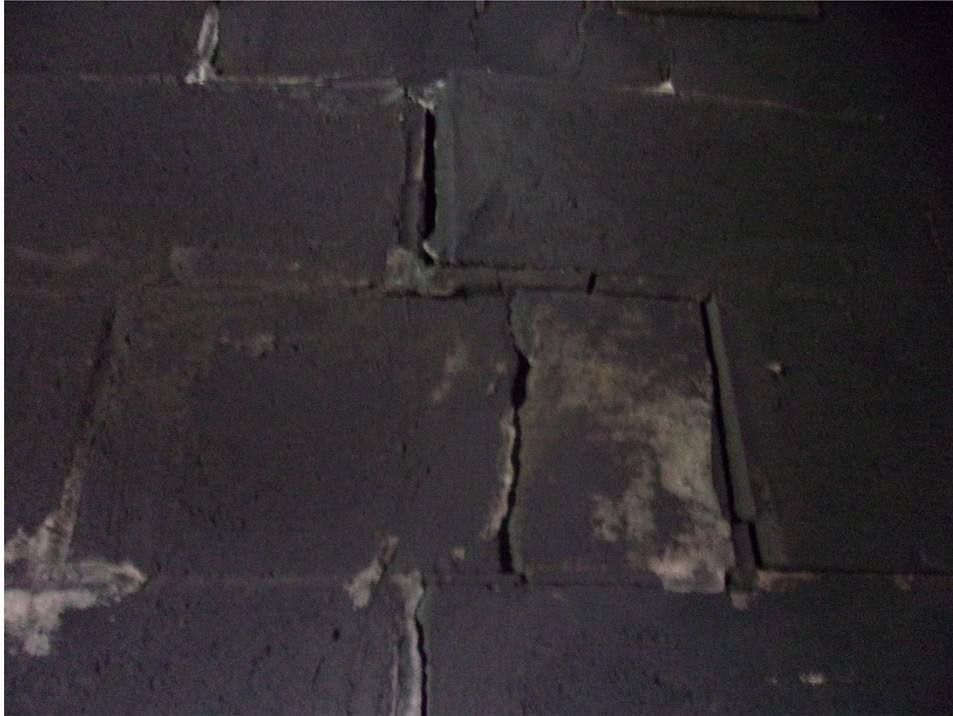
**Severely damaged CMU at east end of south wall in Hallway 202**

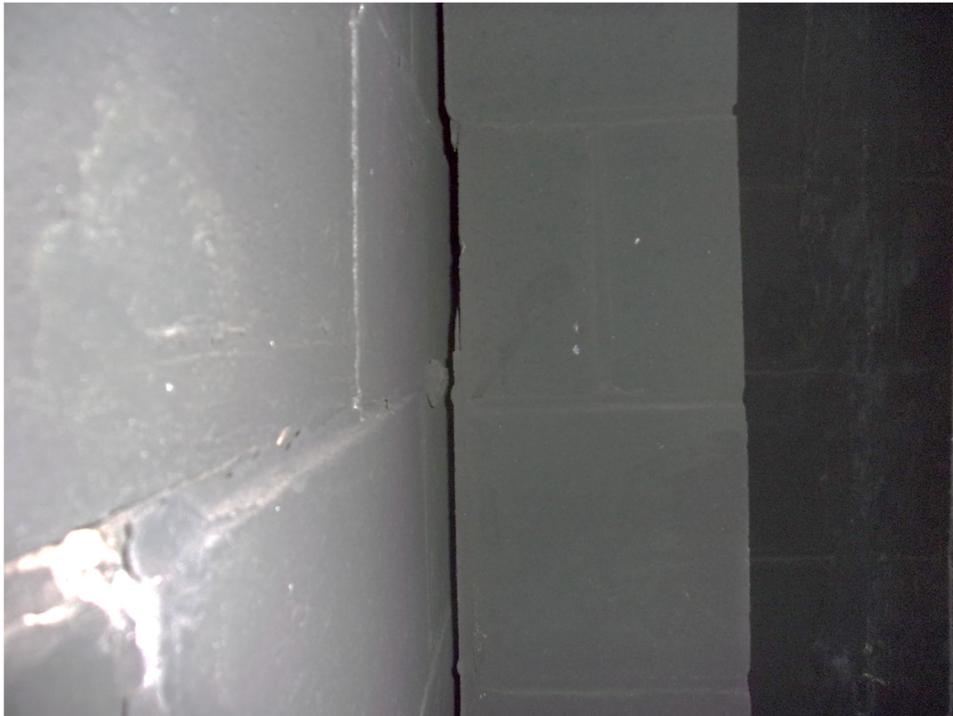
**Severe cracks and bowing at west end of north wall in Hallway 202**

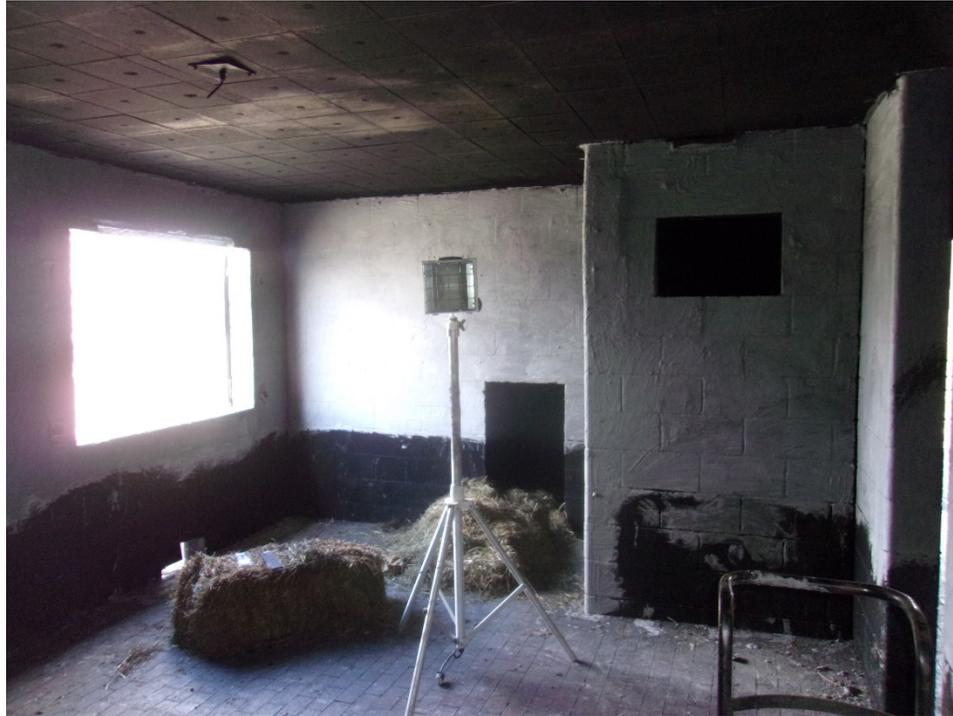
**Loose CMU (not tied back to adjacent walls) at chase at north side of Hallway 202**

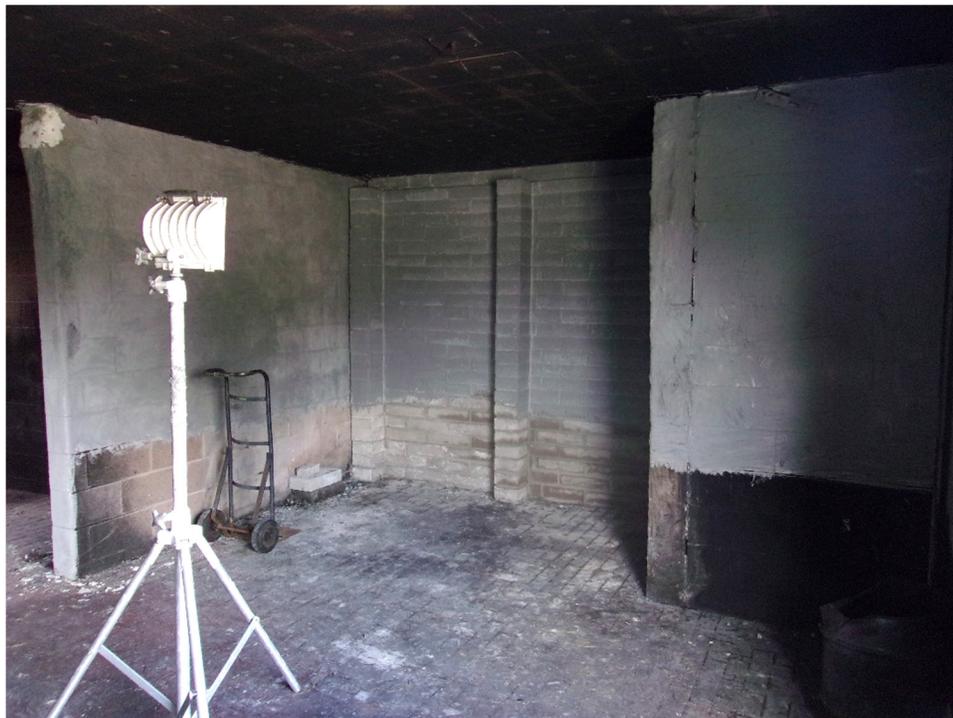
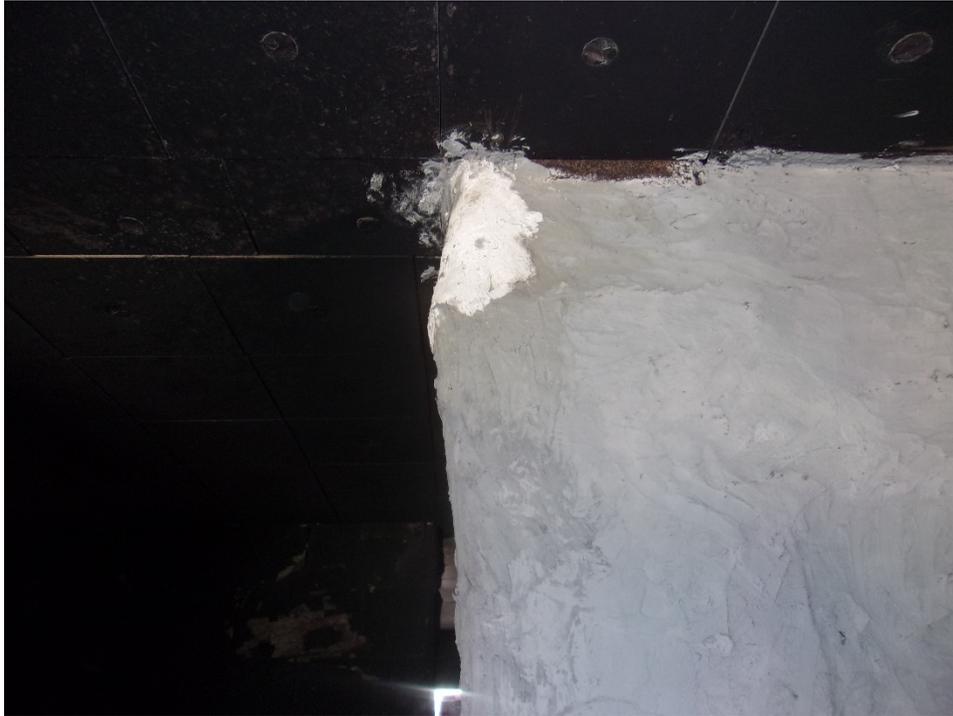
**Room 203 walls prepped with refractory cement prior to upcoming burns and new unreinforced wall constructed in front of heavily damaged west wall (below)**

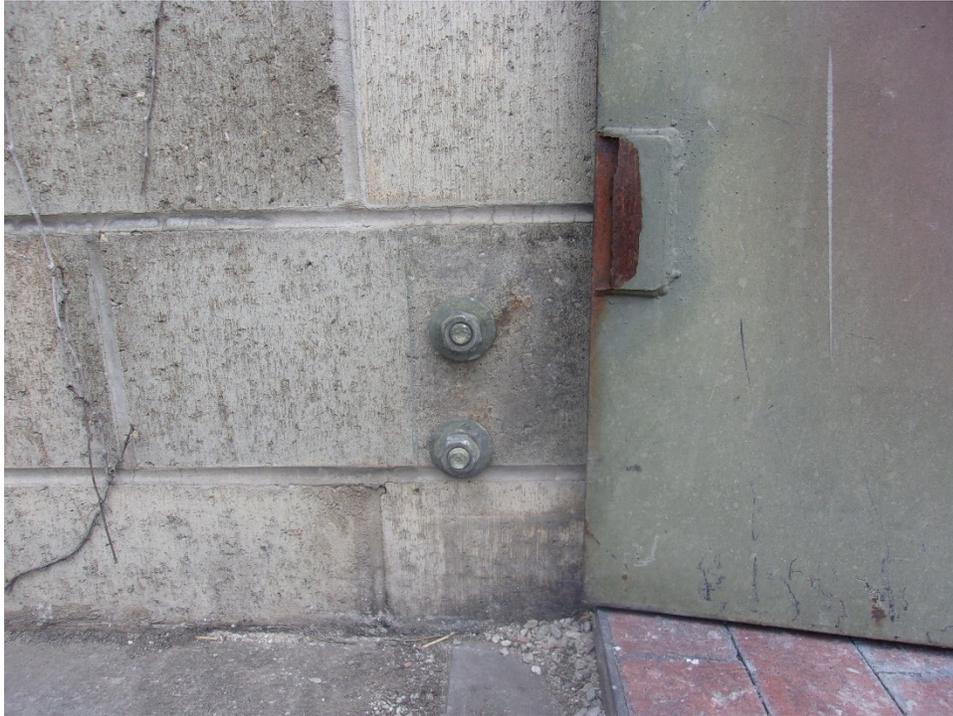
**Corroded, warped and sagging double doors at exterior of Room 100**

- Remove and replace all the doors and windows and associated hardware, with the possible exception of the door between the interior and exterior concrete stairs (if the exterior walls around the stairwell are not replaced).

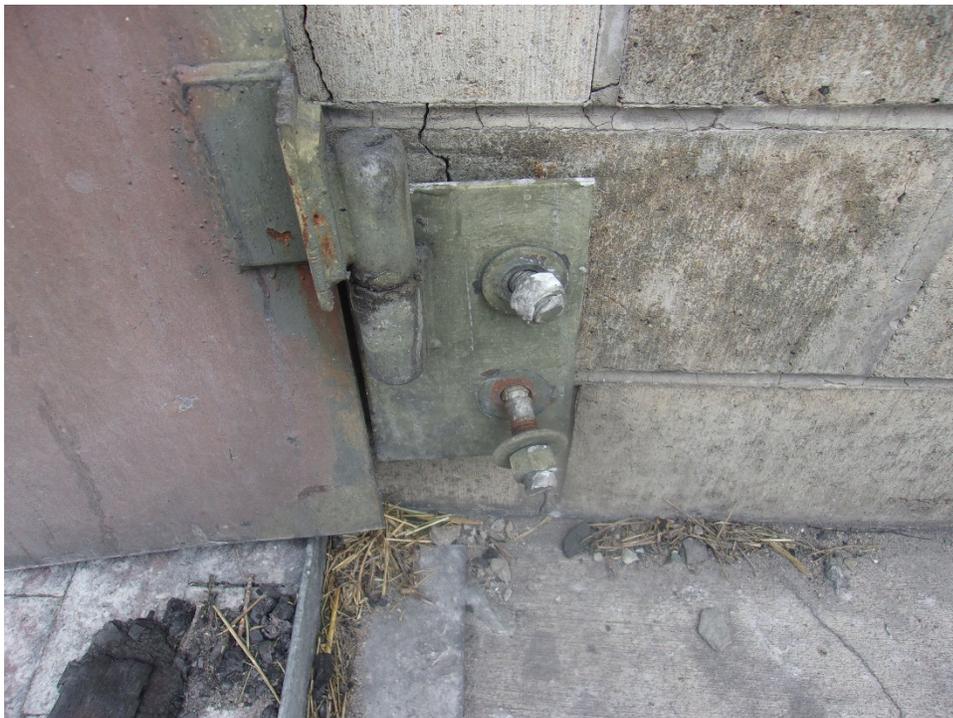
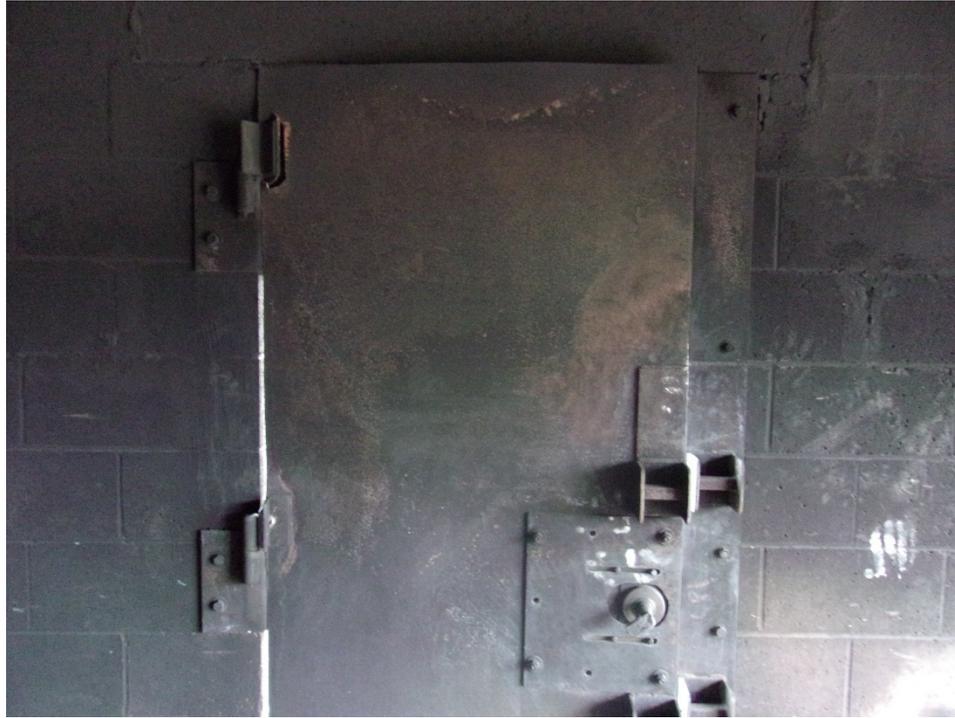
**No bottom hinge at north door leaf (above) and loose anchors at bottom hinge at south door leaf (below) at double doors at exterior of Room 100**

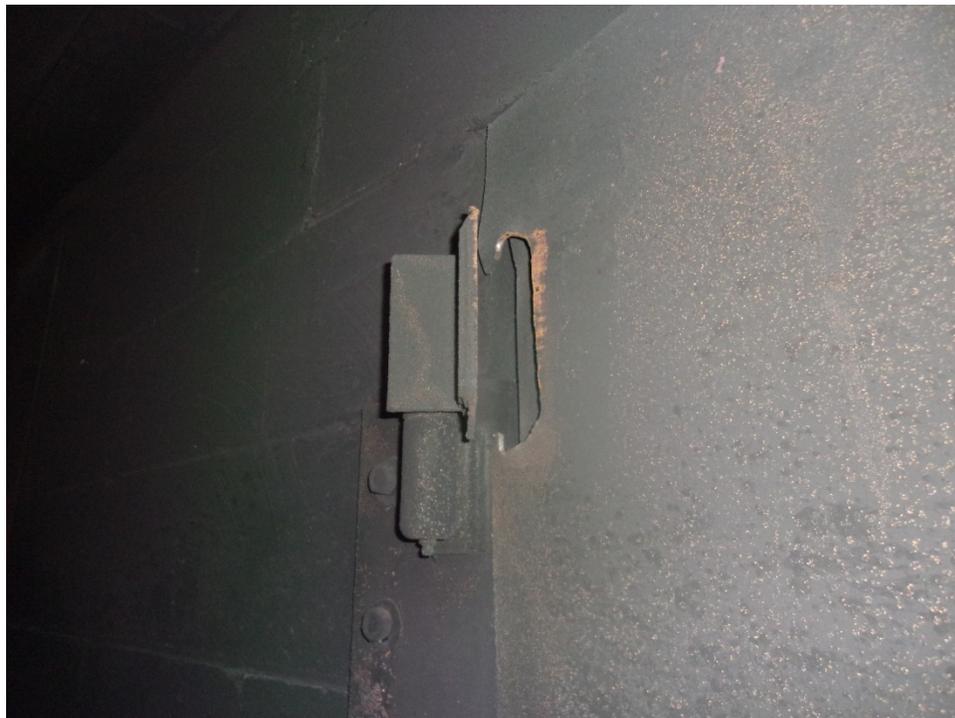
**Corroded and warped exterior door at Room 100 (above) - top hinge broken (below) and door cannot be latched.**

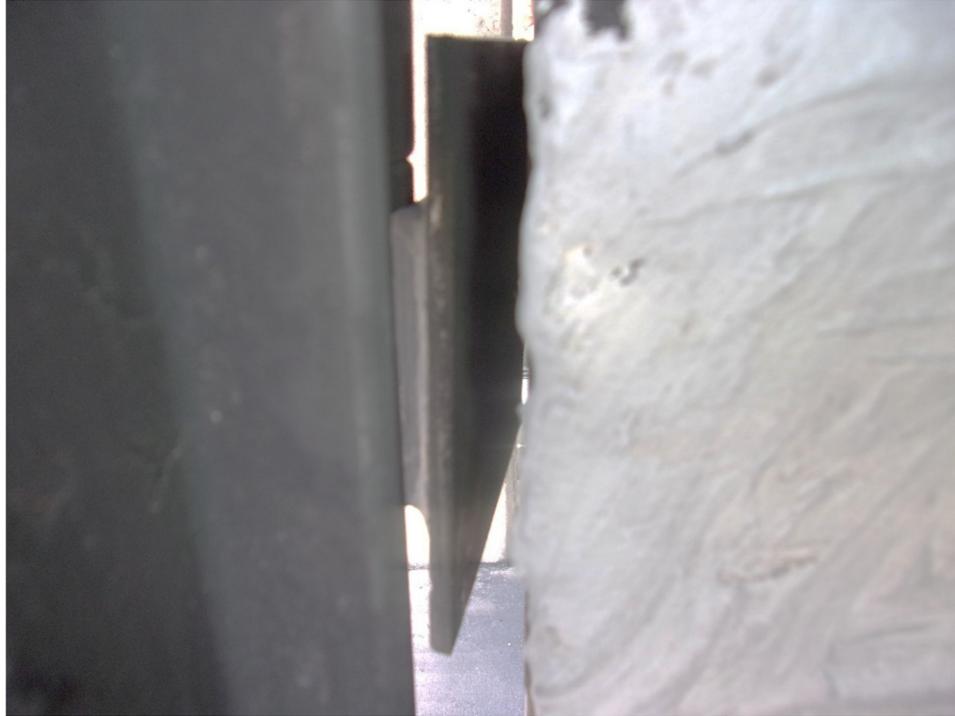
**Corroded, warped and sagging shutters at Room 203 cannot be latched.**

- Immediately repair or replace the loose bolts/hinge at the shutter in Room 203 so that the shutter does not fall to the ground. Another option is to remove the shutters.

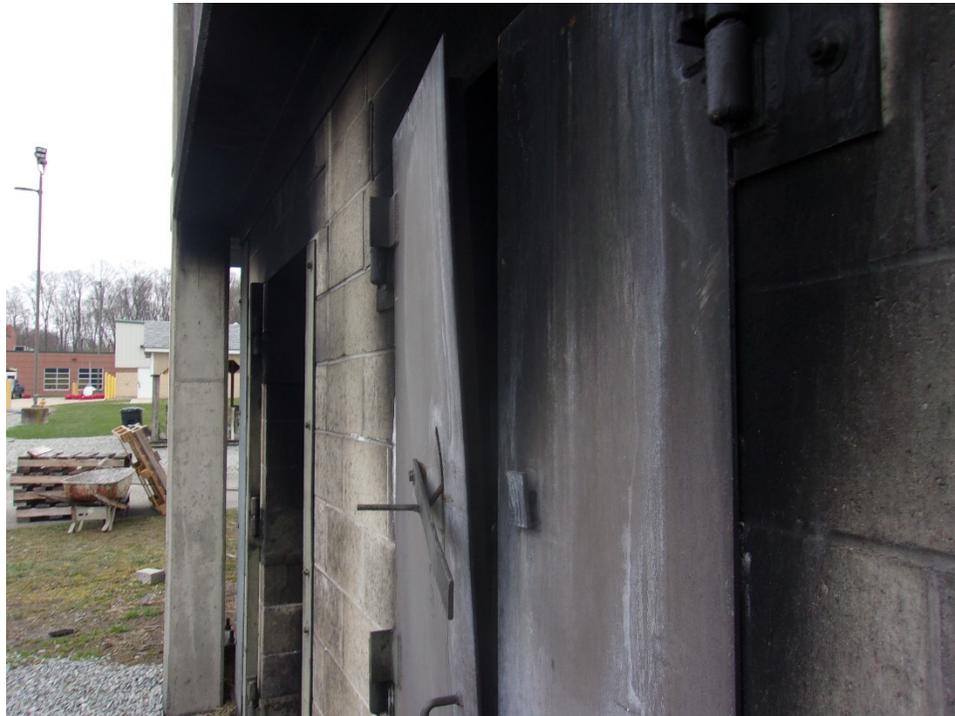
**Loose bottom hinge at east shutter leaf at window in Room 203**

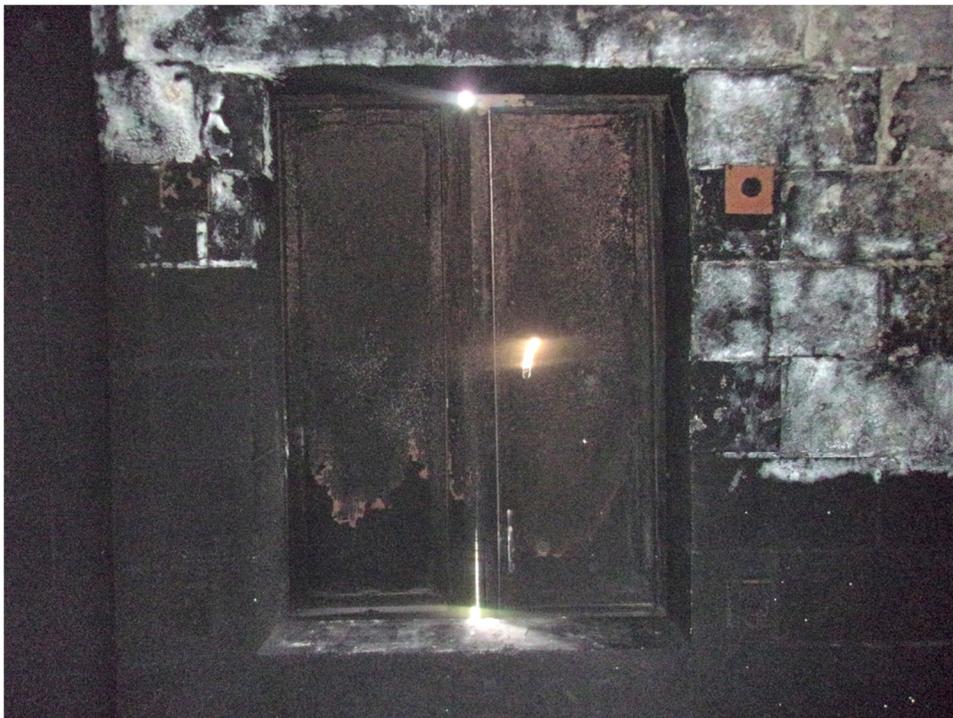
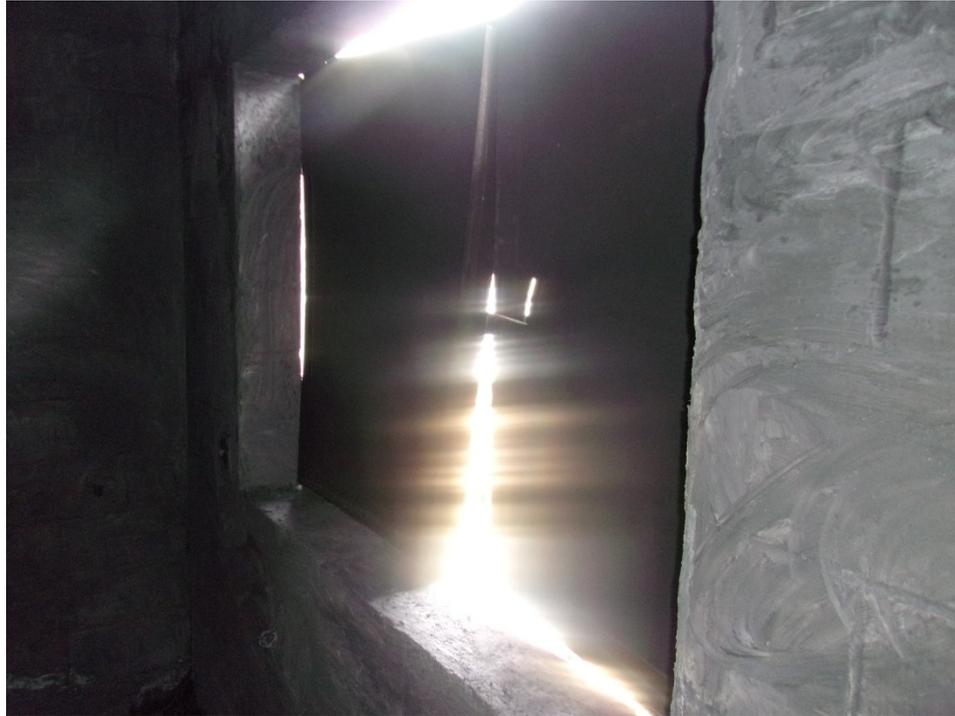
**Warped and corroded shutters at Room 101 (above and below)  
with bent latch bar cannot be latched.**

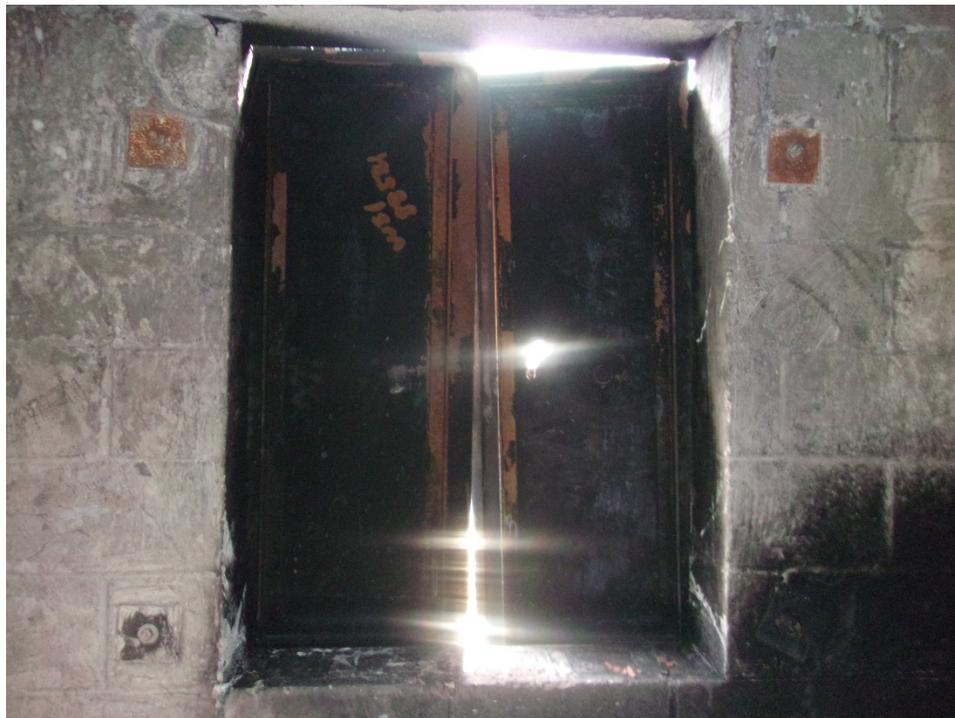
**Corroded, warped and sagging shutters at Room 200 (above)  
and at Room 201 (below) cannot be latched.**

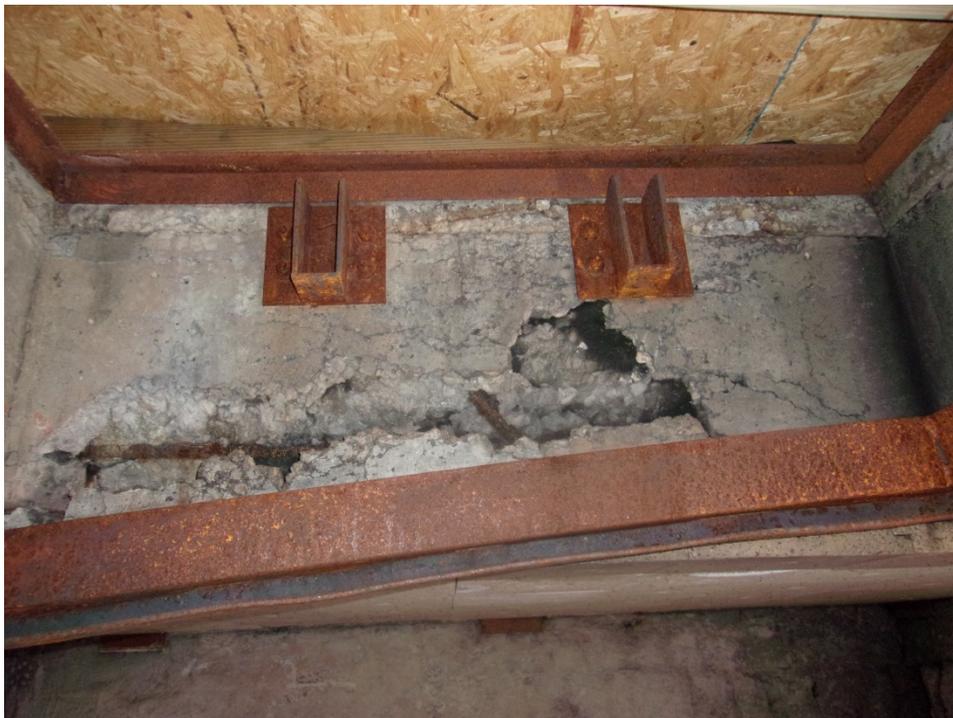
**Corroded, warped and sagging pulldown frame and corroded joist hangers at chopout opening at ceiling of Room 201 (above and below)**

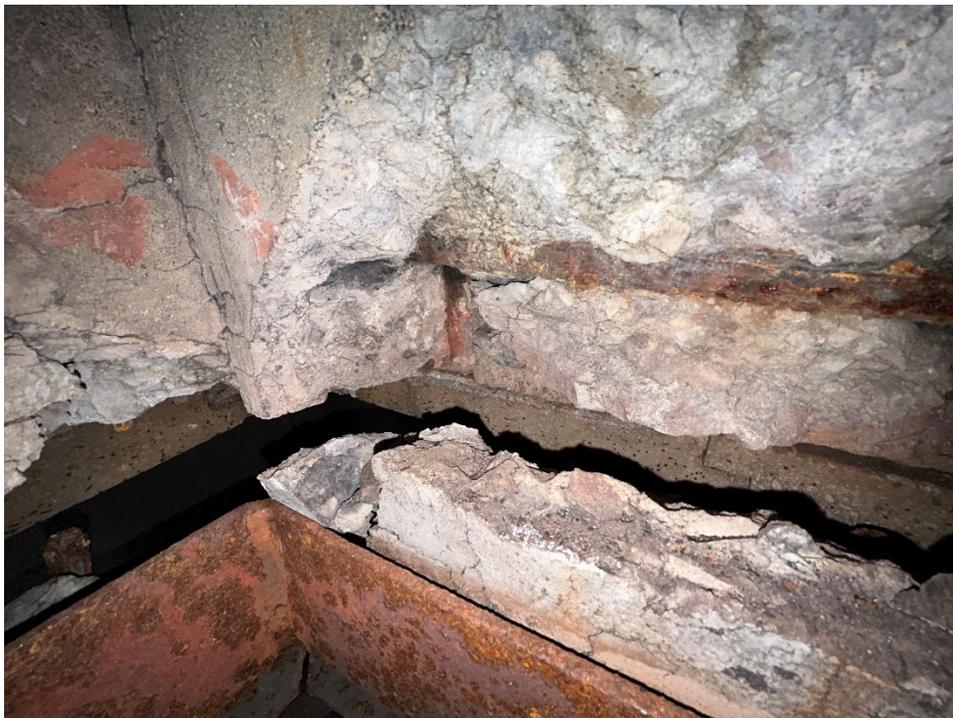
**Anchors pulling out at pulldown frame, which is holding spalled concrete, at chopout opening at ceiling in Room 201 (above and below)**
