## **Structural Evaluation**

**Westmoreland County Community College PSTC Class A Live Fire  
Training Structure ("Burn Building")**

**EL&M No.: 23012**

**July 18, 2023**

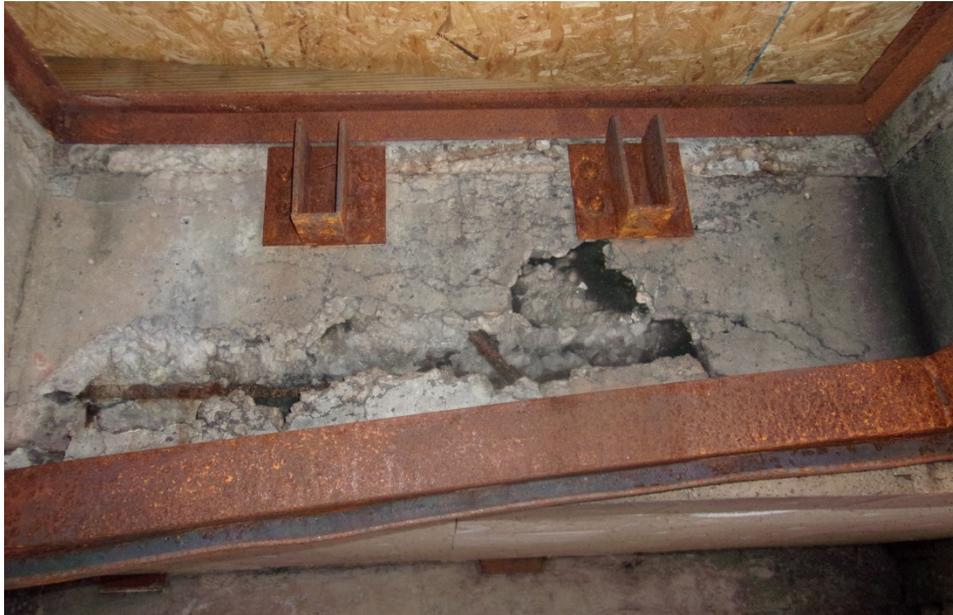
Item	Observations and Recommended Actions
Elevated Floor and Roof Slabs (Items 6, 14, 16, 19, and 22 in Appendix 1)	<p><u>Observations:</u> There are several hairline/minor <i>cracks</i> at the vertical edges of the second floor and roof slabs, including within the interior stairwell, in the top surface of the second floor slab, where the fire brick was removed from the floor in Room 203 during the 2021 survey, and at the bottom surface of elevated second floor and roof slabs, at locations where inspection tiles were removed for observation during the 2021 survey in Rooms 100, 101, 201, and 203. The cracks are likely due to shrinkage after initial curing, temperature related movements, and weathering.</p> <p>There are severe <i>cracks</i>, <i>spalls</i>, and <i>delaminations</i> in the vertical slab edges within the ventilation chopout opening at the ceiling of Room 201, which is not protected with thermal linings. This damage is noticeably worse than during our 2021 evaluation.</p> <p>There are minor <i>cracks</i>, shallow <i>spalls</i>, and <i>delaminations</i> in the top surface of the second floor slab, where the fire brick was removed from the floor in Room 201. This damage was likely caused by heat passing through the fire brick to the top of the slab during repetitive live fire training evolutions.</p> <p>There is a moderate <i>crack</i> in the vertical face of the second floor slab at the interior corner of the interior stairwell. This crack was visible in the 2021 evaluation and has worsened since. It is now wider and there appears to be a slight vertical offset along the crack, with the slab to the left of the crack slightly lower than the slab to the right. <u>This requires additional investigation, per recommended actions below.</u></p> <p>There are minor (shallow) <i>spalls</i> at the top surface of the roof slab, adjacent to the roof ventilation and chopout openings. This damage was likely caused by excessive heat passing through the openings to the top of the slab.</p>

**Severely spalled concrete with exposed reinforcing within chopout opening at ceiling in Room 201 (above and below)**

Item	Observations and Recommended Actions
Elevated Floor and Roof Slabs (cont.)	<p><u>Recommended Actions:</u> After <u>immediately</u> removing the steel frame at the chopout opening at the ceiling of Room 201, saw cut around the perimeter of the damaged concrete and remove all delaminated (loose) concrete, including around exposed reinforcing bars. Remove corrosion from exposed reinforcing and apply an anti-corrosion bonding agent to the exposed reinforcing and the existing concrete surfaces. Patch the concrete with a high strength (bond and compressive strengths), non-shrink, cementitious repair material, such as SikaTop 123 Plus or SikaTop 111 Plus, or other equivalent repair materials from other manufacturers that is suitable for exterior vertical / overhead applications, to restore the slab to its original conditions. Provide proper cover over slab reinforcing. Follow the manufacturer's instructions for preparing slab surfaces and mixing/ placing/curing the patch material. After patching and curing the concrete, provide thermal linings within the opening to protect the concrete in the future.</p> <p>Remove remaining fire brick at the floor in Room 201 to expose the remainder of the top of the slab. Rout and seal all cracks wider than 1/32" in the top surface of the second floor slab in Room 201. Seal cracks with a flexible, exterior-quality sealant such as Sikaflex 1a. Another option is to pressure inject the cracks with an epoxy adhesive such as Sikadur 52. After repairing cracks, apply a coat of MasterProtect H 1000, by BASF, or an equivalent concrete sealer by Euclid Chemical Company or Sika USA, to the entire top surface of the floor slab in Room 201. Prepare the concrete surface and apply the sealer in accordance with the requirements of the manufacturer. Reinstall the fire brick on the floor after applying and properly curing the concrete sealer.</p> <p><u>At the crack in the second floor slab, near the corner of the interior stairwell, more investigation is required.</u></p> <p>Remove the fire brick from the top of the second floor slab in the Closet adjacent to Room 203 for a distance of at least 3'-0" from Column C3 in both directions, or farther if required to reveal the full length of the slab crack that is visible at the slab edge in the stairwell. Remove the 4" CMU wrap around all four sides of Column C3 below the second floor slab and look for</p>

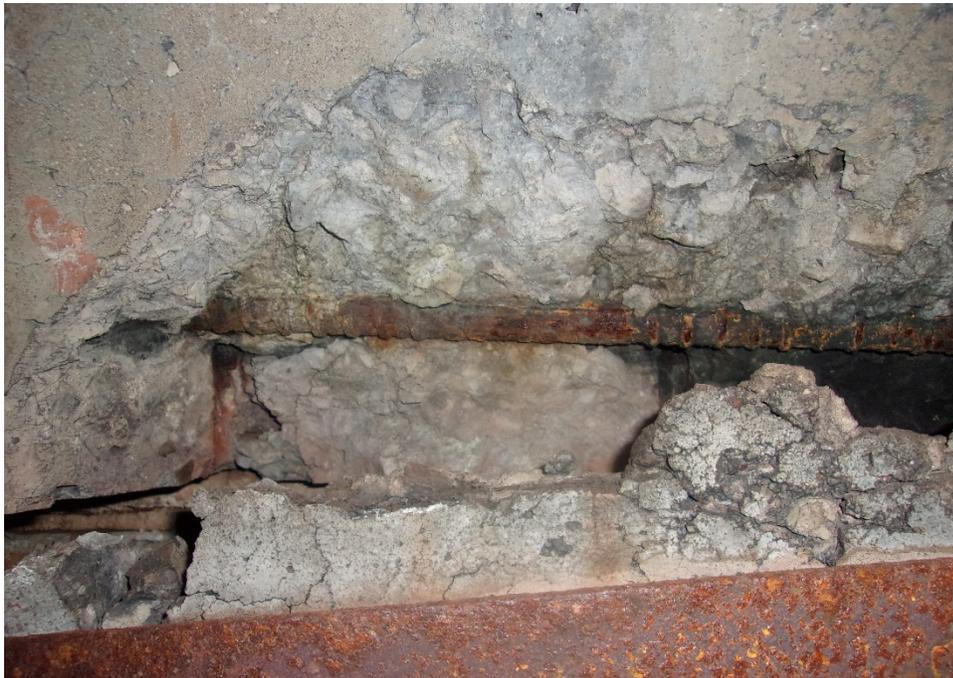
**Cracked, delaminated and spalled concrete within chopout opening at ceiling in Room 201 (above and below)**

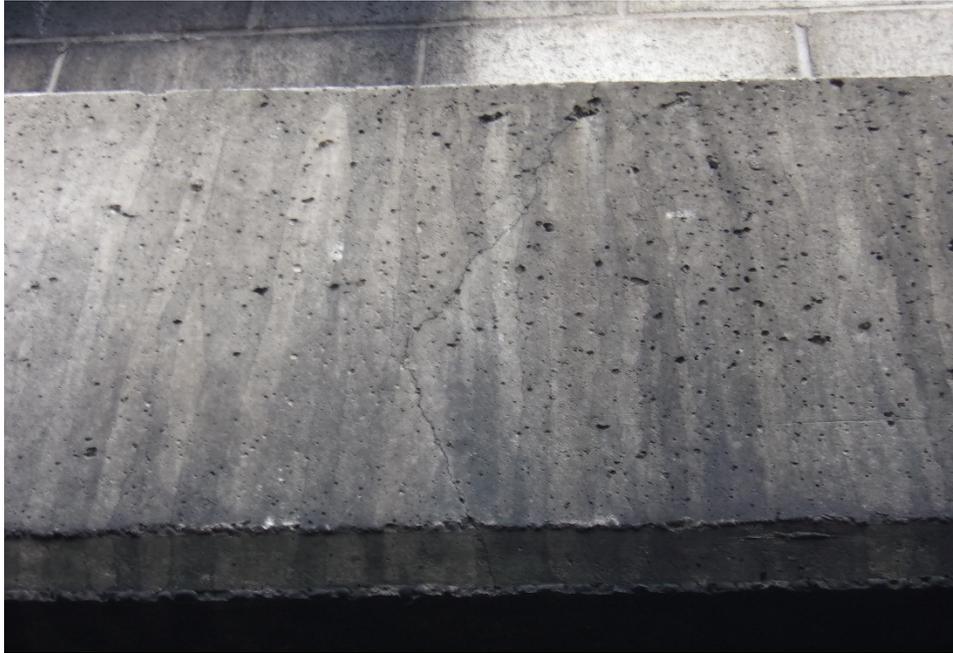
**Typical minor cracks in vertical exterior edges of elevated slabs**

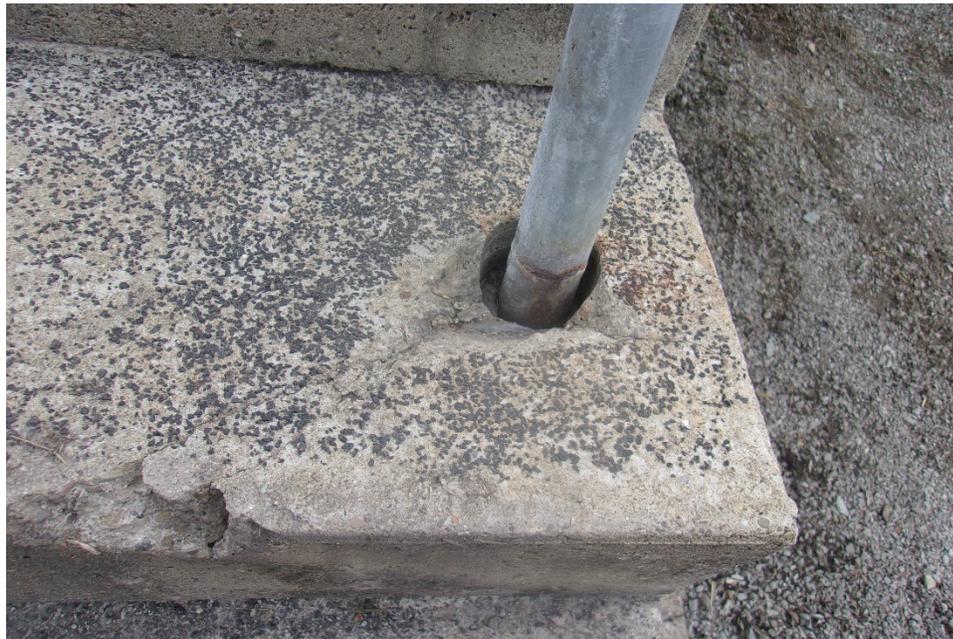
Item	Observations and Recommended Actions
Interior and Exterior Concrete Stairs (Items 12 and 26 in Appendix 1)	<p><u>Observations:</u> There are minor chips in many of the stair nosings at the interior and exterior concrete stairs.</p> <p>There is grout missing from the cores at the base of several of the embedded guardrail posts at the exterior concrete stairs.</p> <p>There are cracks at several of the embedded guardrail posts at exterior stair treads, however none of the posts are loose, but the cracks could worsen and cause the guardrails to become loose and unstable in the future.</p> <p><u>Recommended Actions:</u> No repair required at this time for the chipped stair nosings.</p> <p>Fill the cores at the base of the embedded guardrail posts at the exterior concrete stairs with a non-shrink grout to prevent standing water in the cores, which could freeze and damage the treads further and possibly cause the guardrails to become loose and unstable. Epoxy inject the cracks in the steps adjacent to the guardrail posts.</p> <p>See the guardrails section of this report for additional information.</p>

**Typical minor chips in concrete stair nosings at interior and exterior concrete stairs and typical grout missing from core at base of embedded guardrail posts**

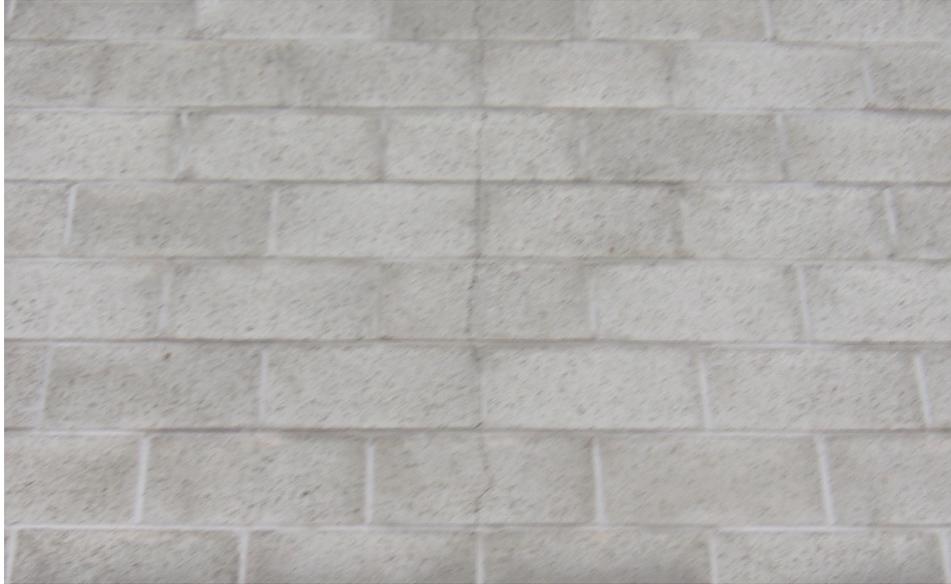
**Typical minor crack at exterior surface of exterior walls around interior stairwell**

<p>For any walls that are not removed and re-built, repoint all cracks that are wider than 3/16" or where mortar is missing from joints. Cracks narrower than 3/16" do not require repair at this time. Continue to monitor the condition of existing cracks and the potential addition of new cracks in the future.</p>
--	--------------------------------------------------------------------------------------------------------------------------------------------------------------------------------------------------------------------------------------------------------------------------------------------------------------------------

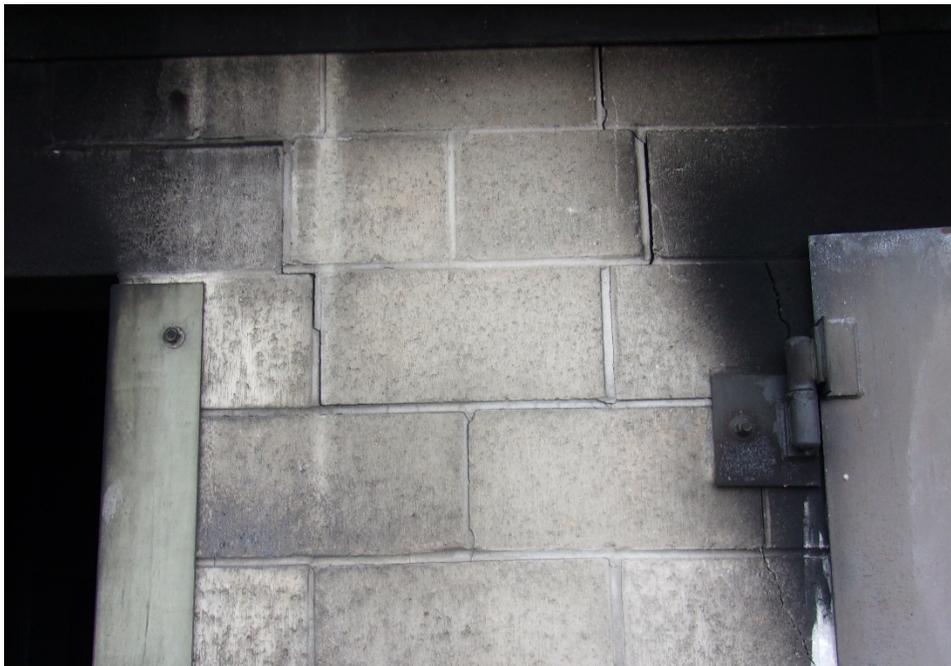
**Moderate cracks at exterior surface of first floor wall at B Elevation**

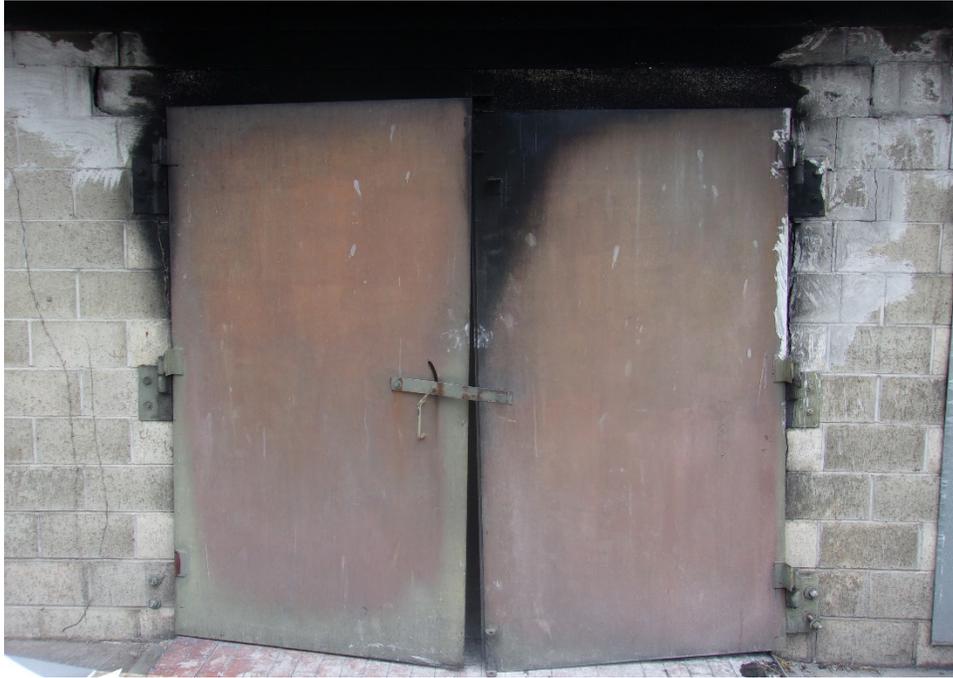
**General deterioration at exterior surface of first floor wall at A Elevation**

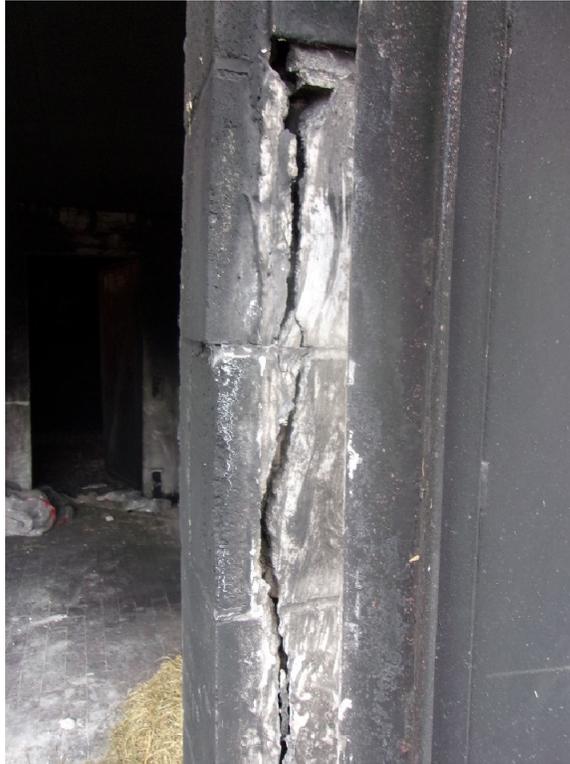
**Severe cracks at south jamb of double door opening in Room 100  
(exterior face above and interior face below)**

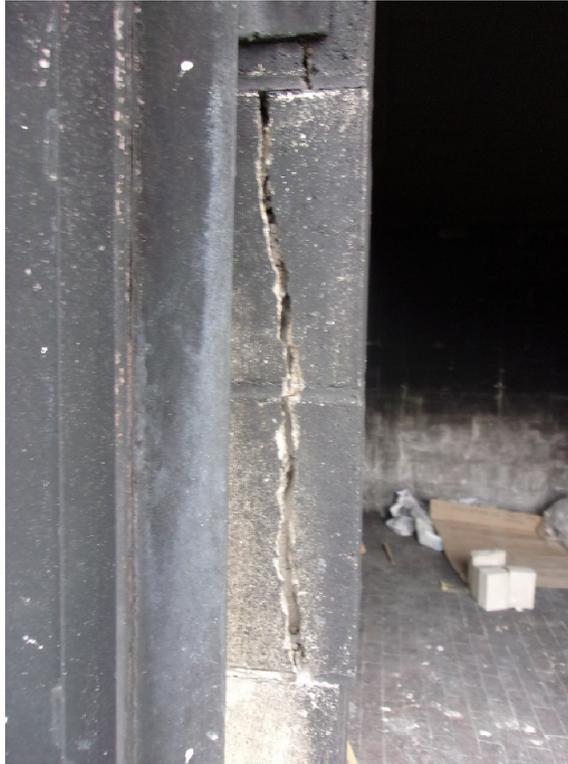
**Severe cracks at north jamb of double door opening in Room 100  
(exterior face above and interior face below)**

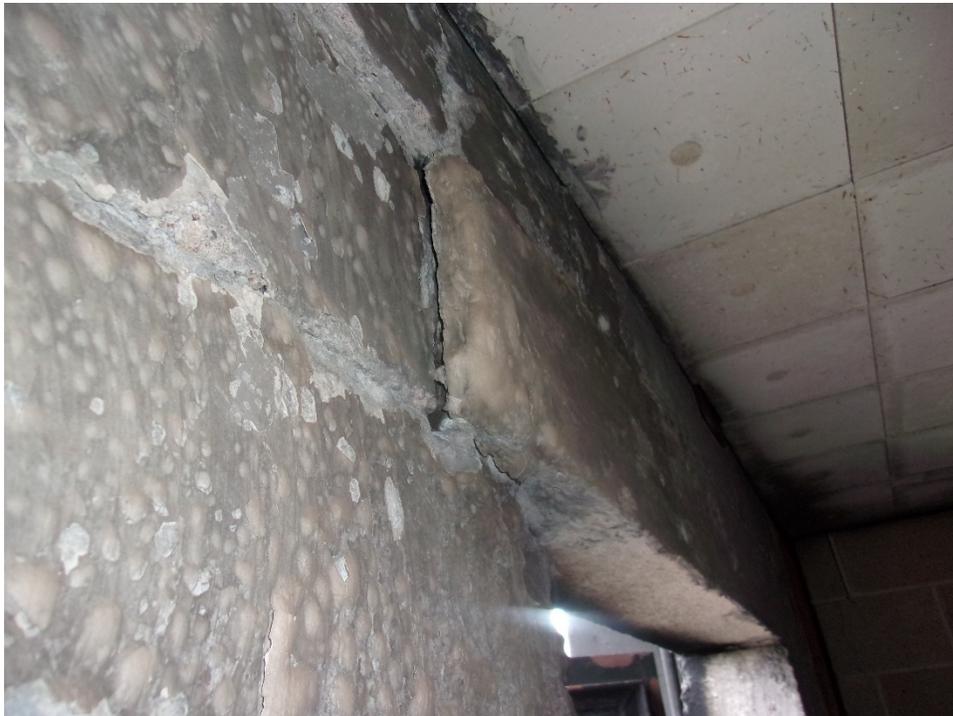
**Displacement at east end of lintel at window opening in south wall in Room 201**

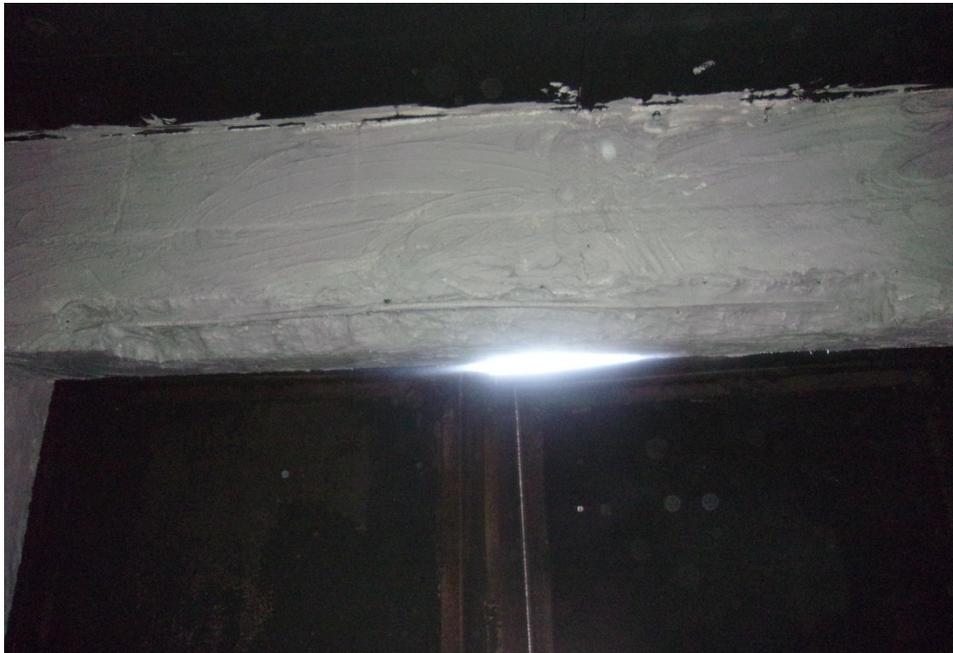
**Severely damaged lintel with exposed reinforcing  
at window opening in north wall of Room 203**

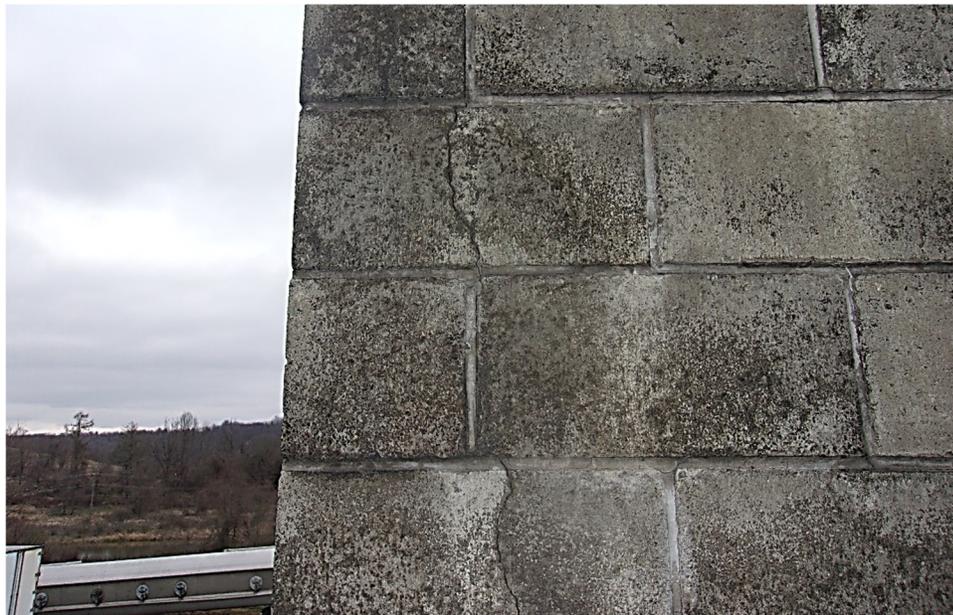
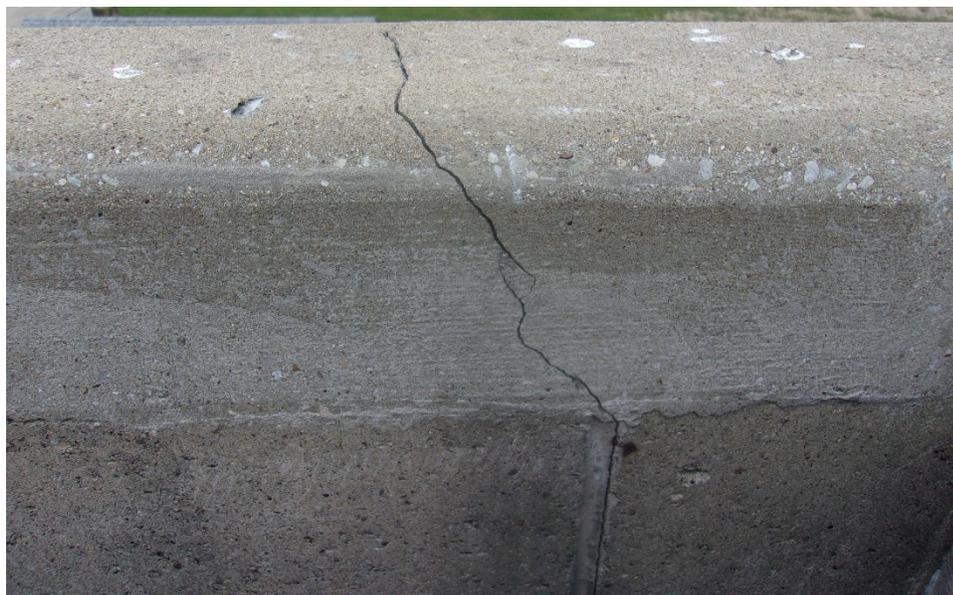
Item	Observations and Recommended Actions
Masonry Parapets at Roof (Item 24 in Appendix 1)	<p><u>Observations:</u> There are minor <i>cracks</i> at several locations at the <i>CMU</i> parapets, including at the concrete cap, at the roof.</p> <p><u>Recommended Actions:</u> The cracks in the parapet are minor and do not require repair at this time.</p>

Typical minor cracks in CMU parapets and concrete caps (above and below)

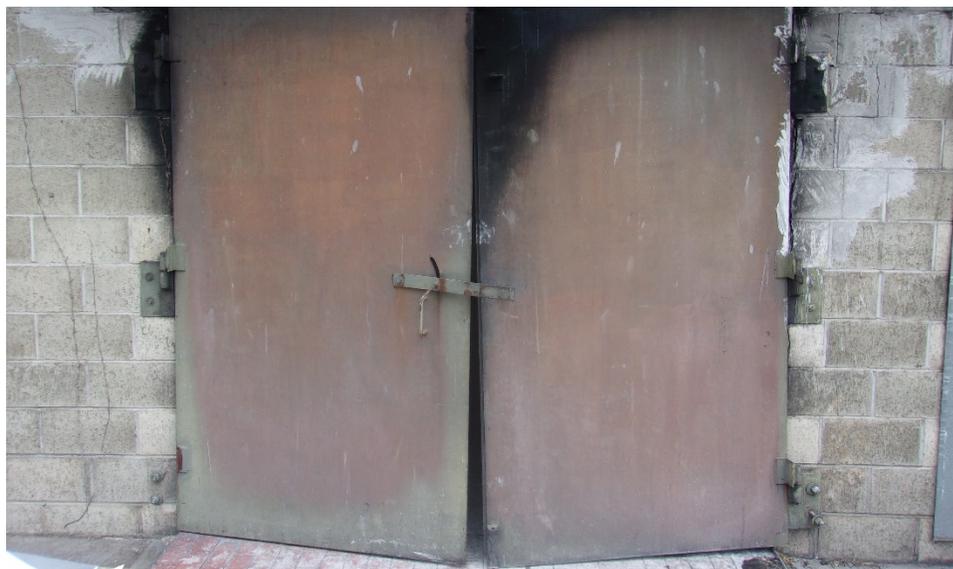
Item	Observations and Recommended Actions
Doors and Window Shutters (Items 2, 3, 17, 30, and 31 in Appendix 1)	<p><u>Observations:</u> There is minor to moderate corrosion, sagging, and warping at numerous steel plate doors and shutters. The latch bars are bent at several doors and shutters, so those doors and shutters cannot be latched properly. The top hinge is broken at the exterior door at the south side of Room 100, and the bottom hinge is broken at the interior door between Rooms 100 and 101. There are stiff hinges at several doors, so the doors are left in the open position and cannot be closed. There is a loose hinge (hinge bolts are loose and pulling out) at the east shutter at the window in Room 203. There is a missing hinge and loose anchors at another hinge at the double doors at the exterior of Room 100. The latch bar sticks in the latch catch at the exterior door between the exterior steel stairs and Hallway 202, and the latch is difficult to open.</p> <p><u>Recommended Actions:</u> <u>Immediately</u> repair or replace the loose bolts/hinge at the shutter in Room 203 so that the shutter does not fall to the ground. Another option is to remove the shutters.</p> <p>Remove and replace all the doors and windows and associated hardware, with the possible exception of the door between the interior and exterior concrete stairs (if the exterior walls around the stairwell are not replaced).</p>

**Corroded, warped and sagging double doors at exterior of Room 100**

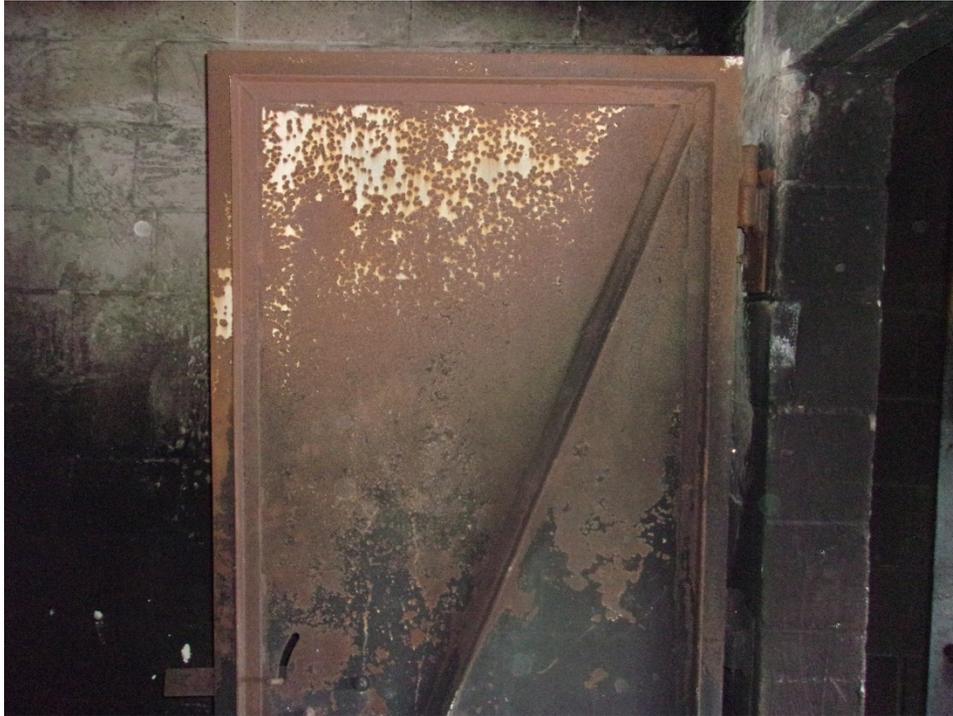
**Corroded, warped, and sagging doors between Rooms 100 and 101**

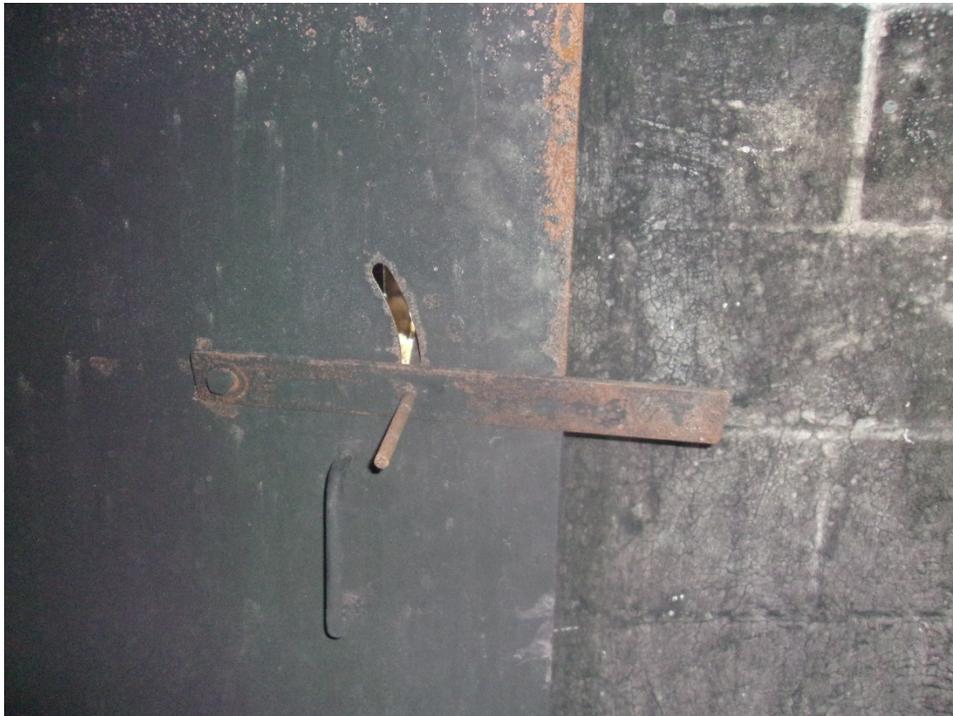
**Bent latch bar and no means of latching interior door between Rooms 100 and 101**

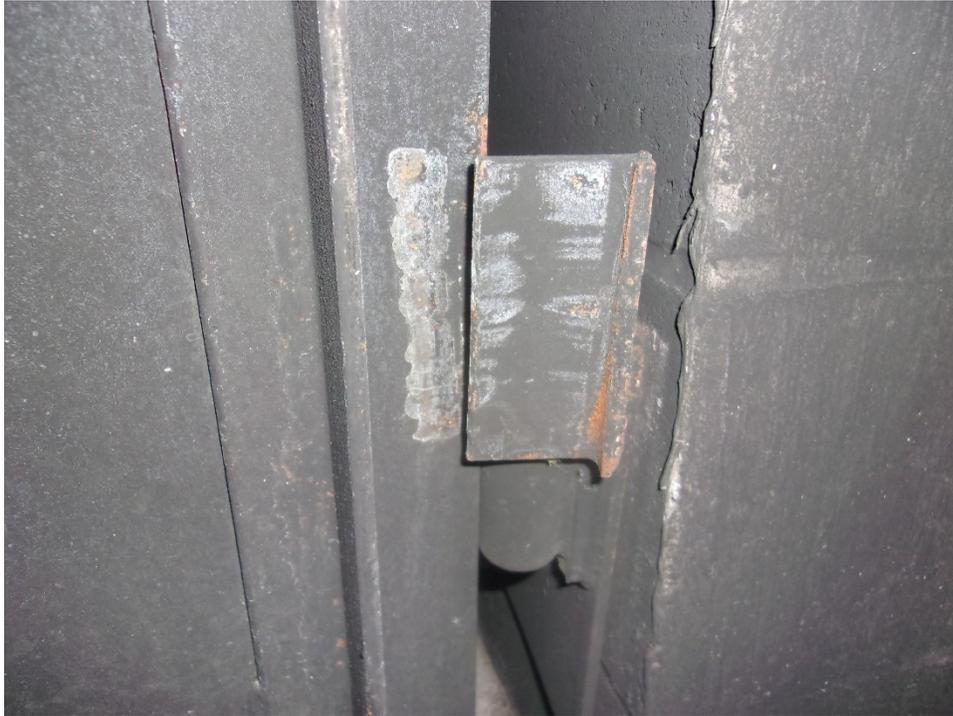
**Broken bottom hinge at door between Rooms 100 and 101**

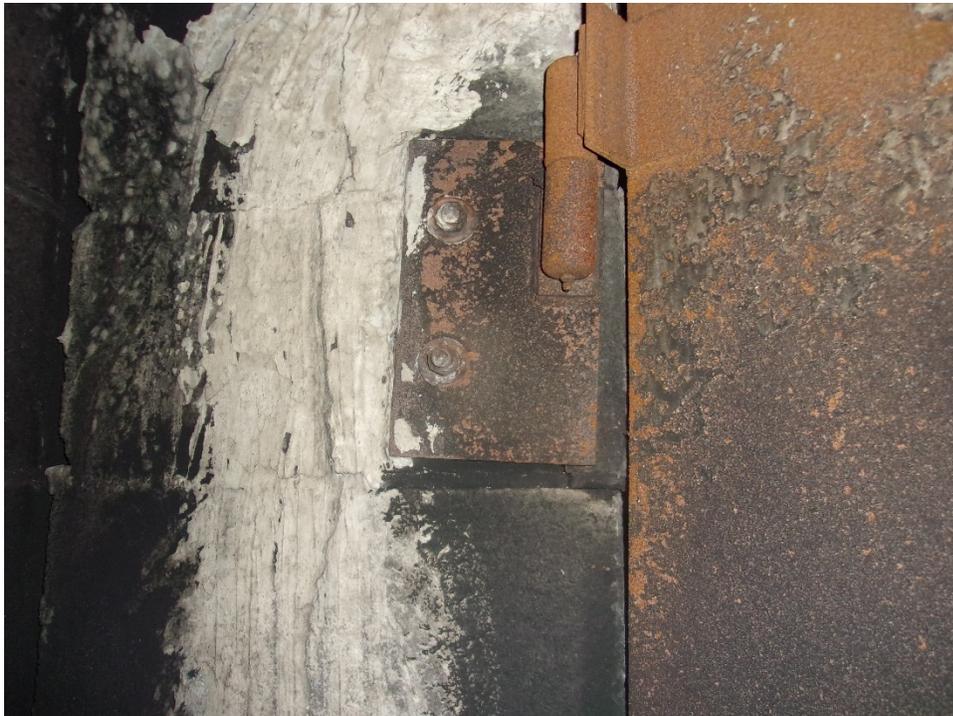
**Corroded and binding top hinge at door between Rooms 100 and 101**

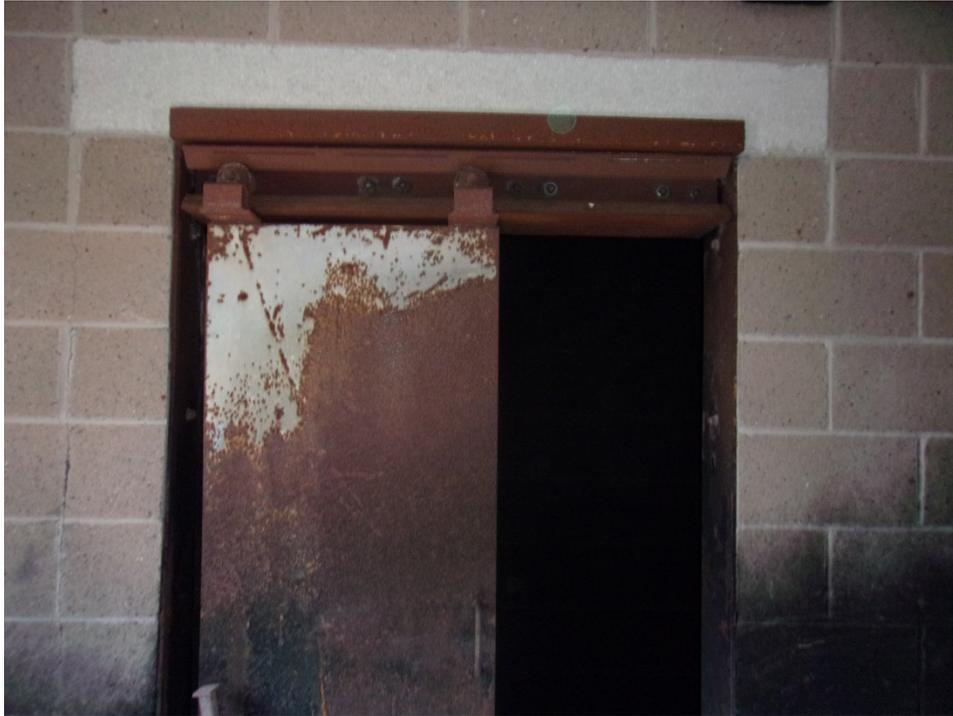
**Corroded sliding doors at closet in Room 201 are inoperable.**

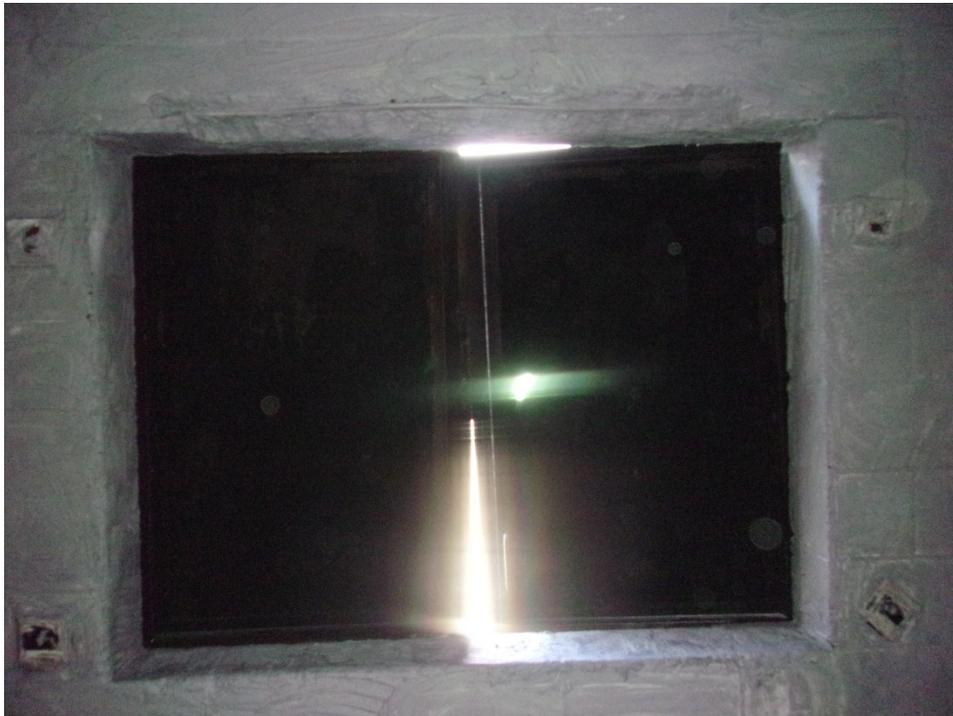
**Corroded, warped and sagging shutters at Room 203 cannot be latched.**

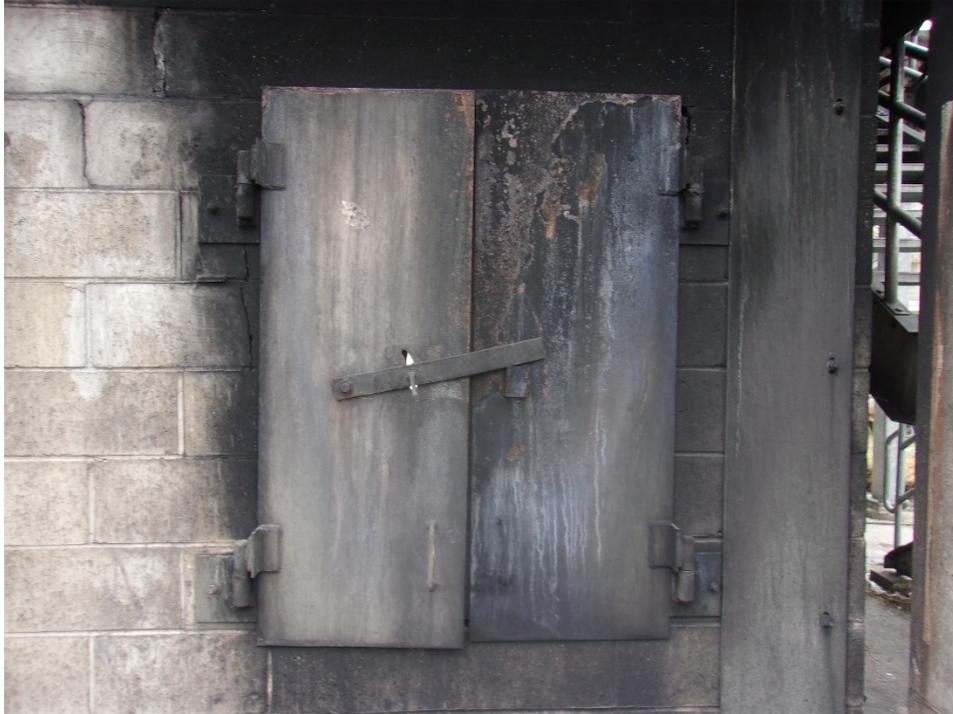
**Warped and corroded shutters at Room 101 (above and below)  
with bent latch bar cannot be latched.**

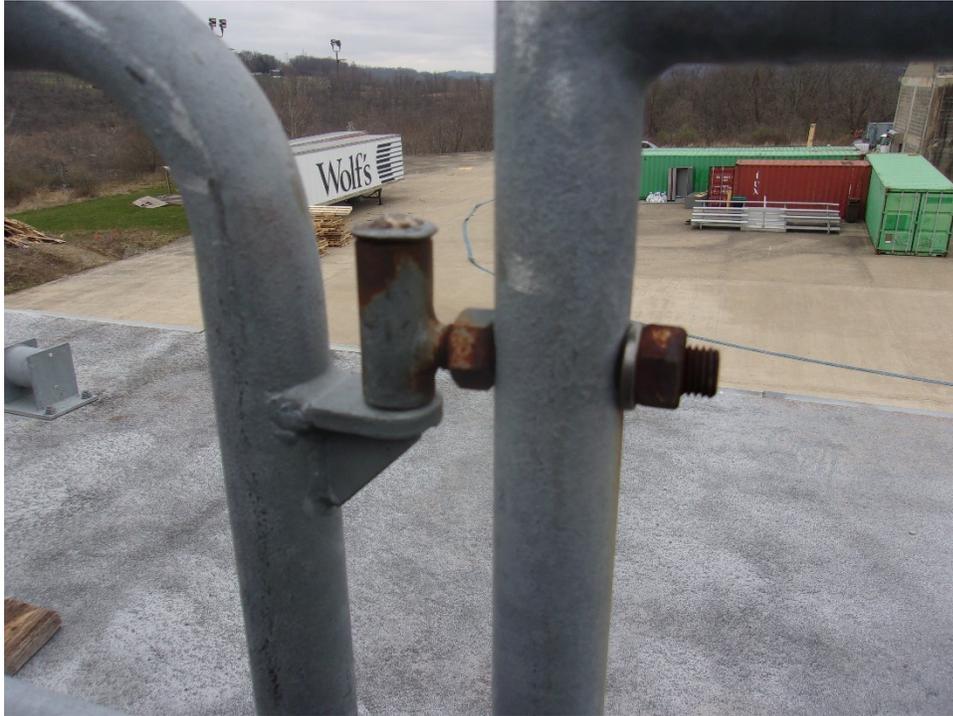
Item	Observations and Recommended Actions
<p>Guardrails at Roof, Exterior Steel Stairs and Exterior Concrete Stairs (Items 25 and 27 in Appendix 1)</p>	<p><u>Observations:</u> There is minor corrosion on guardrails at several locations at the roof and at the exterior steel and concrete stairs. There are several missing bolts at the guardrails at the north side of the second floor deck at the exterior steel stairs. As previously indicated at the embedded guardrail posts at the exterior concrete stairs, there is grout missing from the cores at the base of the embedded guardrail posts at the roof.</p> <p>There are galvanizing ventilation holes in guardrails at the roof and at the exterior steel and concrete stairs. It is possible for water to enter the guardrails through the galvanizing vent holes, filling up the posts and corroding the posts from the inside or freezing, expanding and cracking or spalling the surrounding concrete. This condition, although not severe, has occurred at several other burn buildings.</p> <p><u>Recommended Actions:</u> Provide galvanized bolts where they are missing at the guardrails at the north side of the exterior steel stairs.</p> <p>Fill the cores at the base of the embedded guardrail posts at the roof with a non-shrink grout to prevent standing water in the cores, which could freeze and damage the surrounding concrete and possibly cause the guardrails to become loose and unstable.</p> <p>Plug any galvanizing vent holes in the guardrails to help prevent moisture and/or insects from getting inside the railing pipes. Holes can be plugged in several ways. One way is to hammer in a zinc galvanizing vent hole plug by Bruce Reichelt Enterprises (503-879-9085), grind it smooth, and touch up with galvanizing repair paint. A second option is to plug the holes with a black nylon bumper panel retainer by Au-ve-co Products (Part number 10831) and supplied by Fastenal (Fastenal part number 0162595 at <a href="http://www.fastenal.com">www.fastenal.com</a>). Provide a different size plug if galvanizing vent holes are a different size than the specified plug. A third way, although more time consuming and costly, is to plug weld the vent holes, grind the welds smooth, and touch up with galvanizing repair paint.</p> <p>If desired, remove corrosion from guardrails and touch up with two coats of galvanizing repair paint.</p>

**Typical minor corrosion on hinges at guardrail gates at roof**

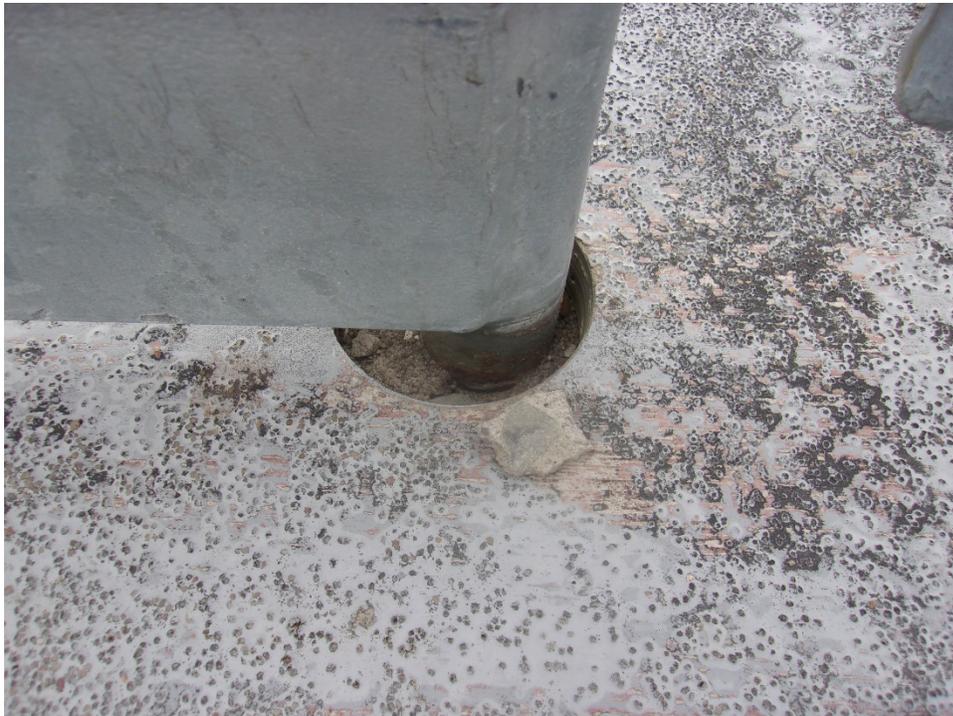
**Typical missing grout in core at base of embedded guardrail posts at roof**

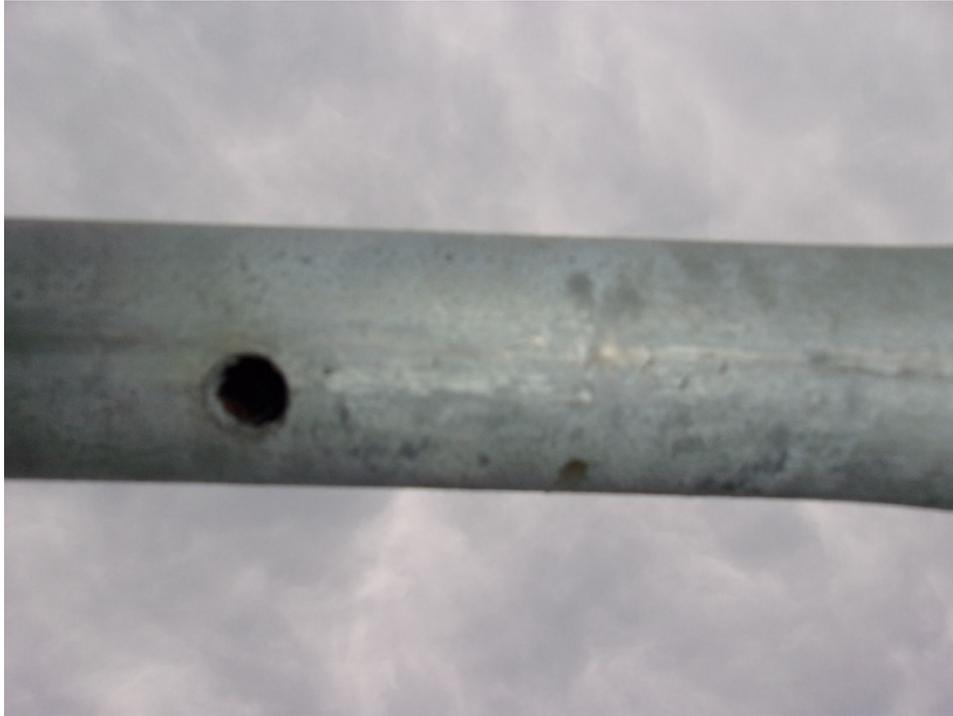
**Typical galvanizing vent holes in guardrails at roof**

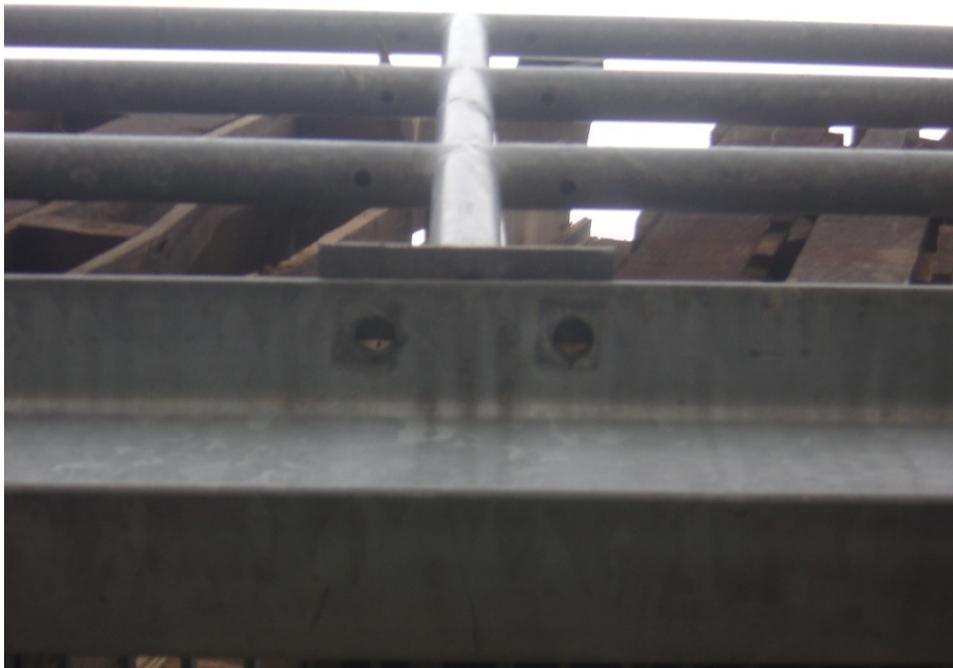
**Missing bolts at guardrails at north side of exterior steel stairs**

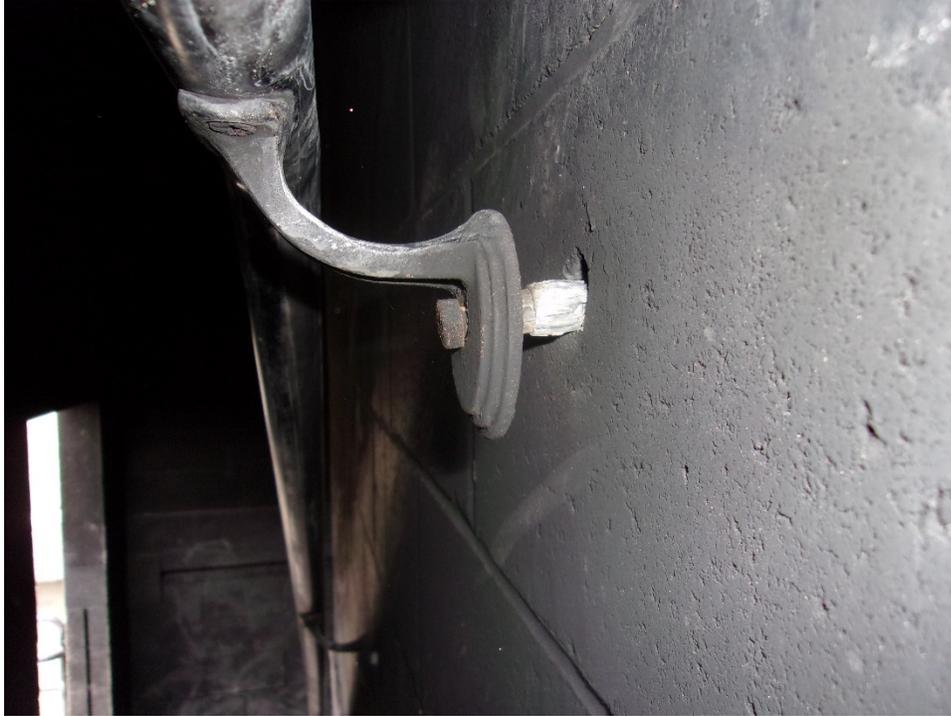
Item	Observations and Recommended Actions
Handrails at Interior Stairwell (Item 15 in Appendix 1)	<p><u>Observations:</u> There are loose anchors at several handrail brackets in the interior stairwell.</p> <p><u>Recommended Actions:</u> Tighten or replace loose anchors at handrail brackets at the interior stairwell.</p>

**Loose anchor at handrail bracket at interior stairwell**

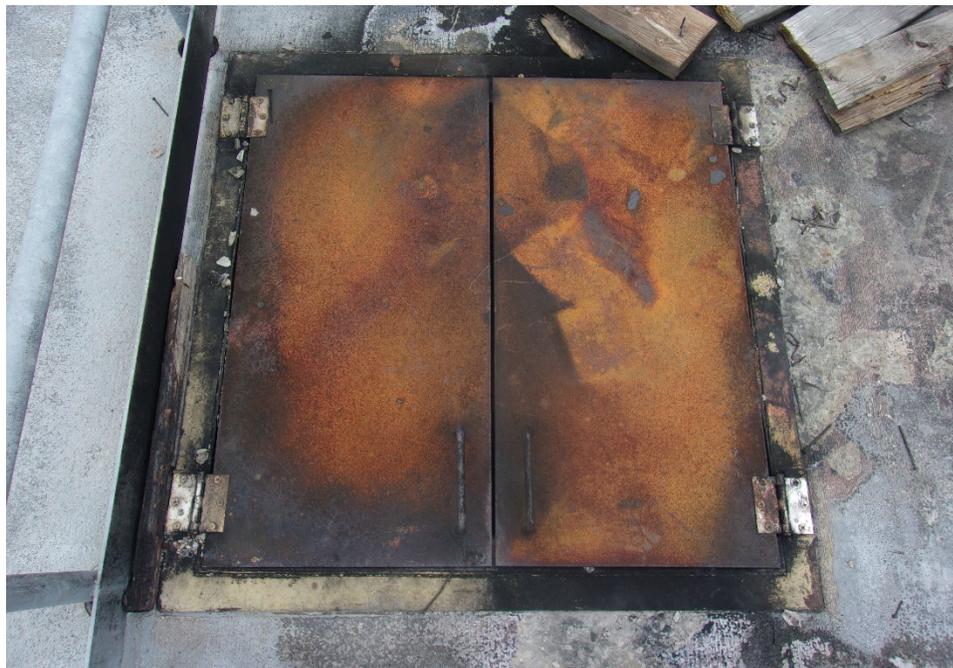
Item	Observations and Recommended Actions
Miscellaneous Steel Items (Items 18 and 23 in Appendix 1)	<p><u>Observations:</u> There is moderate corrosion and warping on steel items at the chopout opening at the ceiling of Room 201, including the pulldown frame at the bottom of the opening and the joist hangers within the opening. Anchors are failing and pulling out of the concrete at the pulldown frame, which is sagging and holding chunks of concrete that have spalled at the opening.</p> <p>There is moderate corrosion on the steel cover plates at the ventilation opening at the roof (ceiling of the Room 203 closet that has been blocked in from below).</p> <p><u>Recommended Actions:</u> <u>Immediately</u> remove the pulldown frame and the joist hangers at the chopout opening at the ceiling of Room 201. Make concrete repairs as described on Page 8 of this report.</p> <p>If desired, remove corrosion from the cover plates at the ventilation opening at the ceiling of the Room 203 closet and apply two coats of exterior quality paint. Another option is to remove the existing cover plates and replace with a new refractory concrete curb at the roof slab around the opening and new steel cover plates over the opening.</p>

**Corroded cover plates and no concrete curb at Room 203 ventilation opening**

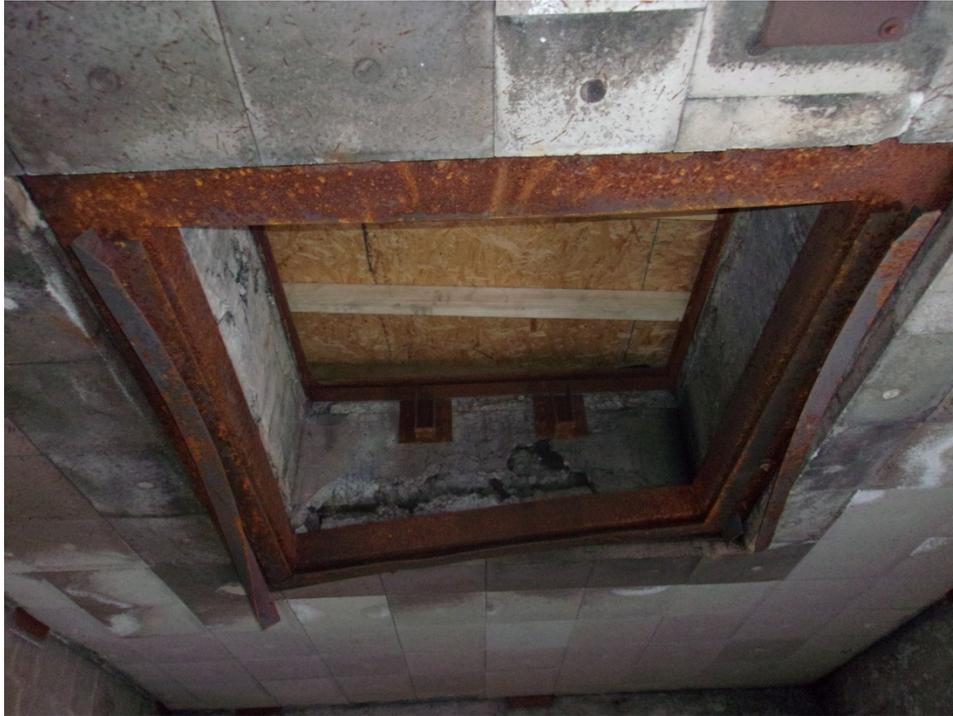
**Corroded, warped and sagging pulldown frame and corroded joist hangers at chopout opening at ceiling of Room 201 (above and below)**

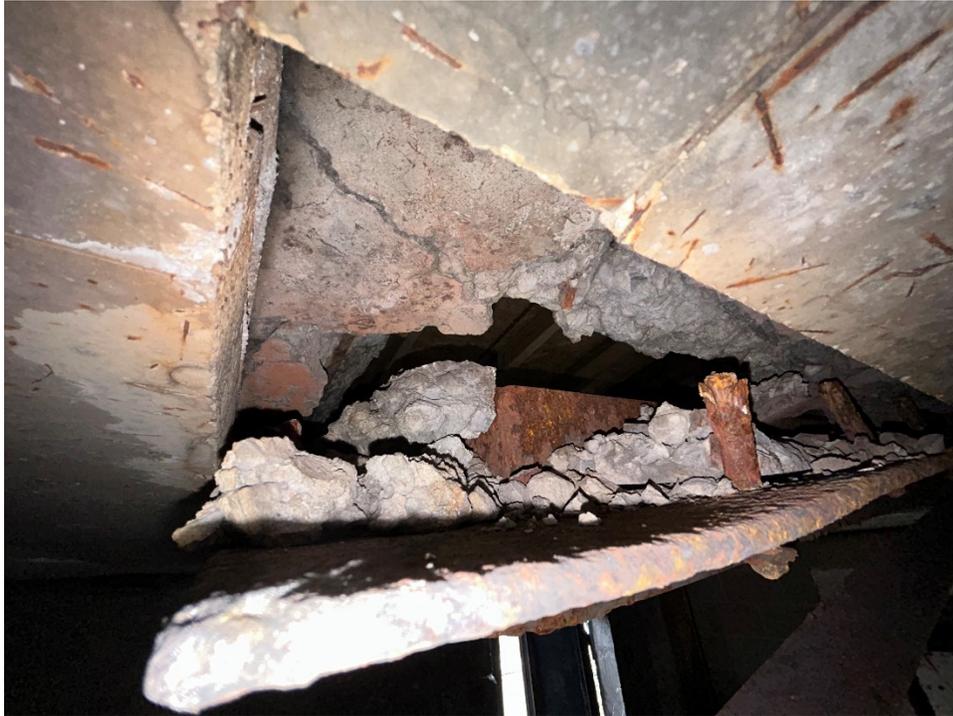
**Anchors pulling out at pulldown frame, which is holding spalled concrete, at chopout opening at ceiling in Room 201 (above and below)**
