## **Structural Evaluation**

**Westmoreland County Community College PSTC Class A Live Fire  
Training Structure ("Burn Building")**

**EL&M No.: 23012**

**July 18, 2023**

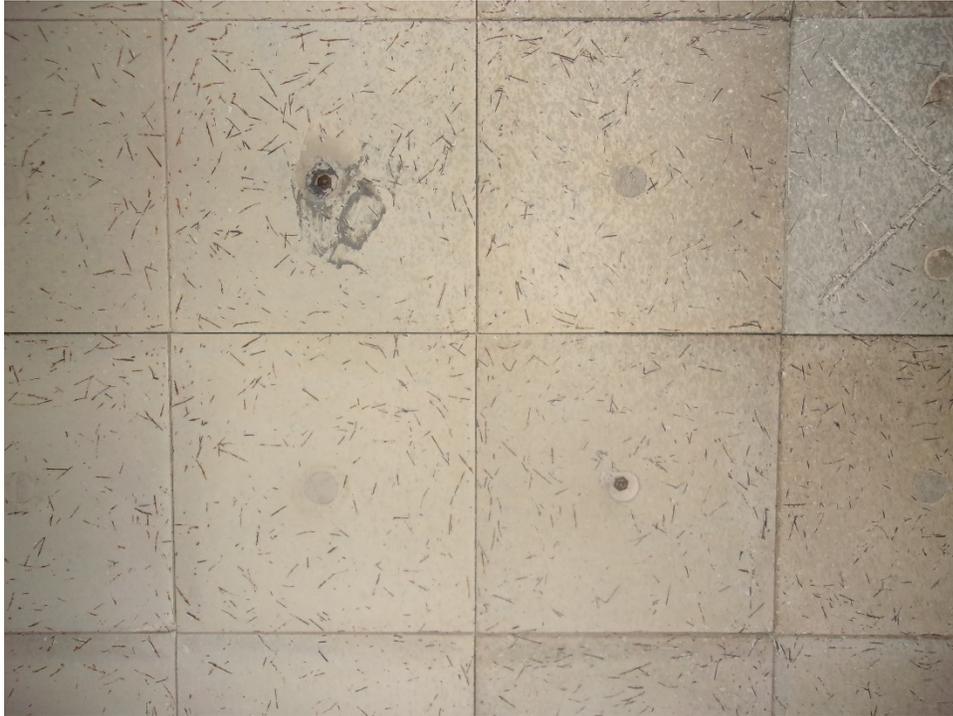
Item	Observations and Recommended Actions
Thermal Lining System on Ceilings and Fire Brick on Floors (Items 1, 9, 10, 11, and 28 in Appendix 1)	<p><u>Observations:</u> There are numerous exposed bolt heads in the HTL System 203 tiles at ceilings and walls, where the fire clay plug covering the bolt has fallen out. There is <i>efflorescence</i> on the surface of lining tiles at the southeast corner of Room 101.</p> <p>There is no thermal lining above the tops of interior walls. This is not easy to observe at the full-height walls, however it is evident when observing the partial-height wall in Room 101, which was originally a full-height wall when the burn building was constructed. The insulation boards and refractory cement that has been used to cover the concrete ceiling above the partial-height wall are cracked and delaminated.</p> <p>The refractory packing at the end of the thermal lining system on the face of the second floor slab is damaged at the north exterior wall.</p> <p>In Rooms 100 and 101, there are several missing brick pavers on the floor at the south side of the rooms. There is also a small area of refractory cement at the floor, at the south end of the partial height wall, that is cracked and delaminated.</p> <p><u>Recommended Actions:</u> Where thermal lining system bolt heads are exposed, tighten the bolt, if necessary, to a snug tight condition. Clean the holes and patch the fire clay plugs over the bolt heads in accordance with the manufacturer's recommendations.</p> <p>When the interior walls are removed, also remove all bracing angles at the tops of the walls. Remove the insulation boards and refractory cement from the ceiling above the partial-height wall in Room 101. Provide thermal linings at the ceiling at these locations. Then construct the new CMU walls and provide stainless steel bracing assemblies at the tops of the interior walls, to brace the tops of the walls.</p> <p>Where refractory packing at the end of thermal lining tiles is damaged or missing, patch the packing in accordance with the manufacturer's recommendations.</p> <p>Replace the missing fire bricks on the floors in Rooms 100 and 101. Remove the damaged refractory cement infill at the south end of the partial height wall in Room 101 and provide new fire brick at the floor instead.</p>

**Clay plugs falling out at thermal lining system tiles**

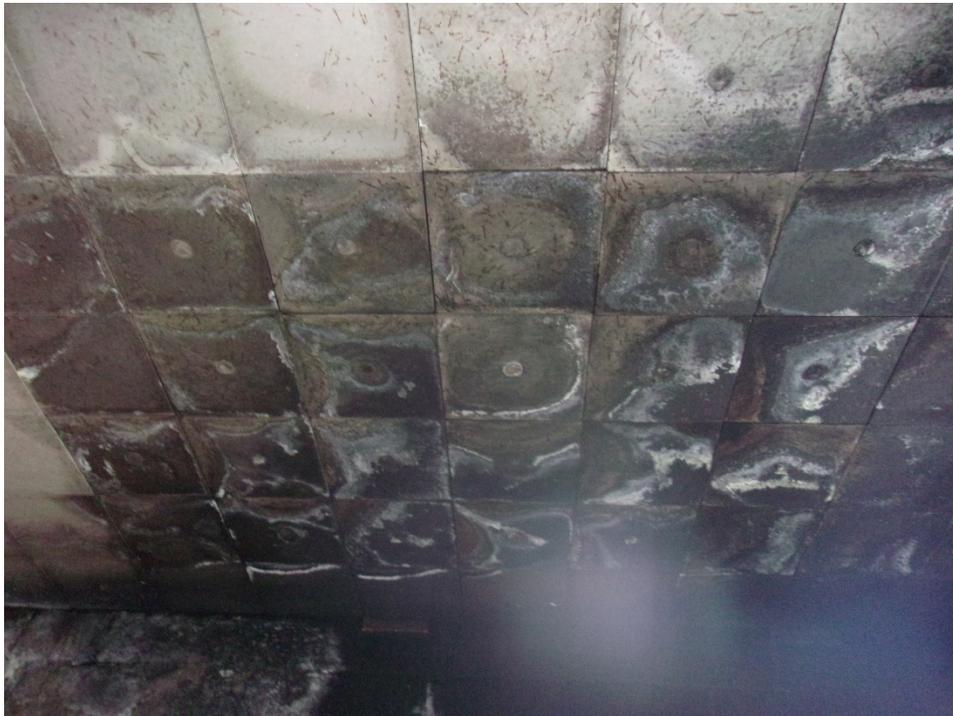
**Efflorescence on thermal lining system tiles at southeast corner of Room 101**

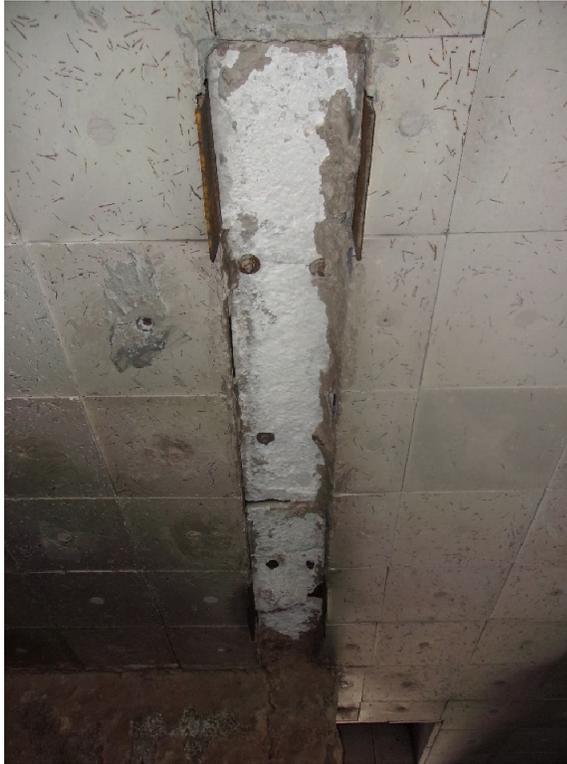
**Insulation boards and refractory cement at ceiling  
above interior partial-height walls in Room 101**

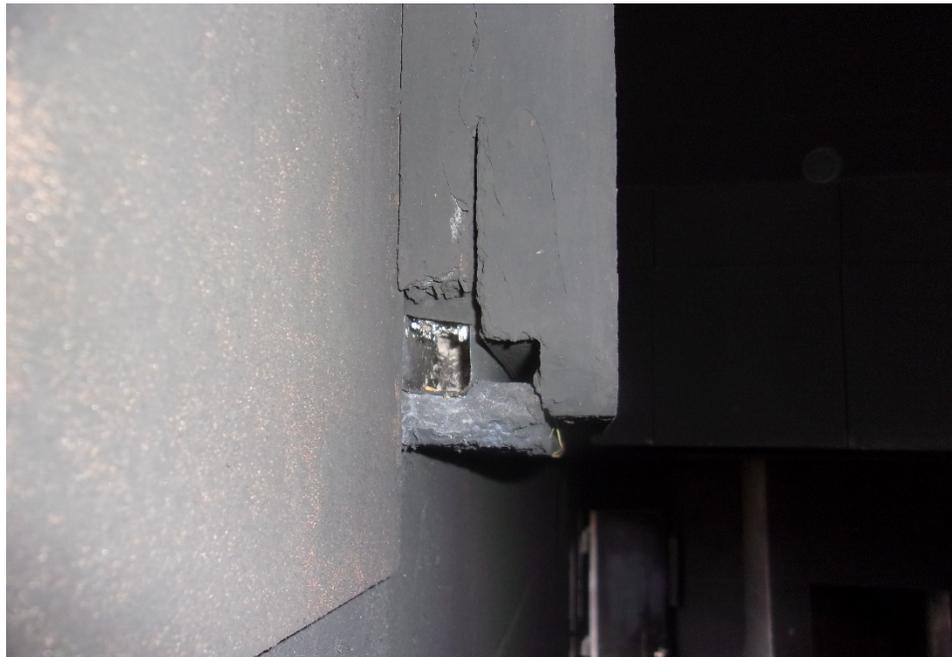
**Damaged refractory packing at end of thermal lining system on face  
of concrete slab at north side of interior stairwell**

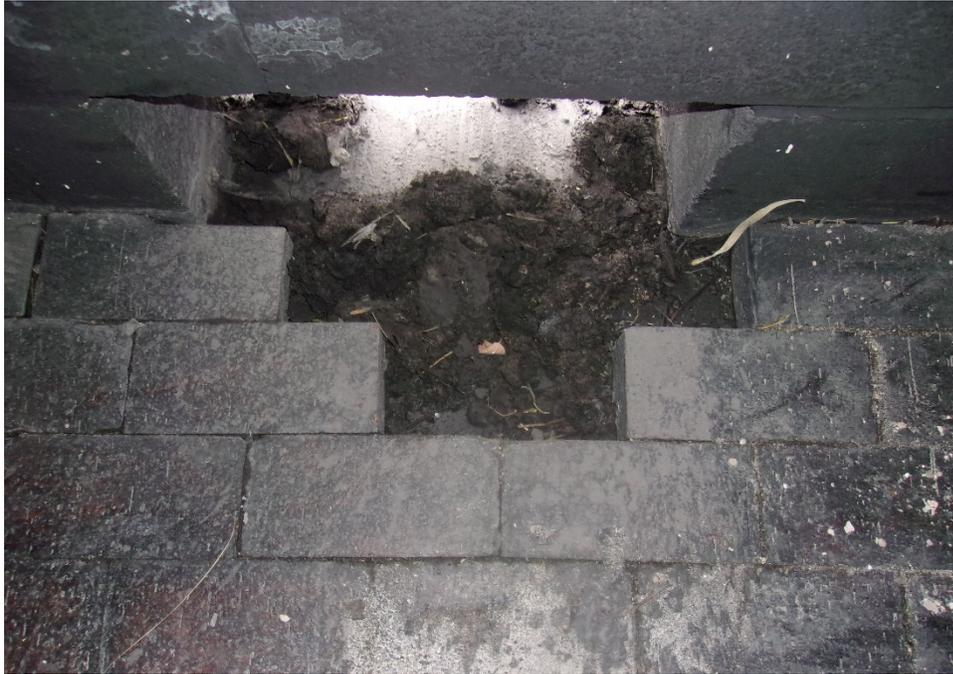
**Missing fire brick at floor in Room 101**

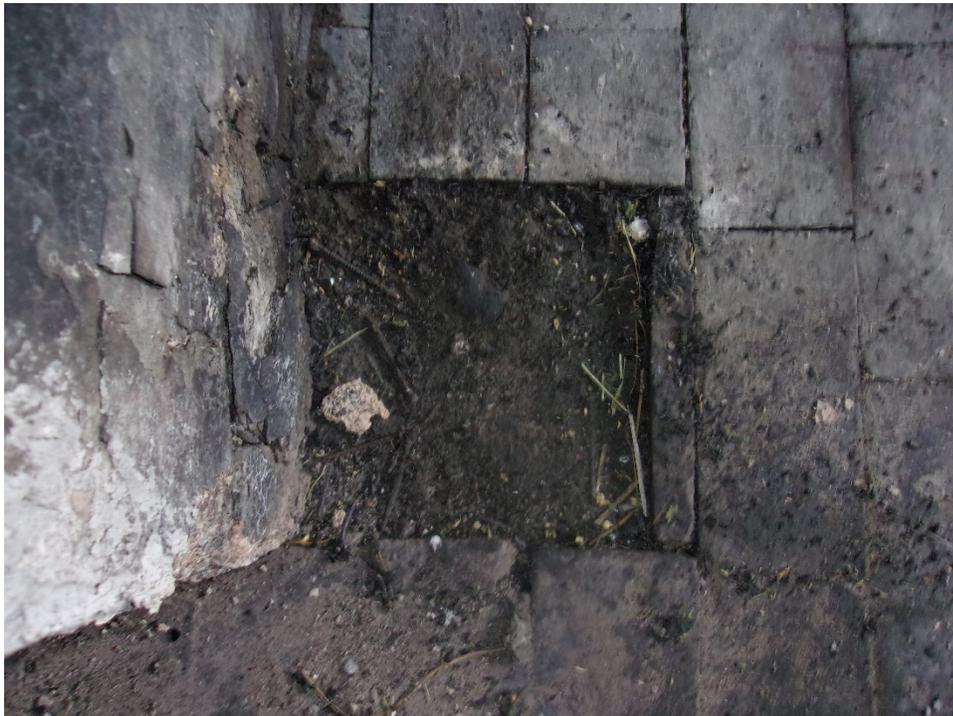
**Cracked and delaminated refractory cement infill at floor  
at south end of interior partial-height wall in Room 101**

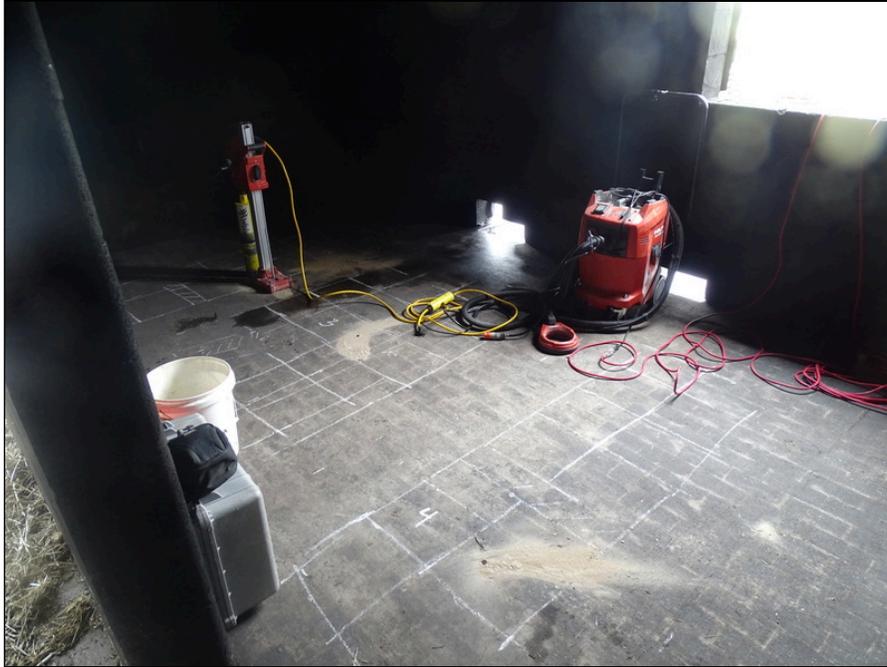
Photograph 1: Coring operations overview

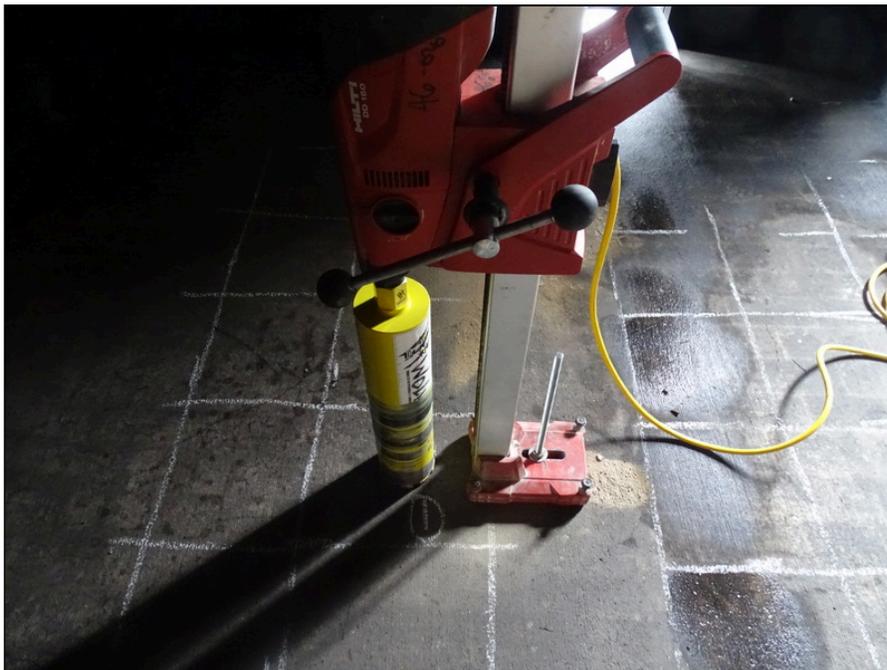
Photograph 2: Coring setup at location #1

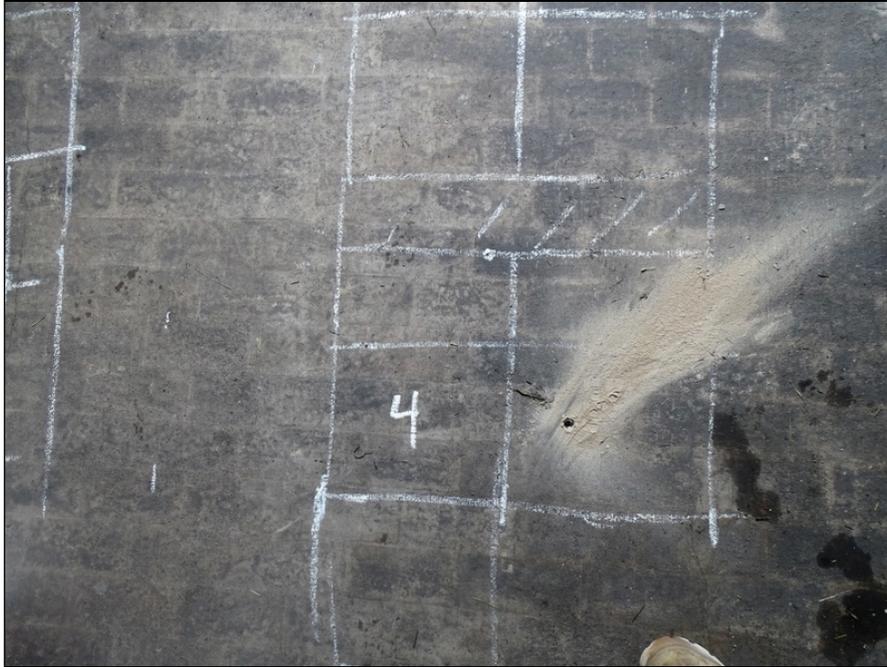
Photograph 5: Core location #4 prior to drilling

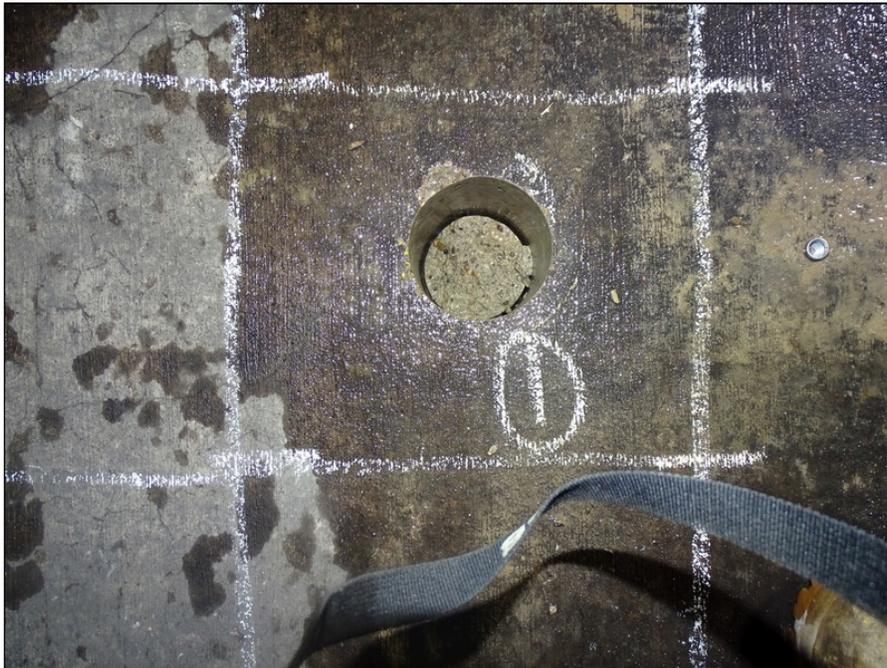
Photograph 6: Location #1 after core extraction

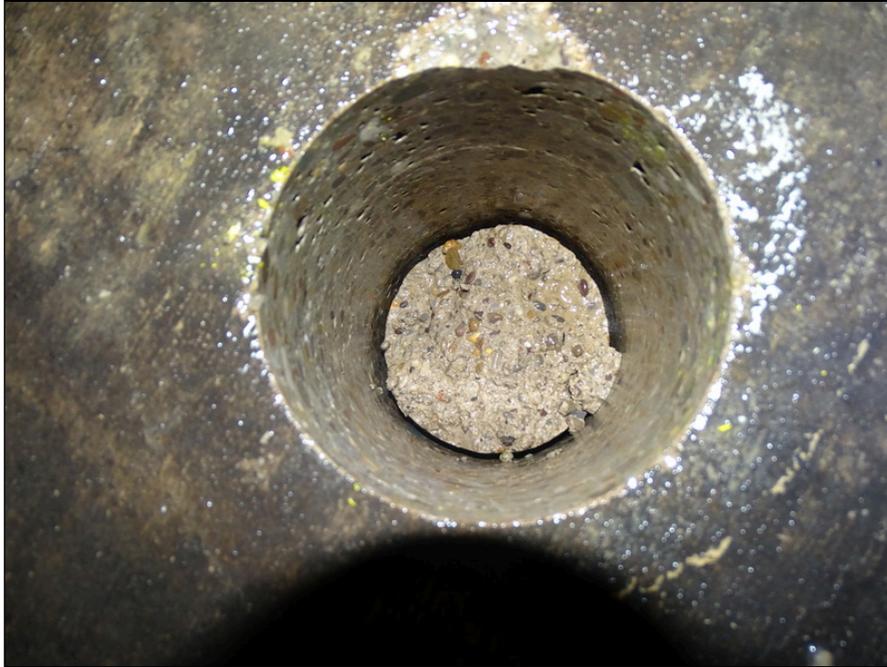
Photograph 7: Location #1 after core extraction

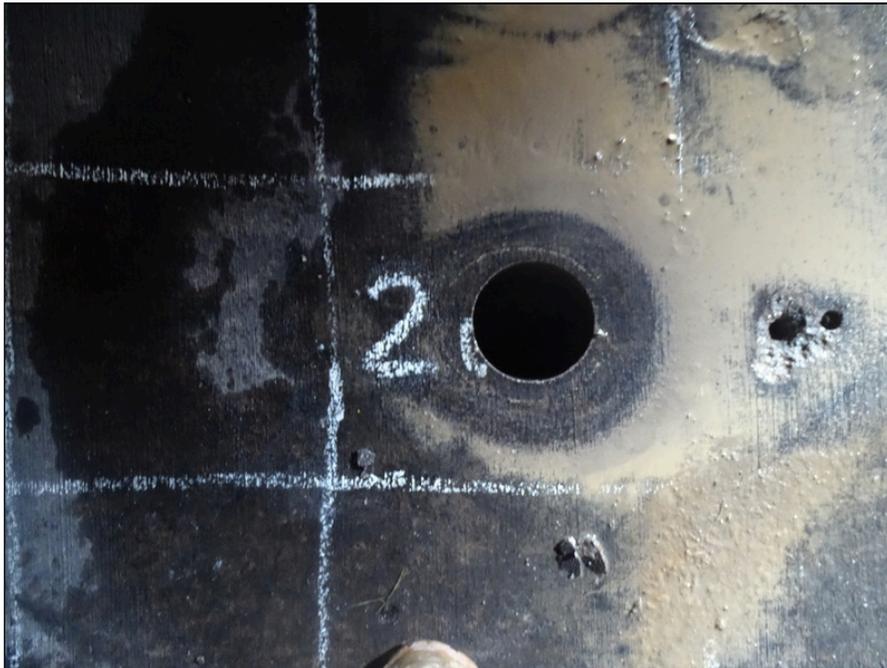
Photograph 8: Location #2 after core extraction

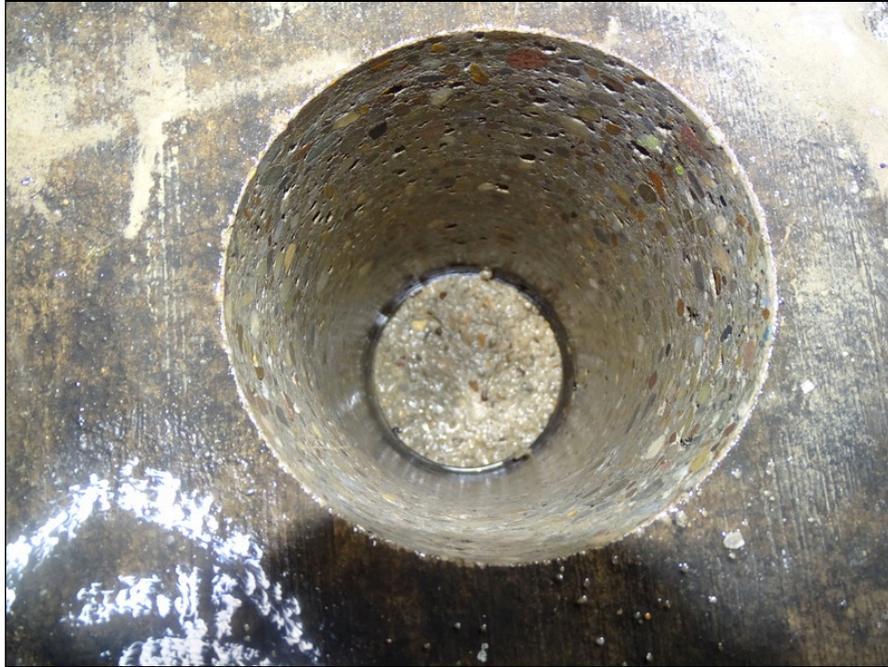
Photograph 9: Location #2 after core extraction

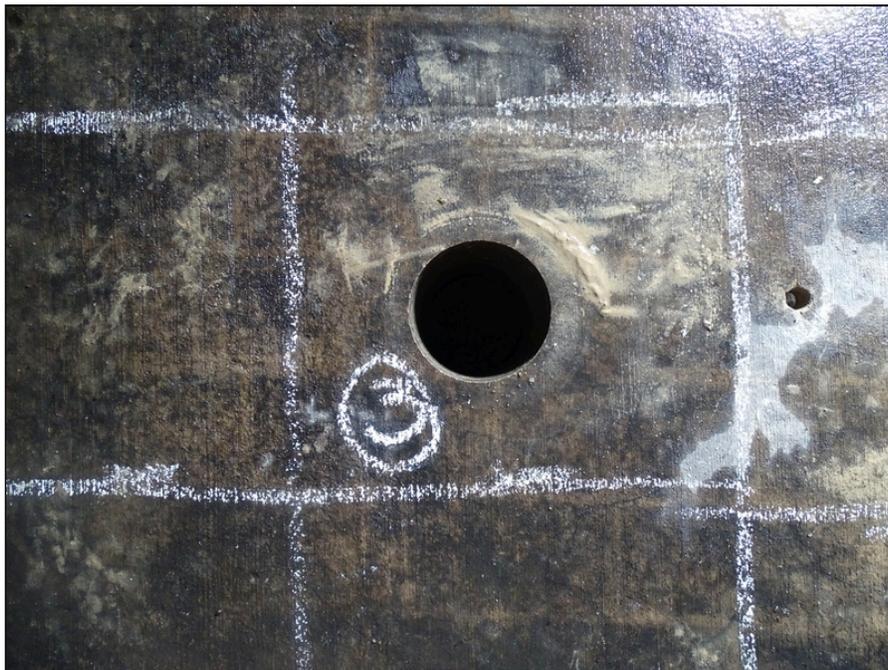
Photograph 10: Location #3 after core extraction

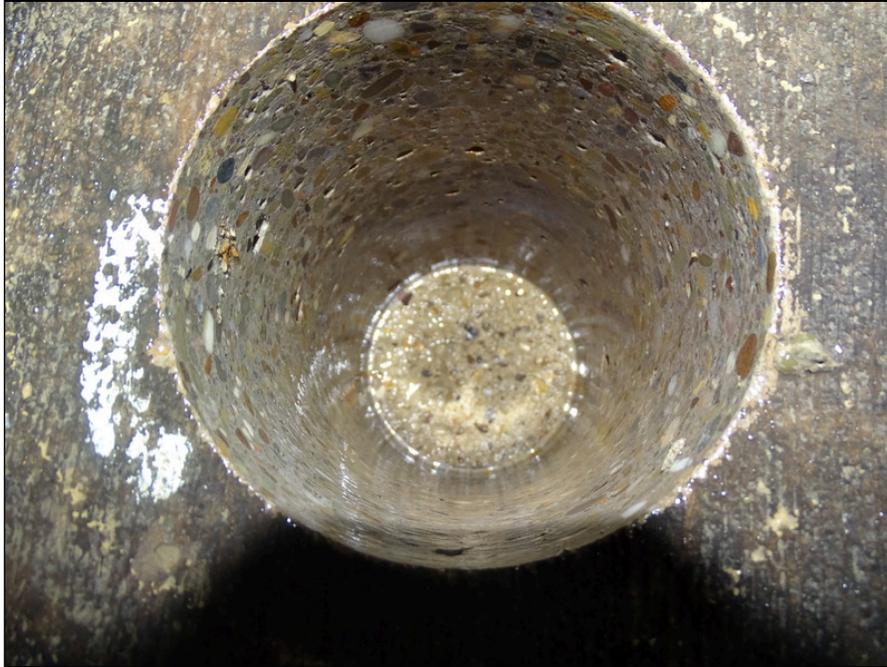
Photograph 11: Location #3 after core extraction

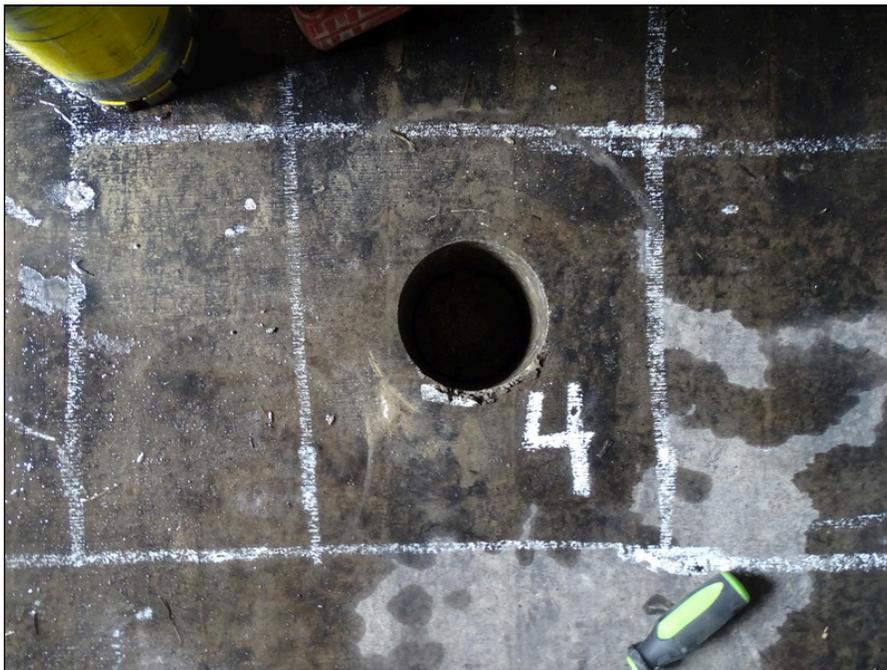
Photograph 12: Location #4 after core extraction

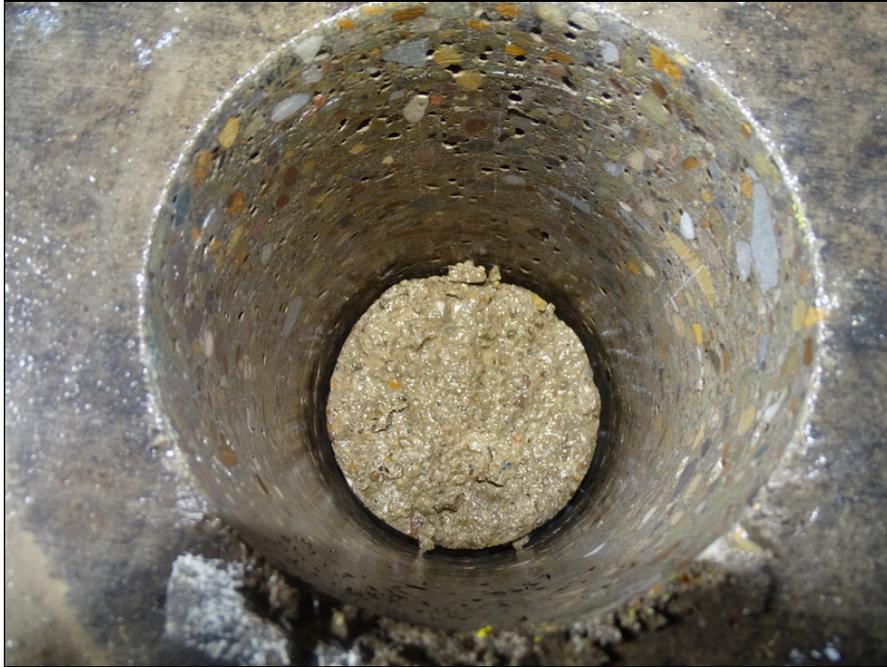
Photograph 13: Location #4 after core extraction

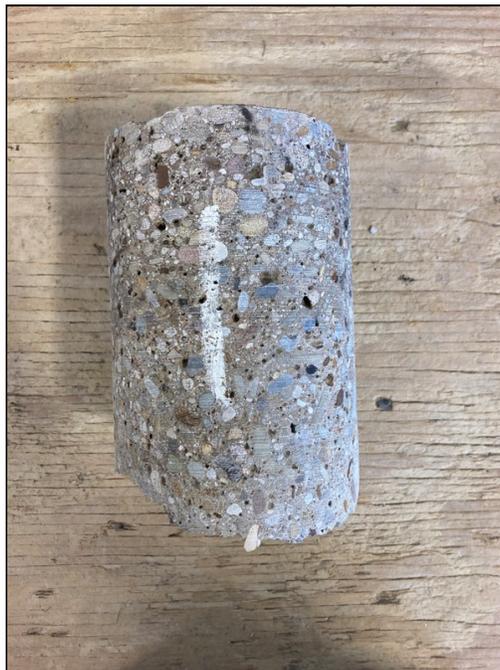
Photograph 14: Laboratory photo of extracted core #1

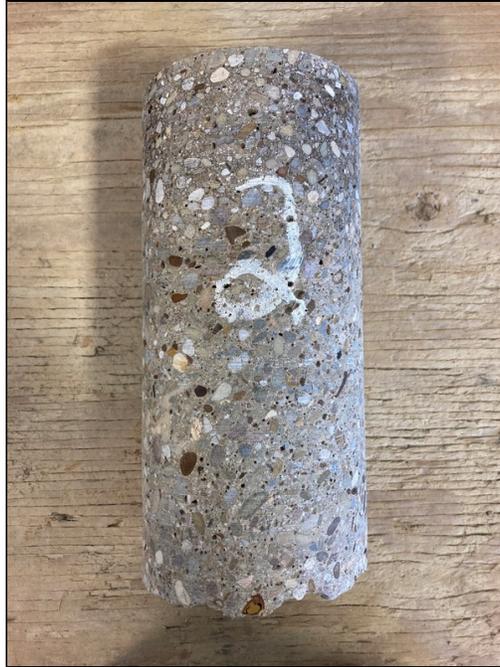
Photograph 15: Laboratory photo of extracted core #2

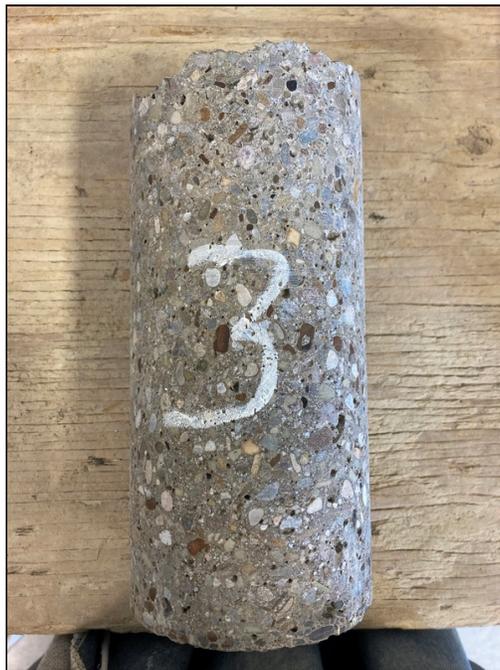
Photograph 16: Laboratory photo of extracted core #3

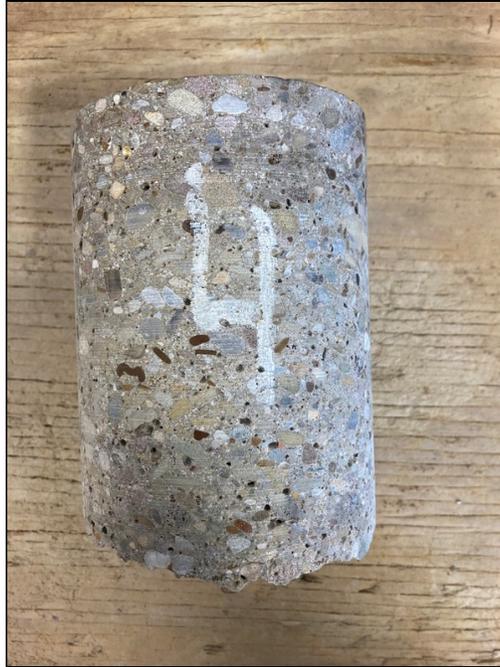
Photograph 17: Laboratory photo of extracted core #4
